## BACKGROUND

Two (2) TPE331-10AV engines were torn down at Product Integrity (PI) in support of a NTSB accident investigation. The engines had been removed from the left and right sides of the same aircraft. The left engine was identified as ESN P106025C. The right engine was identified as ESN P106026C.

**PART NAME:** Torsion Shaft  
**PART NUMBER:** 3108200-1 (Engine)  
**PART S/N:** Unknown

**EQUIP/ENGINE:** TPE331-10AV  
**ENGINE S/Ns:** P106025C/P106026C  
**OPERATING TIME:** Not Reported  
**OPERATING CYCLES:** Not Reported

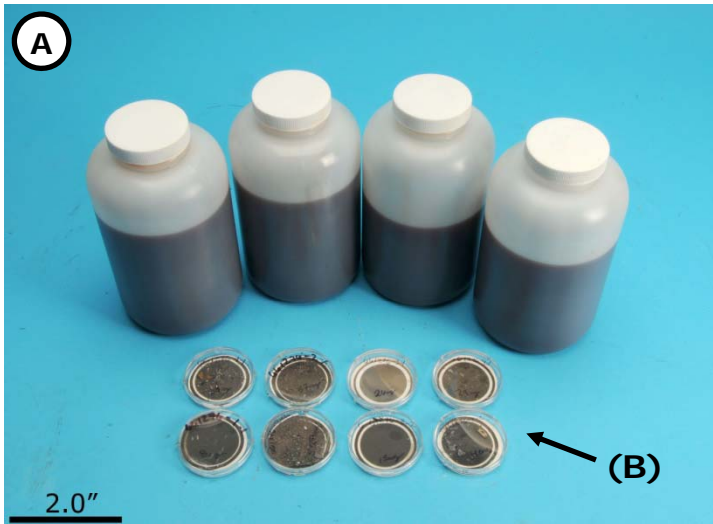
**Figure 11.**

Approximately 1 gallon of oil was collected from ESN P106025C for analysis (Figure 11A). The oil sample exhibited a reddish hue at the time of submission. The oil was filtered using 8  $\mu\text{m}$  Millipore filters. A total of 482 grams of material was removed from the oil (Figure 11B).

(A) Overall photo showing the oil sample collected from ESN P106025C.  
(B) Close-up photo showing the debris collected from the filtered oil sample.

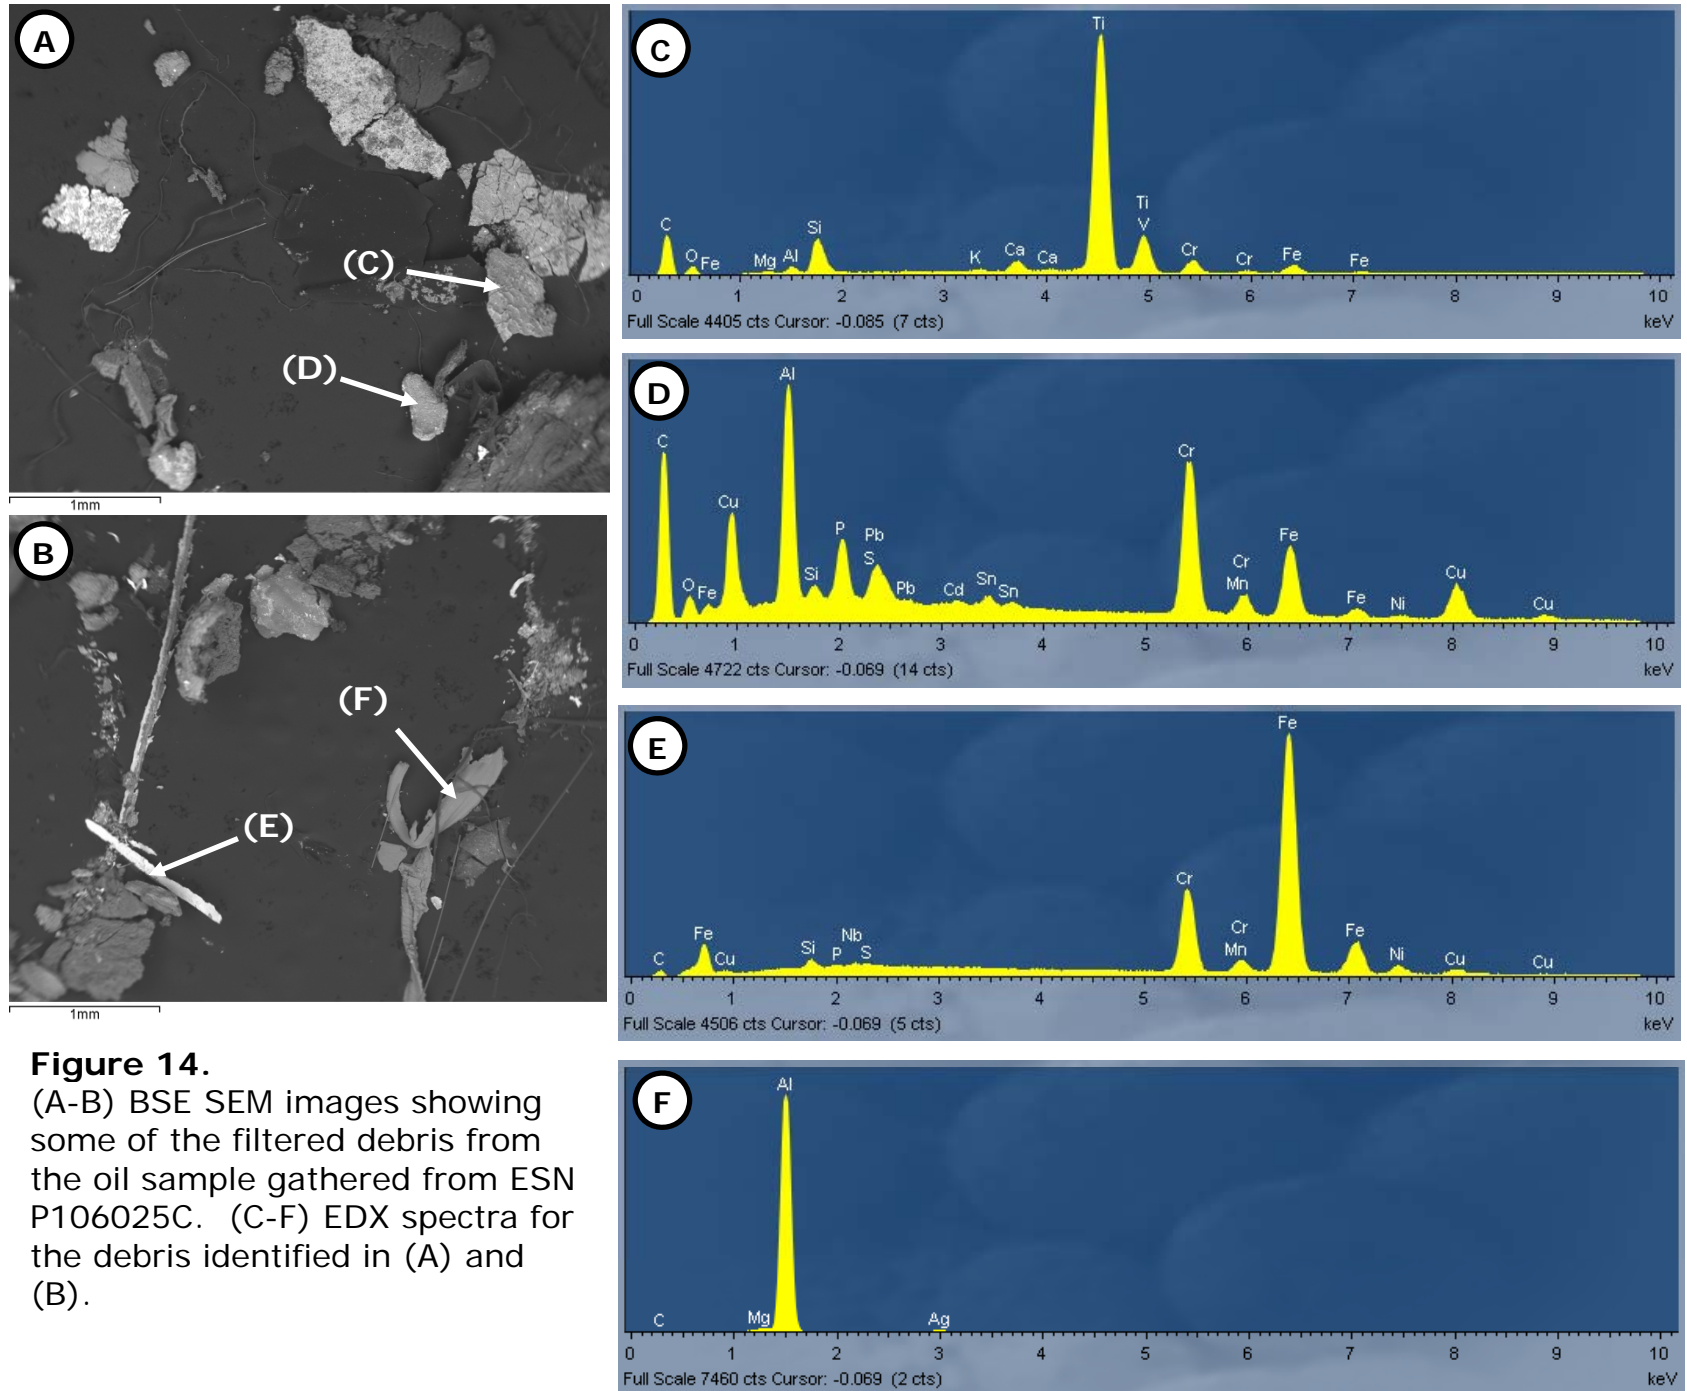
Analysis of the filtered debris samples from the oil collected from ESN106025C detected various metallic and non-metallic particles. The larger metallic particles were typically rich in iron and associated with lesser concentrations of chromium and traces of other various elements. Aluminum, titanium, nickel, and copper rich particles were also detected amongst the debris. The results of the analyses were summarized and tabulated in Table 1. BSE images and EDX spectra of some of the particles are shown in Figures 13-17.

**Figure 14.**  
 (A-B) BSE SEM images showing some of the filtered debris from the oil sample gathered from ESN P106025C. (C-F) EDX spectra for the debris identified in (A) and (B).
