- Final Report -

In the Matter of the October 1, 2015 Loss of the S.S. *EL FARO*

August 31, 2017

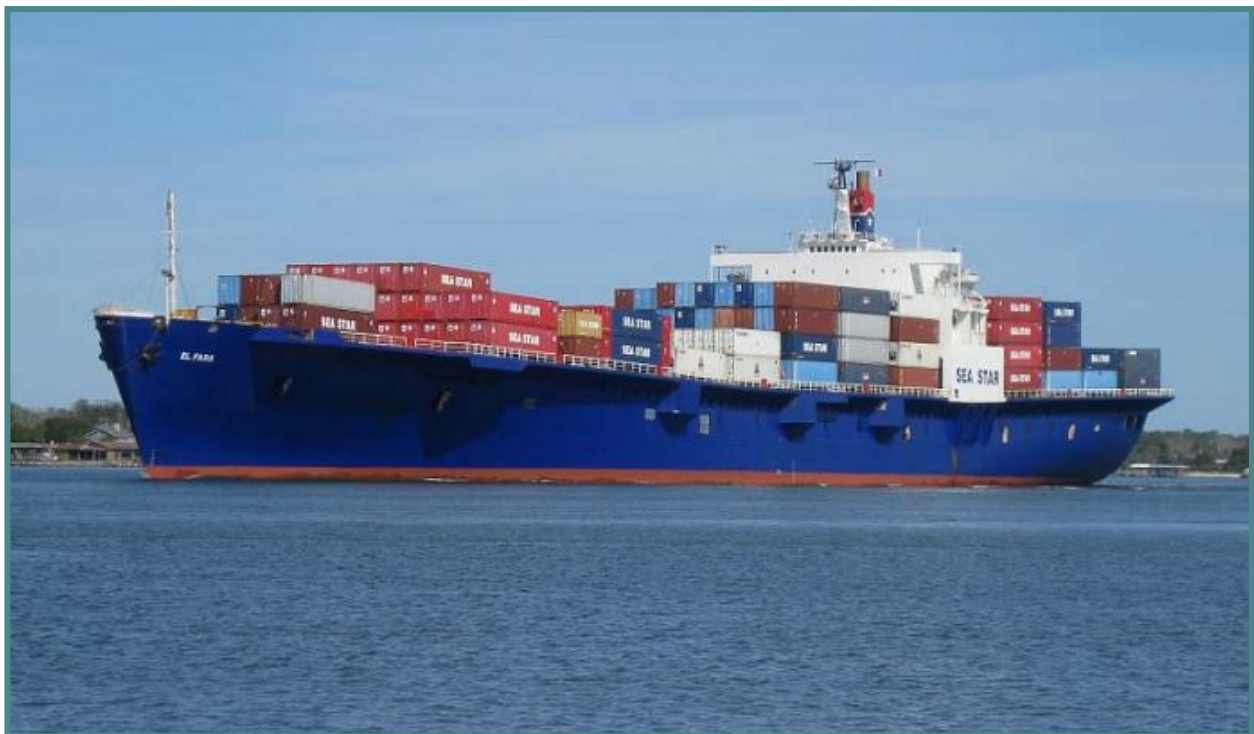
[3] Depicted by the illustration⁴ below, the Vessel was originally built in 1975 as a *roll on-roll off* (“RO/RO”) ship, which is a cargo ship designed to transport “wheeled” units such as automobiles, trucks, trailers, etc. Steel ramp structures deployed between the Vessel’s main deck and a dock surface enable vehicles to be driven aboard on their own wheels. The Vessel underwent refurbishments in 1993 and 2006; the first entailing a lengthening of the Vessel by 90 feet and the second involving its conversion to carry containers as well as RO/RO units.

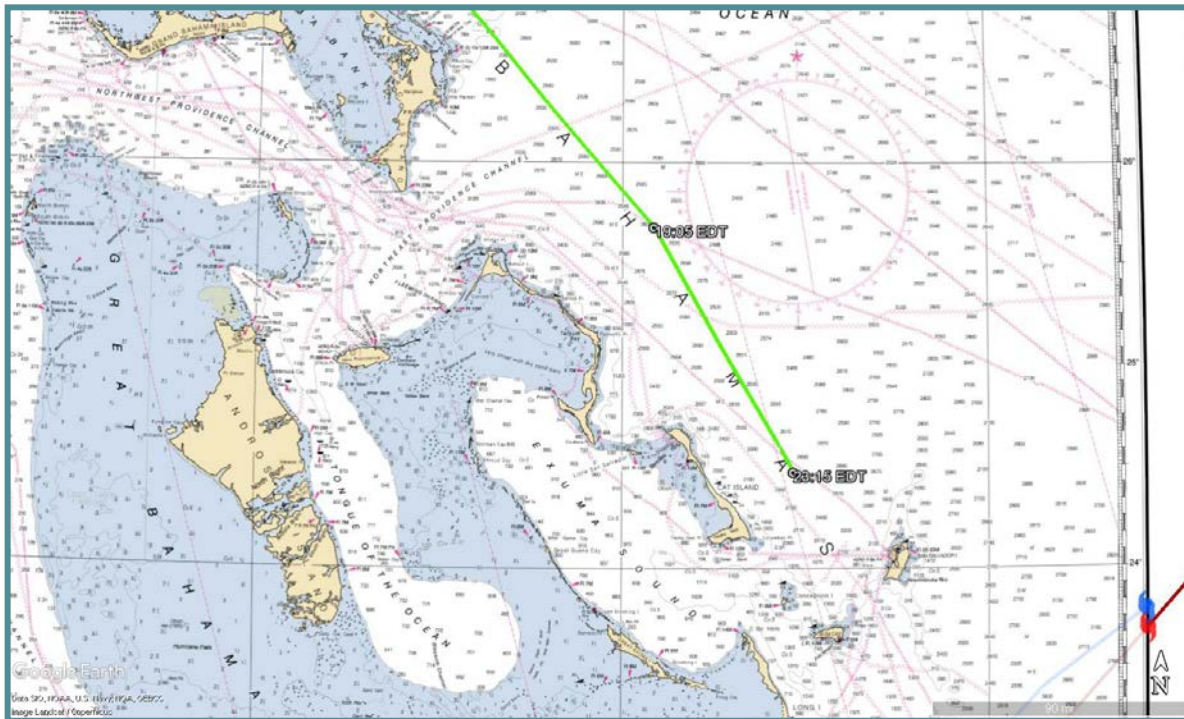
[26] The light green line in the illustration below depicts the Vessel's actual track after the captain implemented a second course deviation further to the south to allow for even more distance between the ship and the developing storm system, which second deviation entailed a course change from about 139° to about 150° at approximately 7:05 pm EDT (1905 EDT/2305 UTC) on September 30, 2015. The track line then shows the Vessel's actual progress up to 11:15 pm EDT (2315 EDT/0315 UTC) of that same evening. The two storm icons in the lower right corner of the illustration below indicate *JOAQUIN*'s forecast (blue icon) position/track, as well as its best (red icon) position/track as determined by the NHC post-incident and identified in the NTSB Meteorological Group Report.

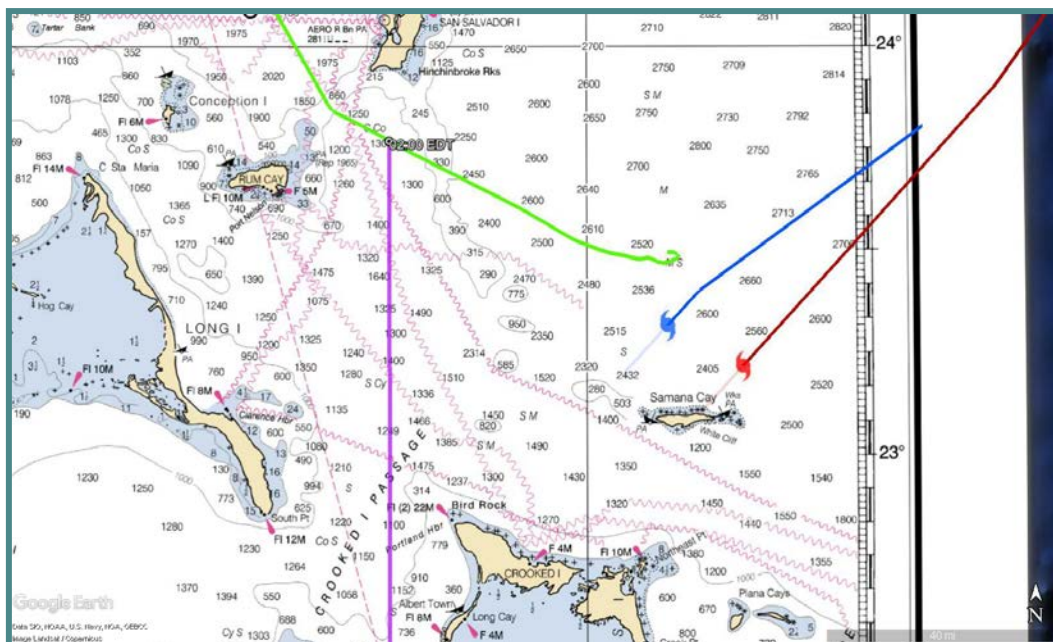
[36] Accordingly, the second mate prepared the new route waypoints and plotted the alternate track through Crooked Island Passage commencing with a course change to the south at 2:00 am EDT on October 1, 2015. This was done with the anticipation that the captain would likely come up to the bridge by that time. The magenta line in the illustration below shows the alternate route planned by the second mate -- the intersection of the magenta line with the bottom of the illustration represents the position the Vessel could have achieved by 6:00 am EDT. The light green line in the illustration depicts the Vessel’s actual track until it lost propulsion shortly after 6:00 am EDT on October 1 and again, the blue and red lines show, respectively, the forecast and best paths of *JOAQUIN* to approximately 6:00 am EDT.
