NATIONAL TRANSPORTATION SAFETY BOARD

Video Study

NTSB Case Number: HWY13MH012

Location:	Mount Vernon, Washington
Date:	May 23, 2013
Time:	7:05 PM PDT
Vehicle 1:	2010 Kenworth truck tractor and 1997 Aspen flatbed semitrailer, hauling an oversize load
Vehicle 2:	1997 Dodge Ram pickup truck, piloting the oversize load

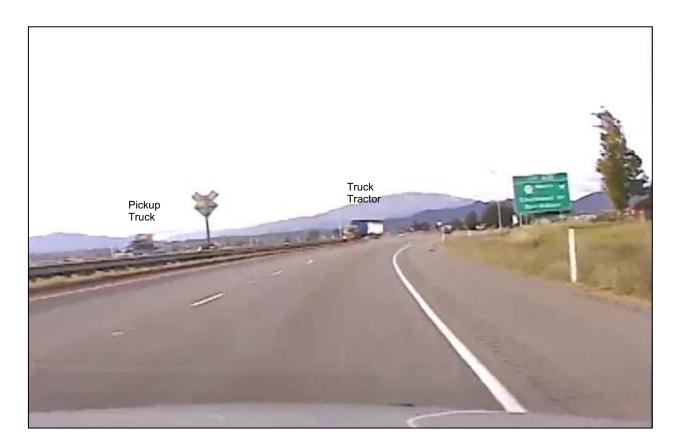
Figure 1 Frame from Patrol Car Video

The last 2.8 seconds of the 7.5 second period when the vehicles were visible were used for analysis. During this time, both vehicles were closest to the camera so that accurate estimation of truck tractor speed and following distance were possible. Figure 1 shows one of the video frames that were analyzed.

The analysis consisted of two stages. First, the location of the patrol car was estimated at eight times during the analyzed 2.8 seconds. This was done using a mathematical model of the camera that was capable of mapping reference points along the highway onto frames from the video. The reference points included highway signs, highway light poles, and points on solid and broken lane lines. Their geographical locations were derived from Google Earth images of the site. About fifty reference points were used, all clearly visible both in Google Earth and in the video.

The patrol car locations were then estimated in an iterative process that varied a simulated patrol car location until the mathematical model mapped the reference points to the pixel locations in the video frames where the reference points were. When the mapped reference point locations were aligned with their actual locations in a video frame, the simulated patrol car and camera had to be at the location where the real patrol car and camera were when that video frame was acquired.

HWY13MH012 Video Study Page 2 of 3 The second stage of the analysis estimated the speed of the truck tractor and its following distance behind the piloting pickup truck (measured from the rear bumper of the pickup truck to the front bumper of the truck tractor). This was done by adding thirty additional reference points along the left side of the lane in which the truck tractor was traveling. These points were evenly spaced by 20 ft and their geographic locations were known. The truck locations at the eight times when the locations of the patrol car were known were then estimated by measuring the location of the truck in the video frame using the thirty evenly-spaced reference points, mapped onto the video frames, as a ruler.

Video frames corresponding to three of the eight known patrol car locations displayed both the truck tractor and the piloting pickup truck. Using the thirty evenly-spaced reference points as a ruler, the following distance of the truck tractor behind the pickup truck was then estimated.
