NATIONAL TRANSPORTATION SAFETY BOARD

Personal Electronic Device

Specialist's Factual Report
By Bill Tuccio, Ph.D.

Location: Orange, Virginia
Date: March 29, 2015
Aircraft: Piper PA-28-140
Registration: N32396
Operator: Private
NTSB Number: ERA15FA170

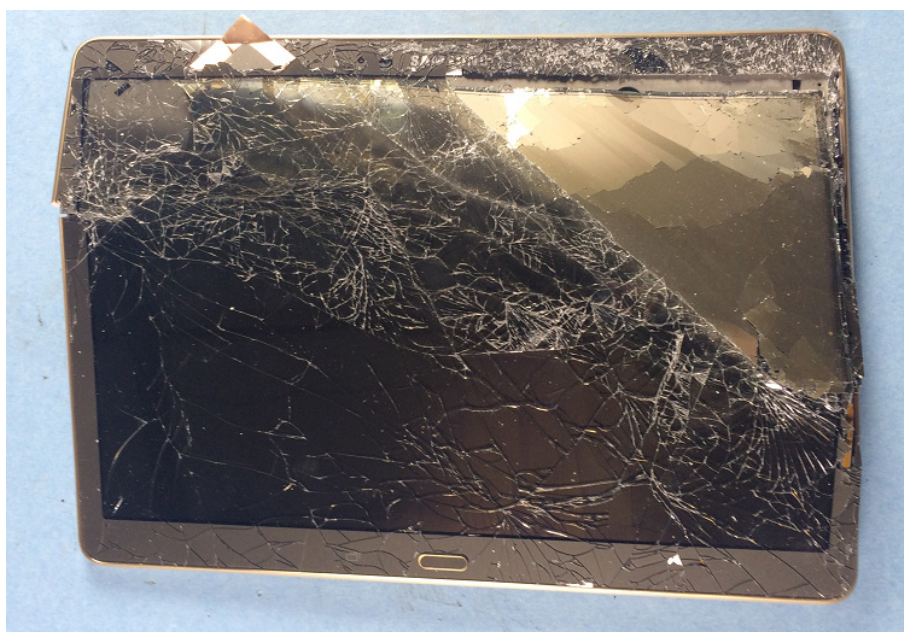
Figure 1. Front of device as received.

Upon arrival at the NTSB Vehicle Recorder Division, an exterior examination revealed the unit had sustained significant impact damage, as shown in figures 1 and 2. An internal inspection revealed the internal component board was intact, as shown in figure 3. The internal board was placed in an operative Samsung Galaxy Tab and the unit powered on. Photos of various screens were obtained and a forensic download was performed.

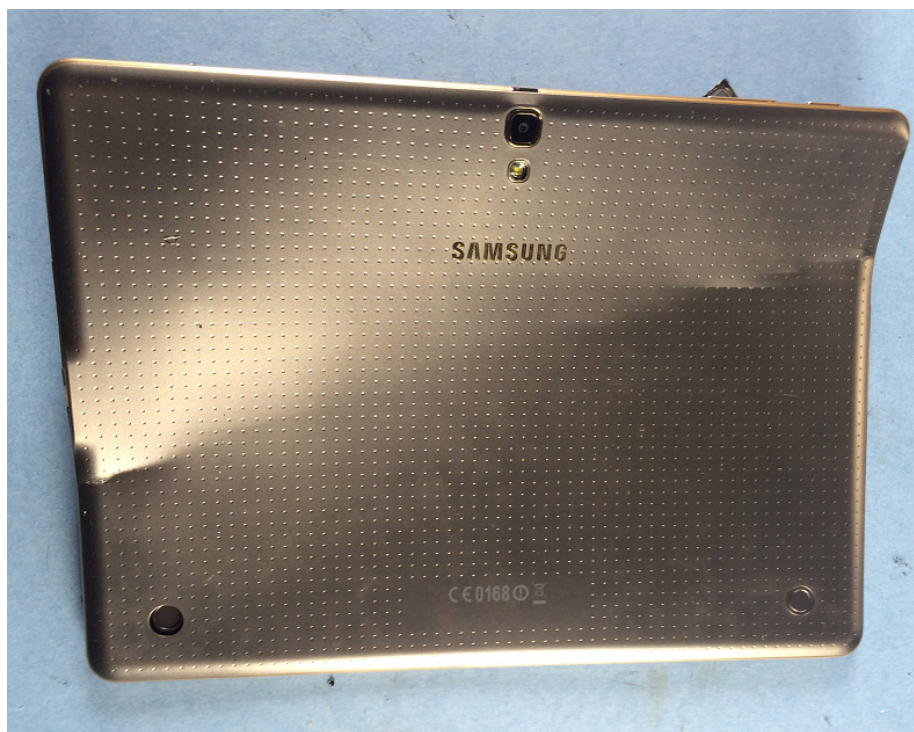
Figure 2. Back of device as received.
