**SPECIALIST'S FACTUAL REPORT OF INVESTIGATION**

**CEN19FA032**

## **Personal Electronic Device**

Location: Santa Fe, New Mexico  
Date: November 26, 2018  
Aircraft: Mooney M20C, Registration N113TA  
Operator: Private  
NTSB Number: CEN19FA032

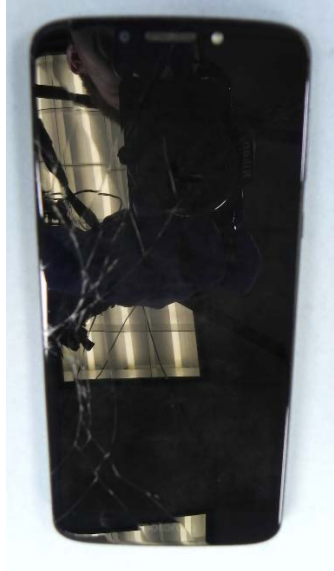
Figure 1. Motorola E5 Supra as received.

Upon arrival at the Vehicle Recorder Laboratory, an exterior examination revealed the device had sustained impact damage resulting in cracks to the screen, as shown in Figure 1. The device powered on normally and was unlocked using the passcode provided by the Investigator-In-Charge (IIC). A forensic image of the device's contents was created for examination using laboratory tools.
