# NATIONAL TRANSPORTATION SAFETY BOARD

## Personal Electronic Device

Specialist's Factual Report  
By Bill Tuccio, Ph.D.

Location: Vienna, Illinois  
Date: December 31, 2016  
Aircraft: Piper PA-28R-200  
Registration: N2806R  
Operator: Private  
NTSB Number: CEN17FA064

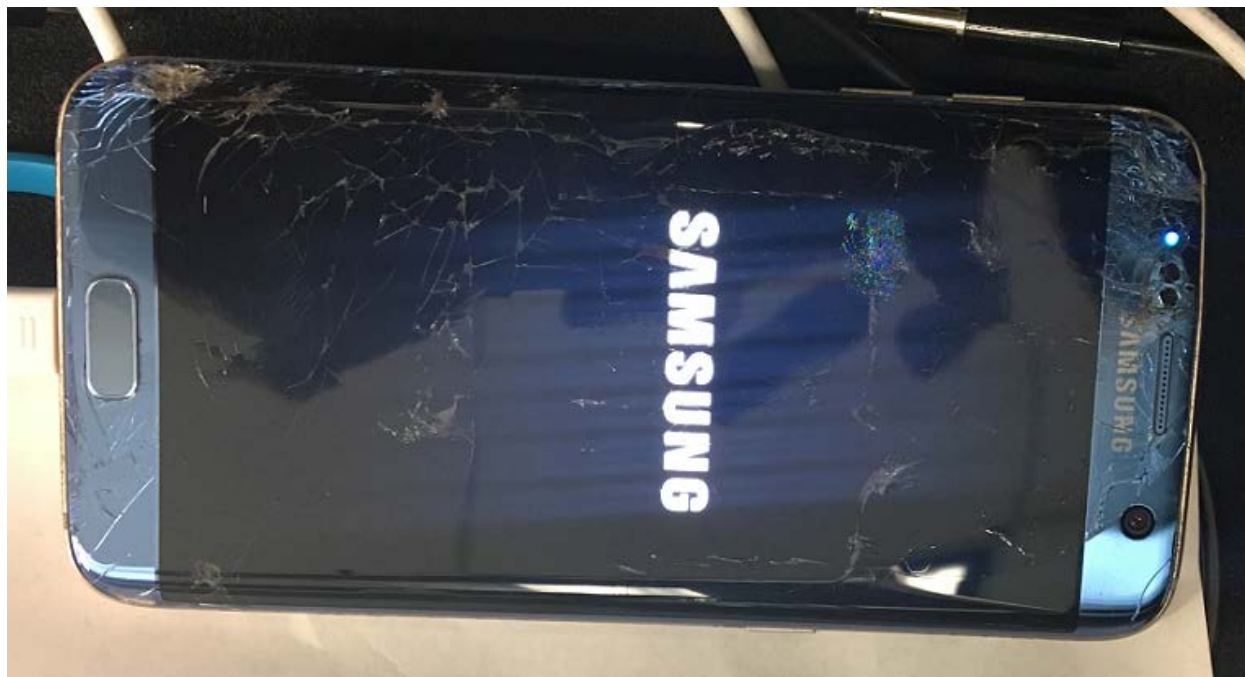
Figure 1. Smartphone after power application during recovery.

The Samsung S7 had a cracked screen, but powered on normally, as shown in figure 1. The phone was protected by a passcode, which could not be determined. A partial download was accomplished.

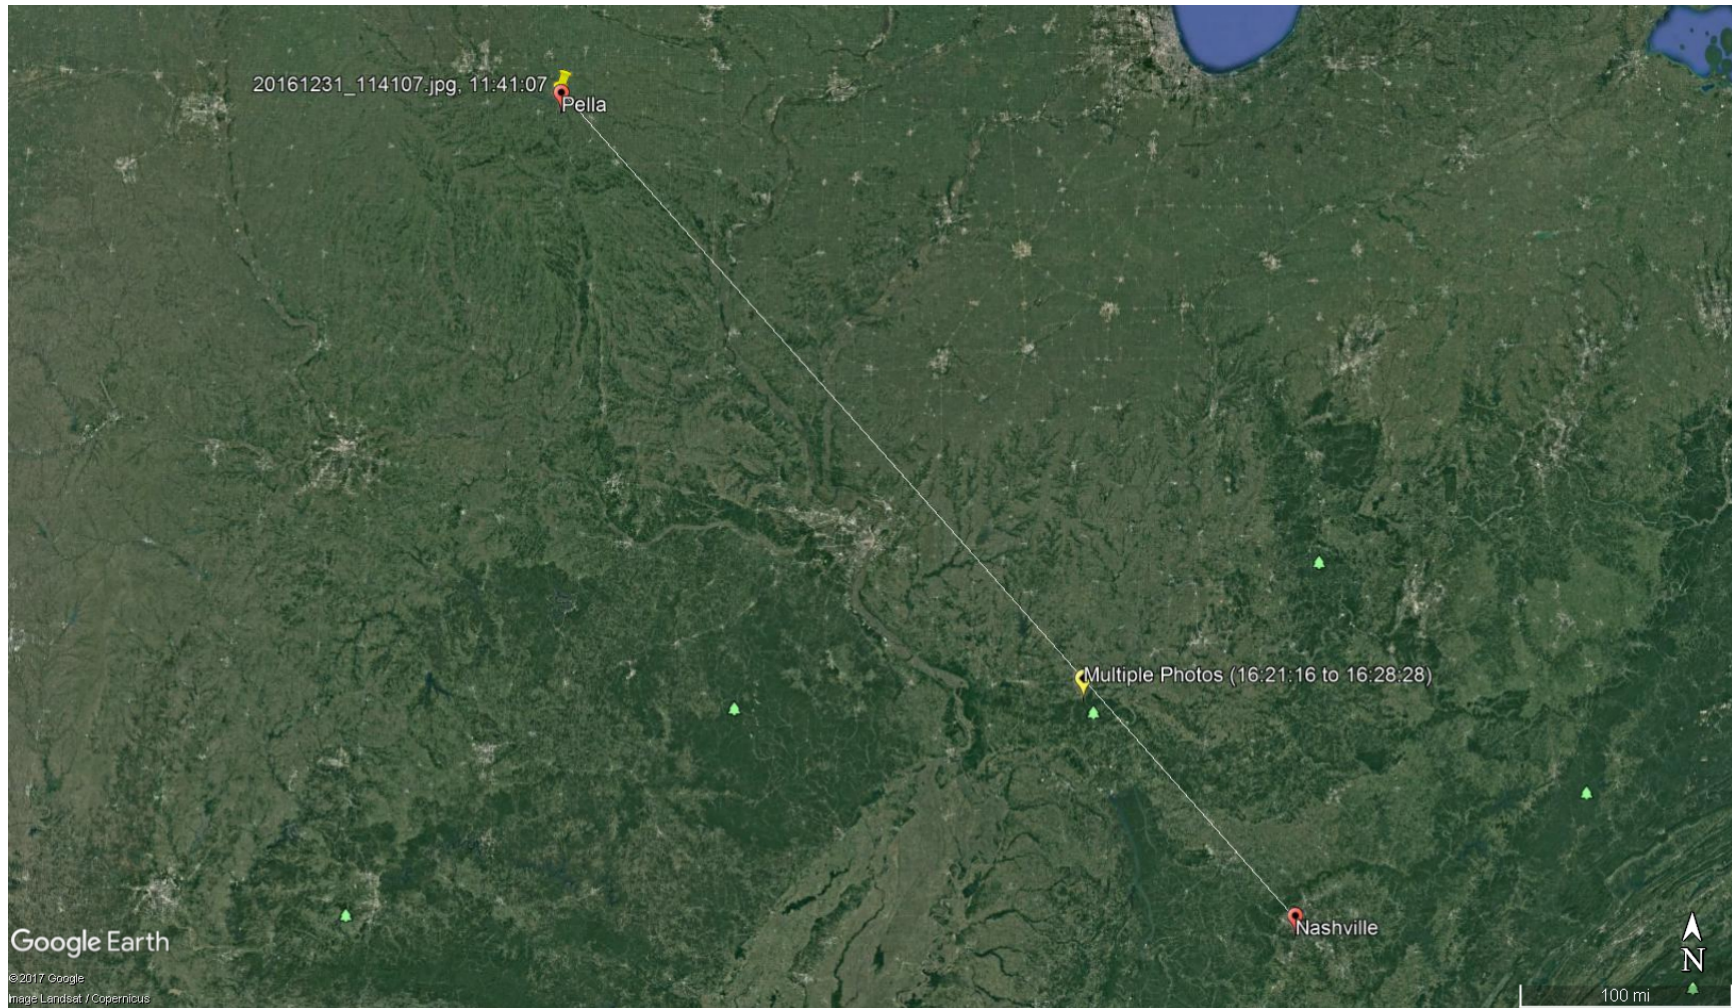
Figure 2. Overlay of recovered photos on December 31, 2016.

Figures 2 and 3 show the position of the photos on a Google Earth overlay, with a reference line between Pella, Iowa and Nashville, Tennessee.<sup>2</sup>

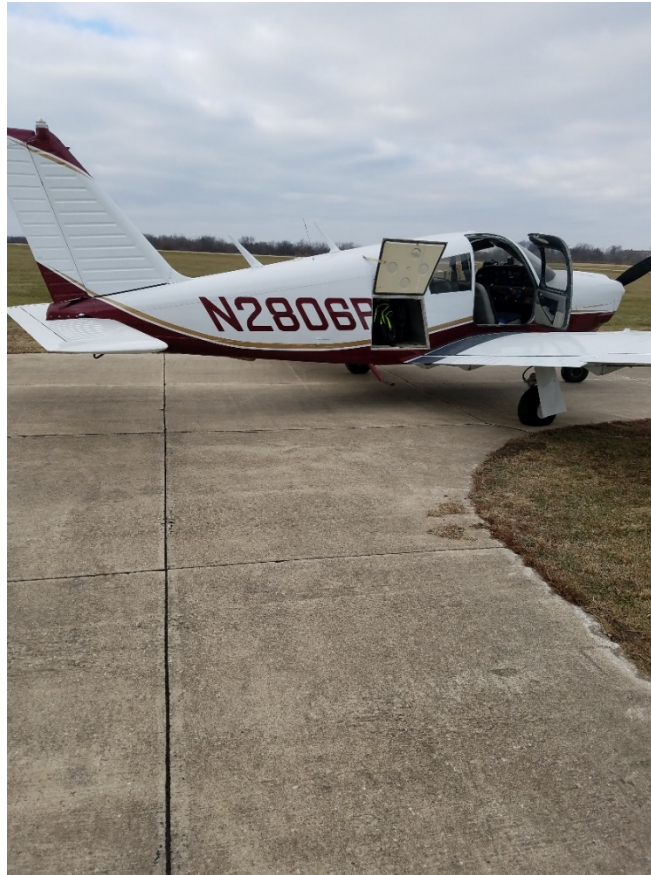
Figure 4. Photo 20161231\_114107.jpg.

The first photo was of the accident aircraft, taken on the ground at Pella, Iowa, from outside the aircraft.

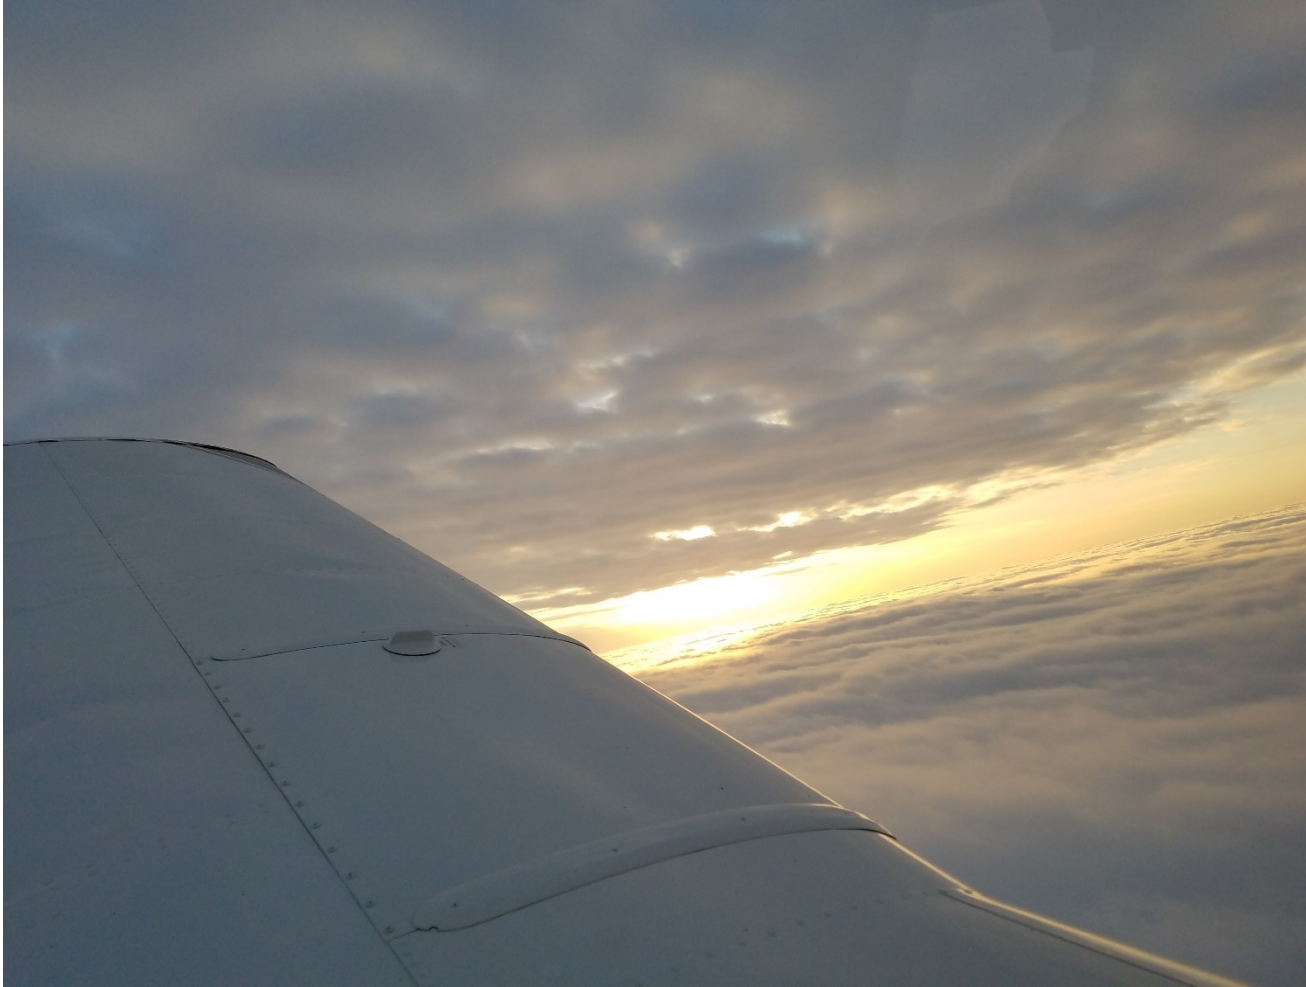
Figure 5. Photo 20161231\_161940.jpg.

The next photo, at 16:19:40, was taken from the southeastern-most location of all photos, followed by photos between 16:21:16 and 16:28:28, which are farther northwest, towards Pella.

All inflight photos show the aircraft flying above an undercast; some with a higher layer of clouds above. The vantage point of the inflight photos was consistent with photos being taken from the rear, left seat.
