# NATIONAL TRANSPORTATION SAFETY BOARD

## Personal Electronic Devices

Specialist's Factual Report  
By Bill Tuccio, Ph.D.

Location: Santa Monica, CA  
Date: September 29, 2013  
Aircraft: Cessna 525A  
Registration: N194SJ  
Operator: Private  
NTSB Number: WPR13FA430

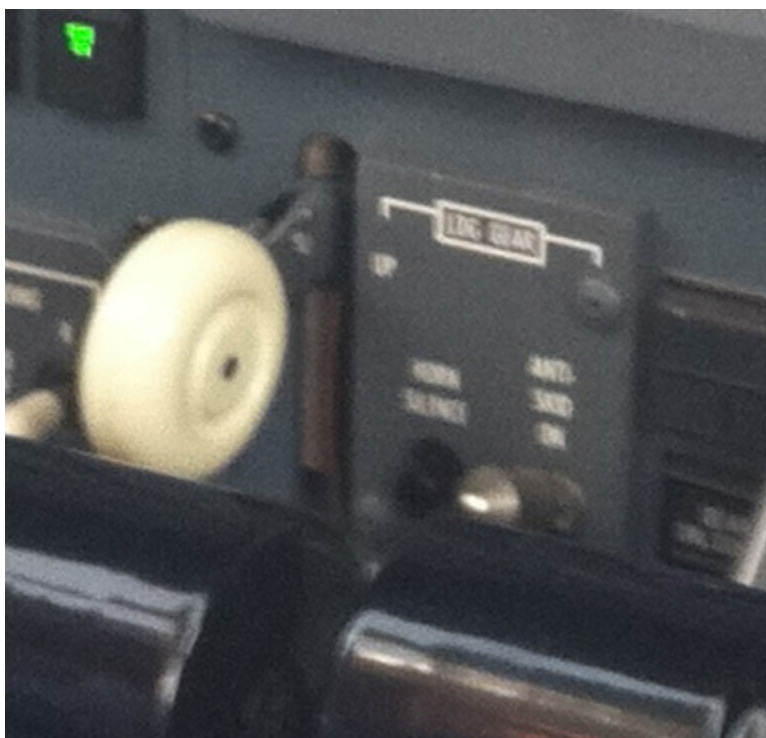
<b>Time</b>	<b>Latitude Longitude</b>	<b>Resolved Location</b>	<b>Description</b>
16:24:59 PDT	43.7452 N -116.3457 W	Eagle, ID	Camera pointed outside aircraft. Aircraft was between cloud layers.
16:35:23 PDT	42.4758 N -114.7448 W	Clover, ID	Camera pointed inside aircraft, showing center to left side of instrument panel. Altitude indicated a climb through 37,300 feet with a target altitude of 38,000 feet; aircraft was navigating to the REBRG intersection; ground track was 199 degrees; indicated airspeed was 167 knots; groundspeed was 251 knots; N-number placard was N194SJ; the anti-skid switch was in the up position (see figure 4).

**Figure 4. Anti-skid switch.**

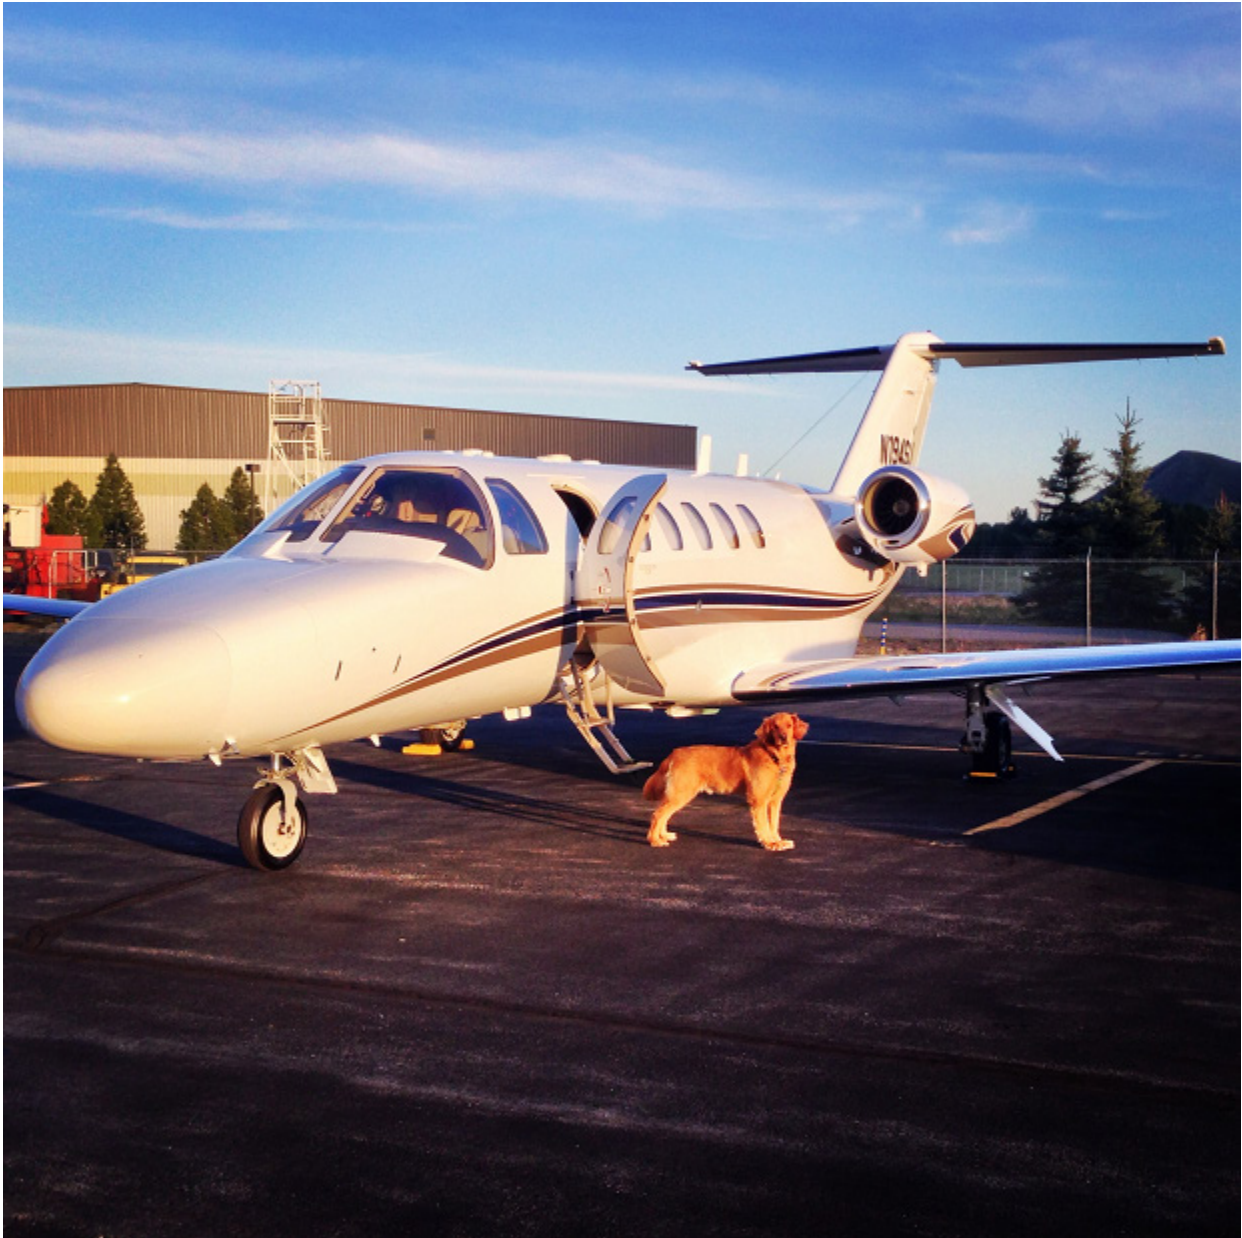
None of the content on the iPad 2 was from the accident flight. Pertinent photos and video were related to N194SJ. Figure 5 shows a photo of N194SJ with a red/brown haired, large dog standing in front of the aircraft.

**Figure 5. N194SJ with large dog in front of aircraft.**
