#### NATIONAL TRANSPORTATION SAFETY BOARD

# **Personal Electronic Devices**

Specialist's Factual Report by Bill Tuccio, Ph.D.

Location:	Boonville, Missouri
Date:	November 30, 2014
Aircraft:	Bellanca 17-30A
Registration:	N6629V
Operator:	Private
NTSB Number:	CEN15FA060

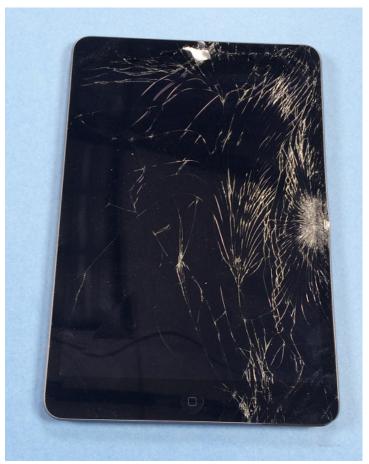
Upon arrival at the NTSB Vehicle Recorder Division an exterior examination revealed the unit had sustained significant impact damage, as shown in figure 1. Power was applied to the unit and it started, though the screen image was fragmented. The unit was examined using a forensic download and through visual inspection of the fragmented display.

Figure 1. Apple iPad Mini as received.

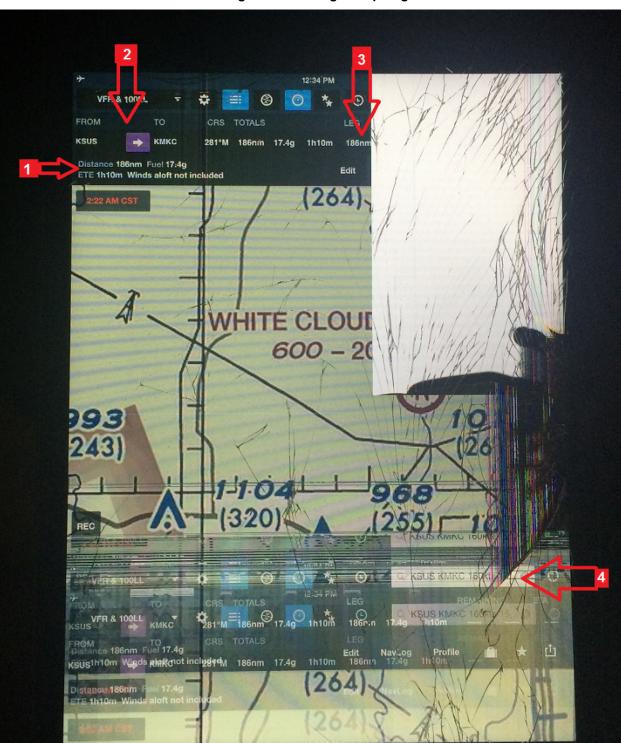
ForeFlight was installed on the device. Figure 2 shows the ForeFlight Map page with four annotations. The ForeFlight Map page revealed the following: a route from SUS to MKC (annotation 2); a distance of 186nm with an anticipated fuel burn of 17.4 gallons for a 1 hour and 10 minute estimated time enroute, based on no winds aloft (annotation 1 and annotation 3); and a true airspeed of 160 knots (annotation 4)<sup>2</sup>.

Figure 2. ForeFlight Map Page.

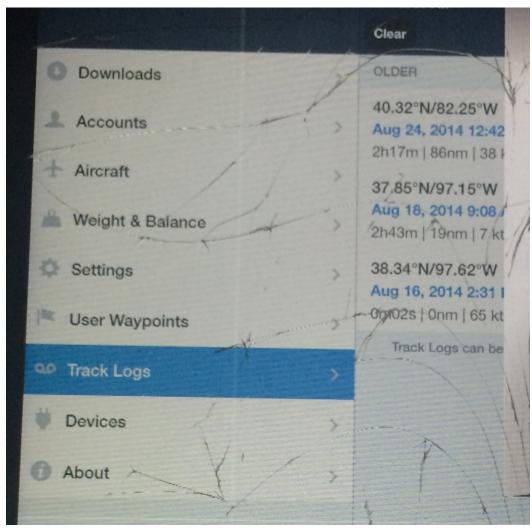
ForeFlight is capable of recording a tracklog history. Figure 3 shows the tracklog history page. None of the tracklogs were older than August, 2014<sup>3</sup>.

Figure 3. ForeFlight tracklog history.

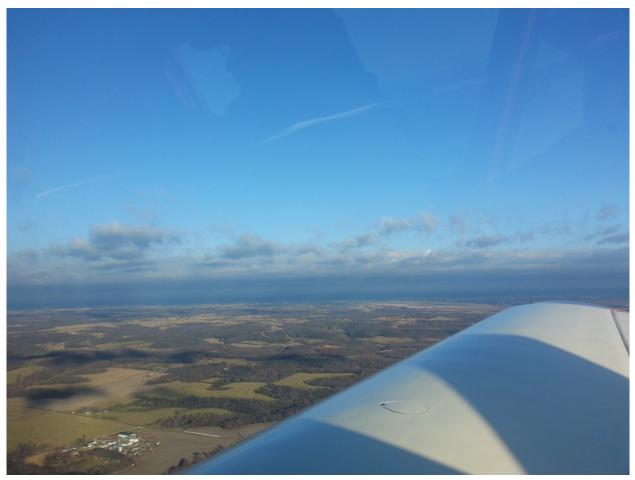
Text messages found on the device were not pertinent to the investigation. Four photos taken while the aircraft was inflight were pertinent and are shown in figures 4 through 7. Photo time stamps indicated the photos were taken on November 30, 2014 between 08:26:47 and 08:31:51 CST. During the five-minute period of recovered photos, cloud cover in the vicinity of the aircraft increased from clear skies to low-level, overcast stratocumulus clouds<sup>4</sup>.

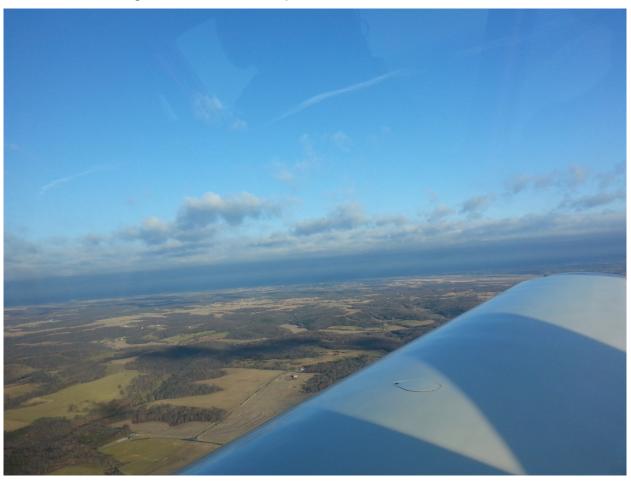
Figure 5. Photo time stamped November 30, 2014 at 8:27:03 CST.

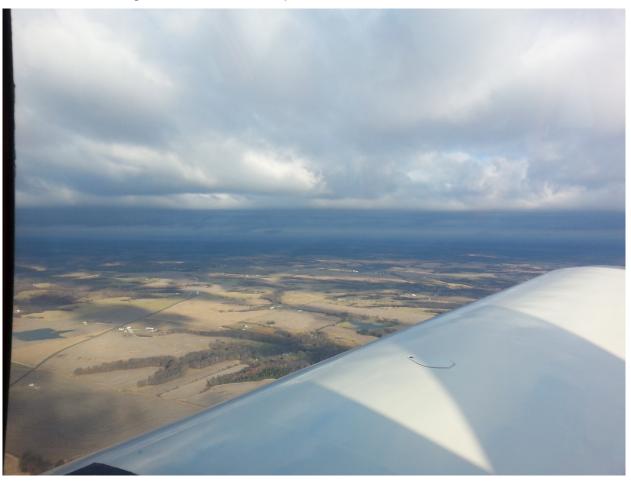
Figure 6. Photo time stamped November 30, 2014 at 8:29:59 CST.

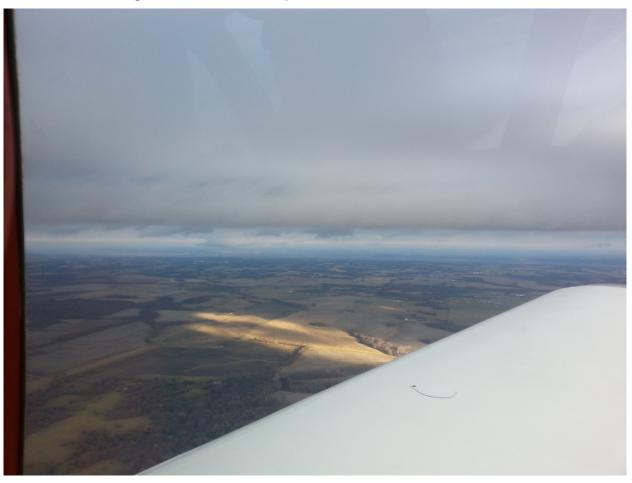
Figure 7. Photo time stamped November 30, 2014 at 8:31:51 CST.
