NATIONAL TRANSPORTATION SAFETY BOARD
Vehicle Recorder Division
Washington, D.C. 20594

Personal Electronic Devices

Specialist's Factual Report By Jane Foster

Location: Alma, Georgia
Date: September 16, 2015
Aircraft: Vans Aircraft RV-10
Registration: N122WK
Operator: Private
NTSB Number: ERA15FA359

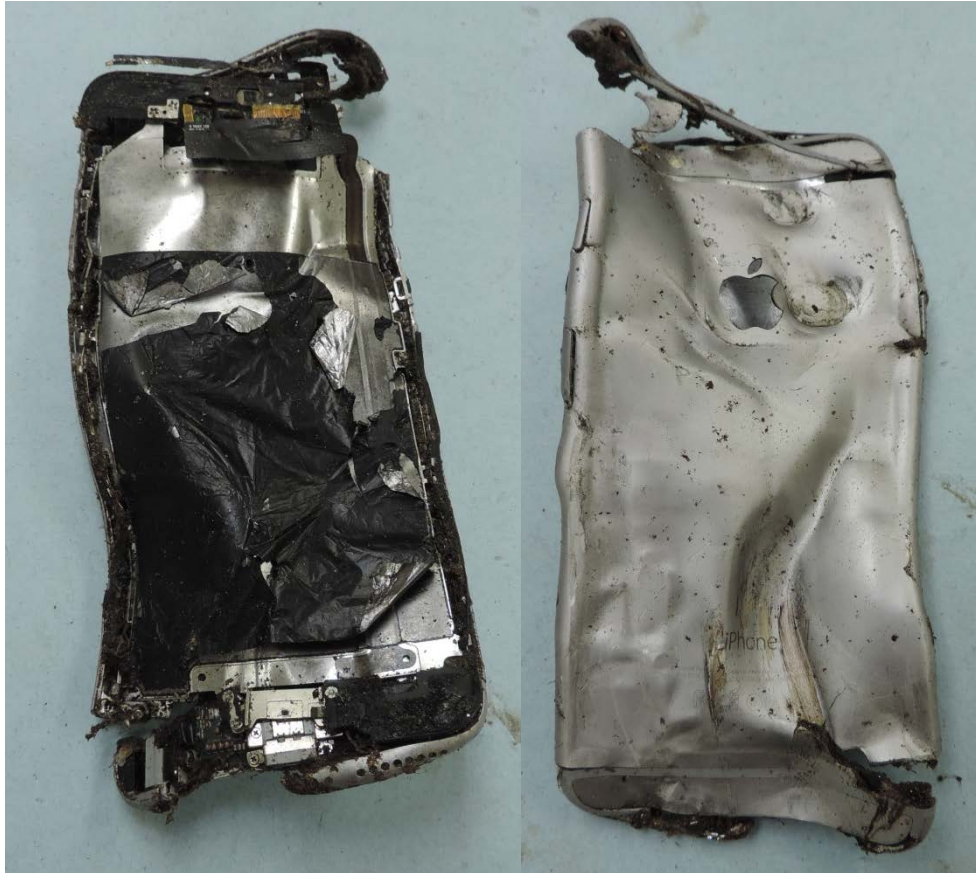
The four PEDs sustained heavy impact damage from the accident. Figures one through four show the devices as received to the vehicle recorder laboratory.

Figure 1. Front and back of Apple iPhone 6+ as received.

The main processing board for the Apple iPhone 6+ was damaged, so no data could be retrieved from the device.

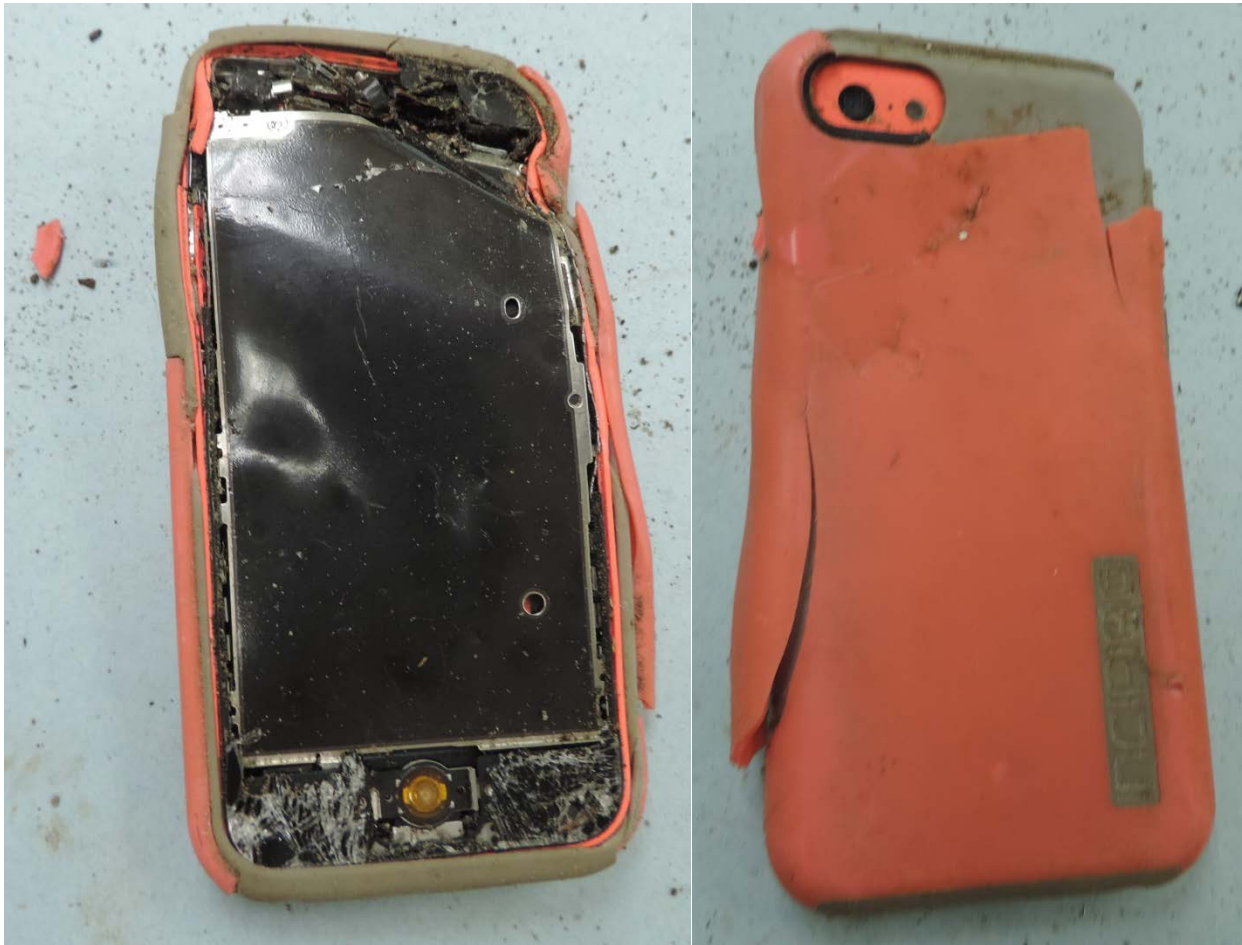
Figure 3. Front and back of iPhone 5c as received.

After further inspection, the Apple iPhone 5c main processing board was cracked, so no data could be retrieved from the device.

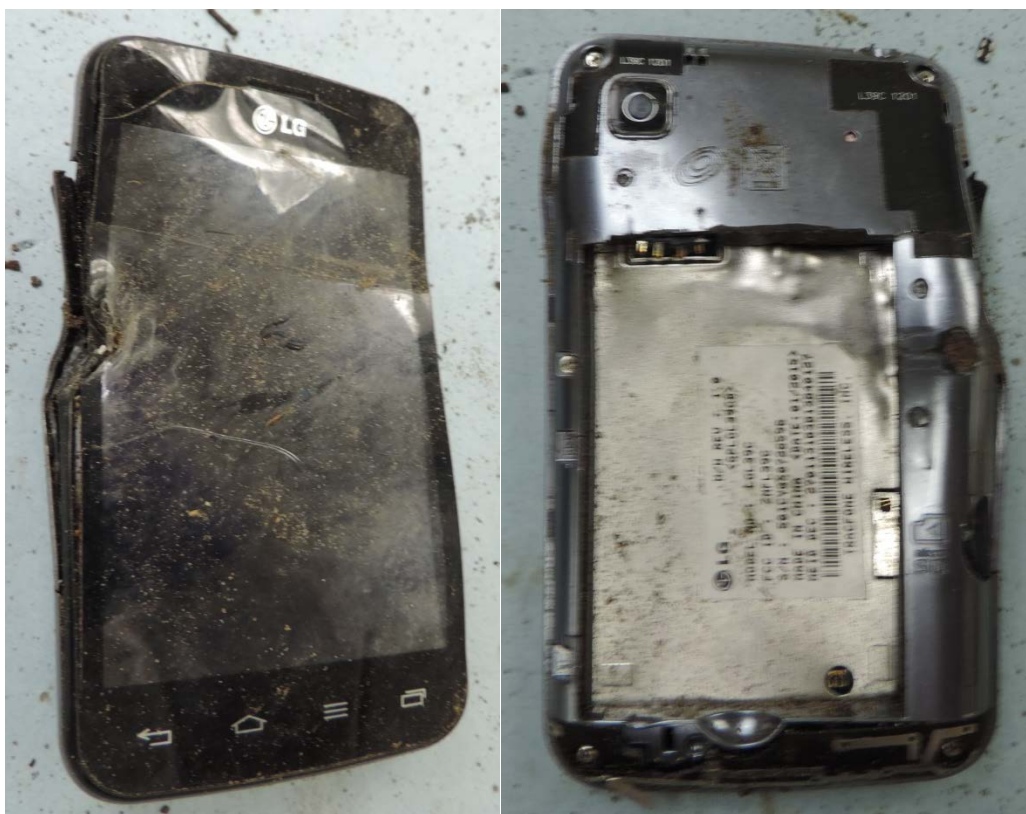
Figure 4. Front and back of LG Optimus Dynamic II as received.

An SD card containing pictures was found on the LG Optimus Dynamic II. None of the pictures contained accident related data or were taken within months of the accident date.
