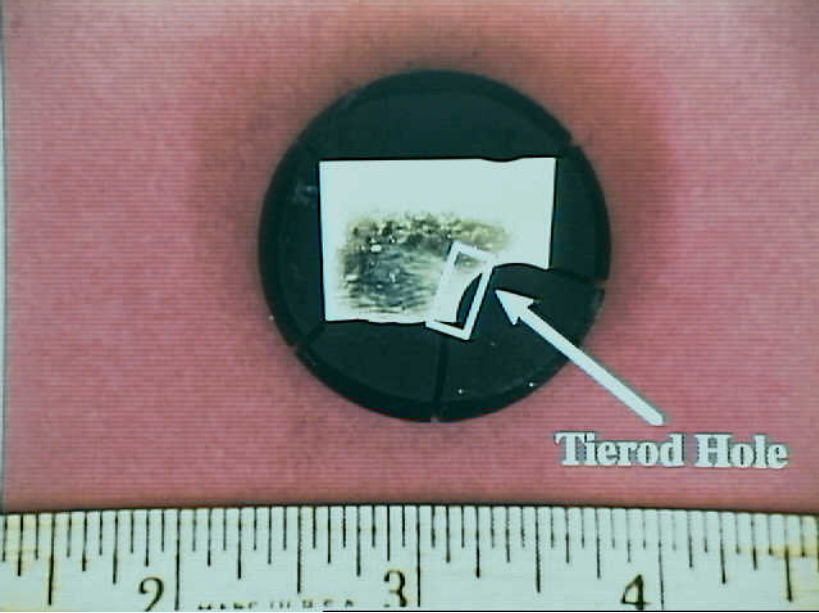
Photo 1. Mounted Specimen. Mounting material was cut before removal for SIMS analysis. The tierod hole is identified. The boxed region contains the fracture origin and the "hardened layer".
