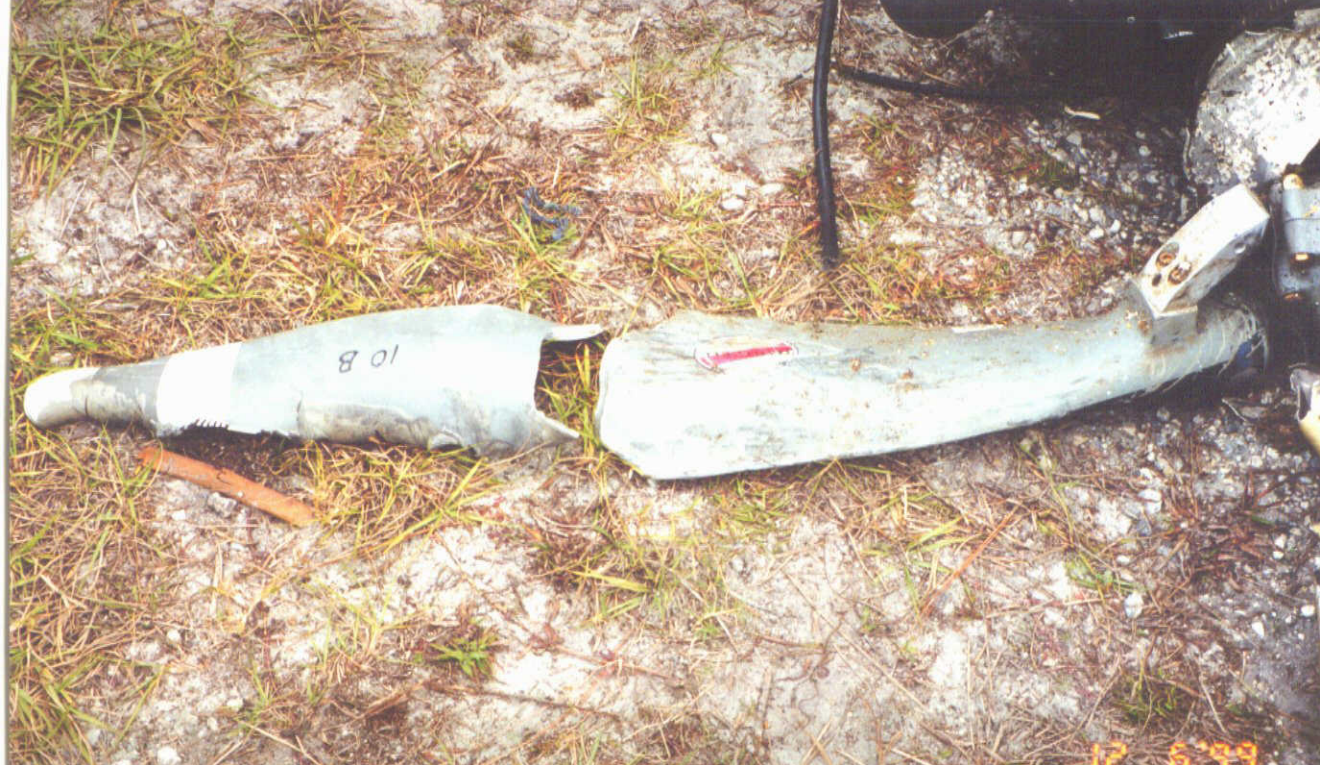
Photo 10: View of the fractured propeller blade from the left propeller of the Seminole
