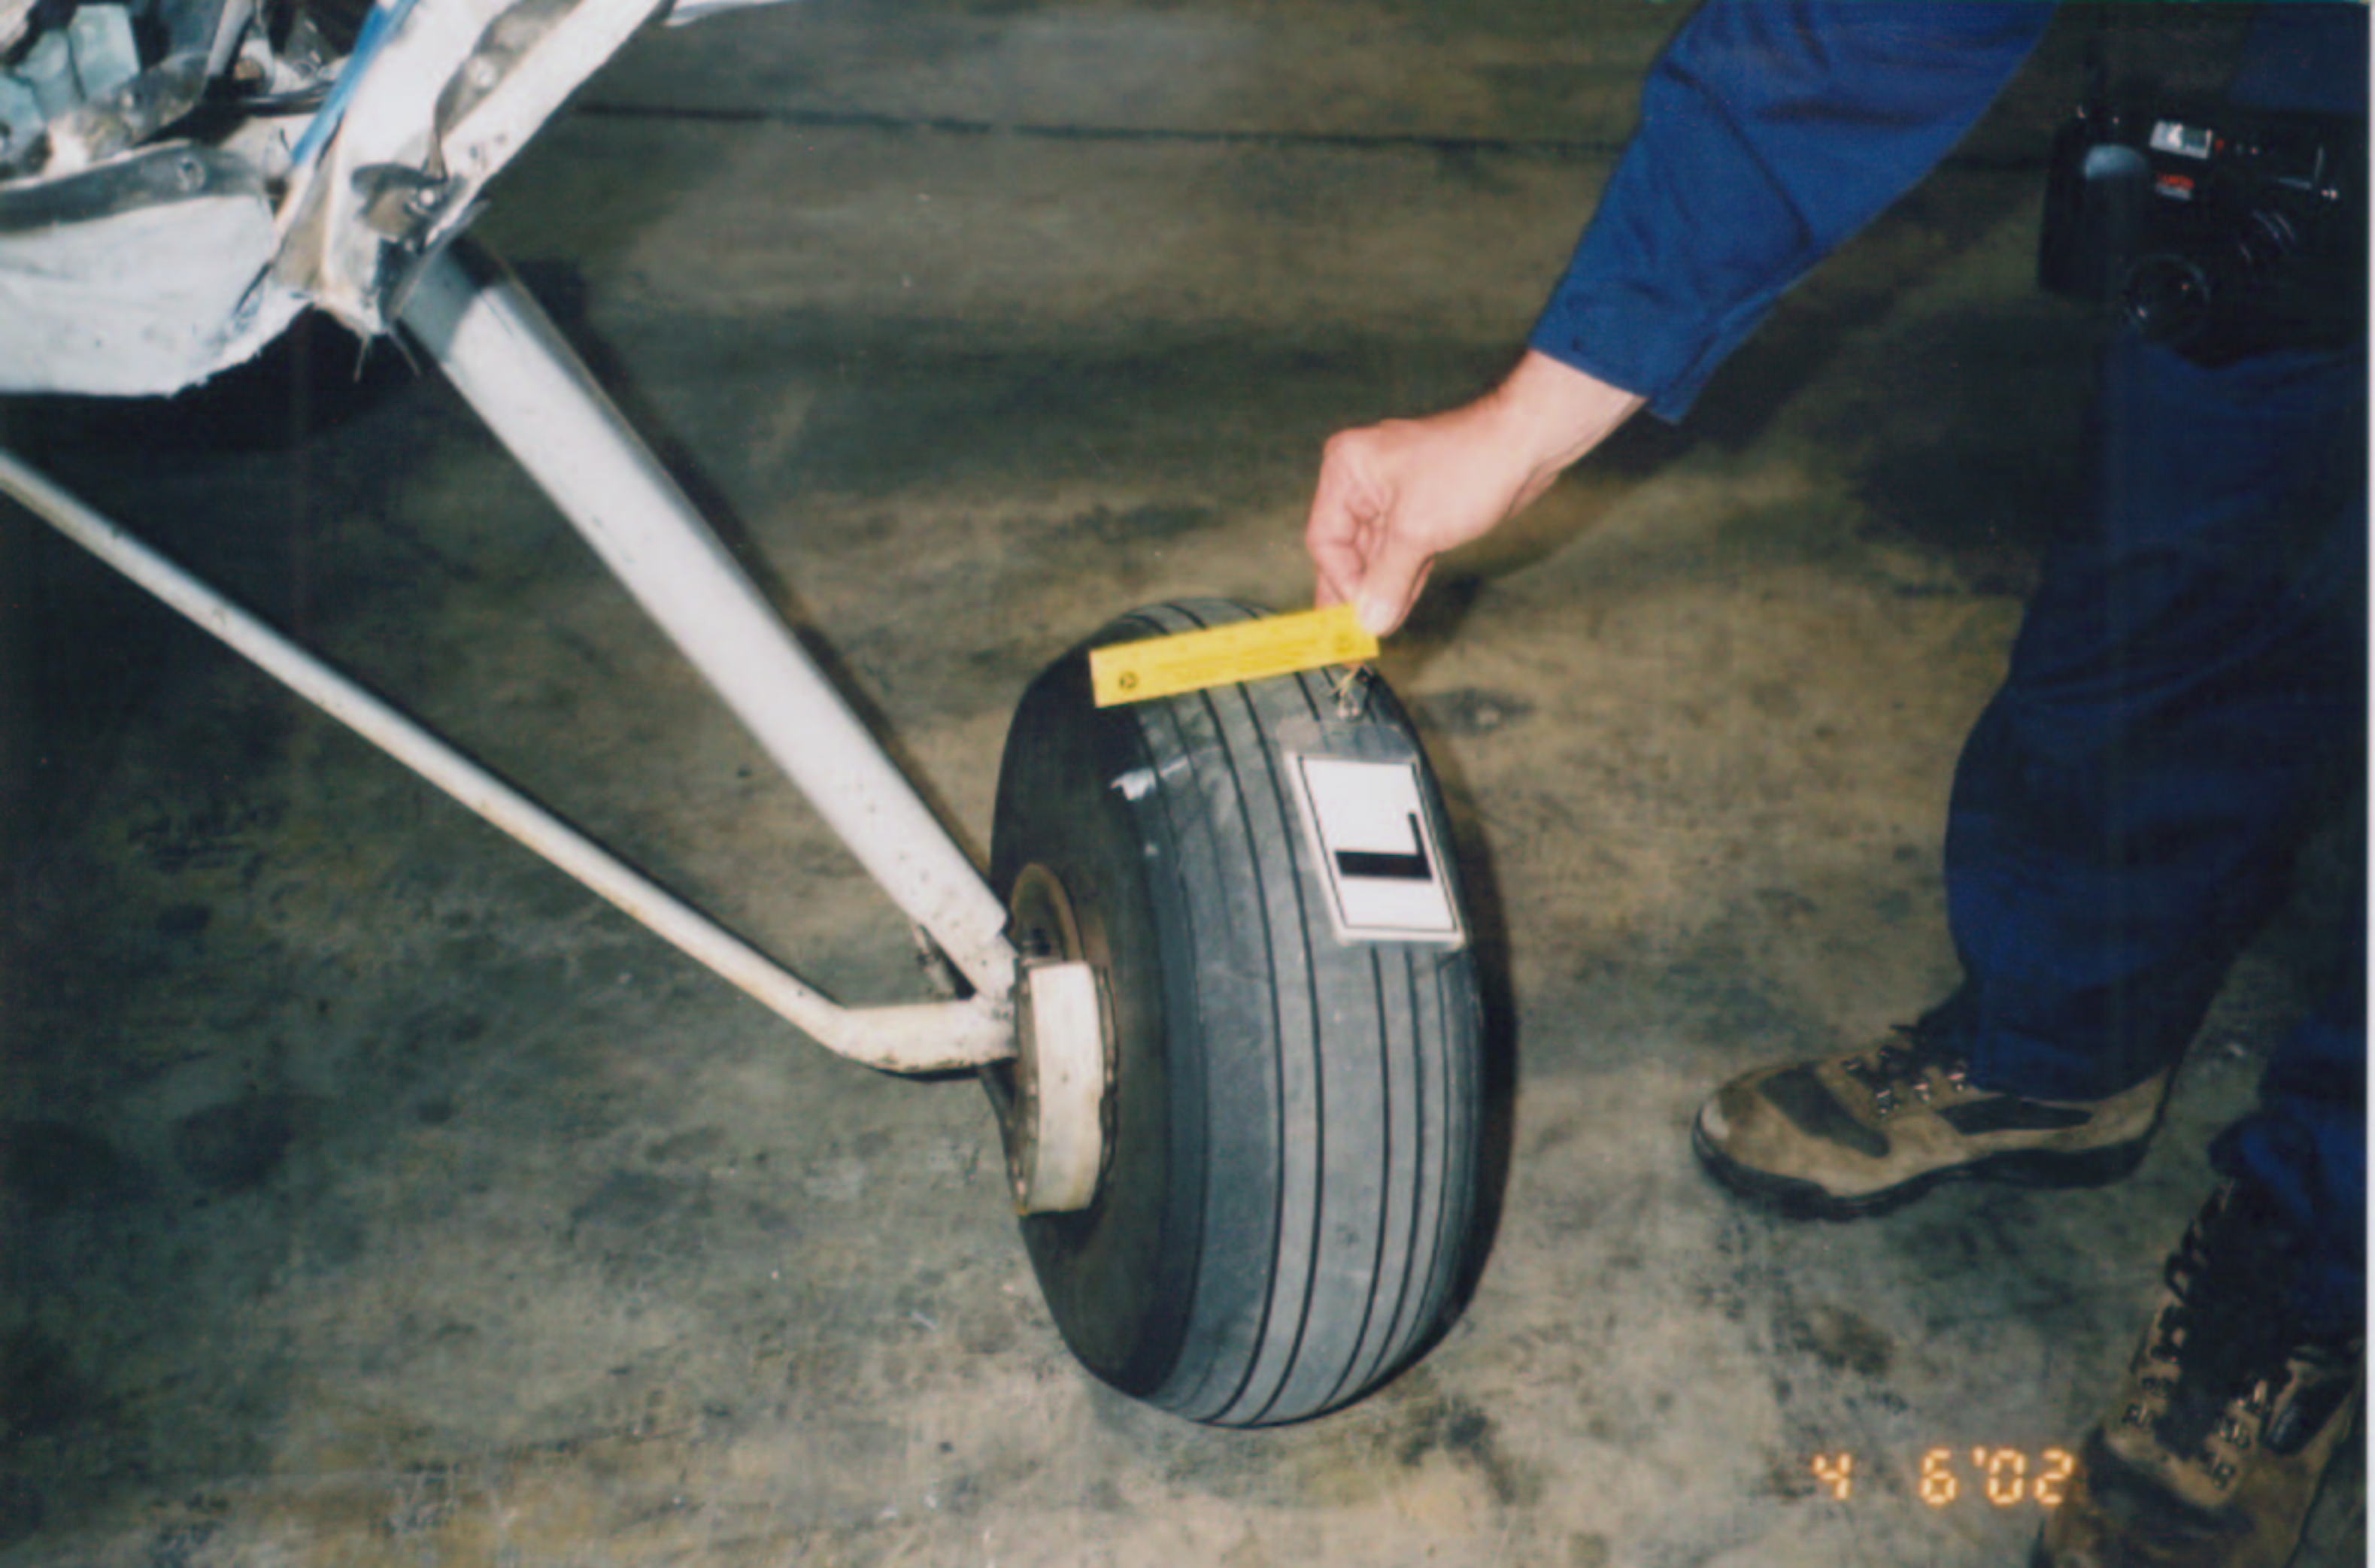
Photo 11 - Faint paint transfer of maroon paint on N5293H left main landing gear
