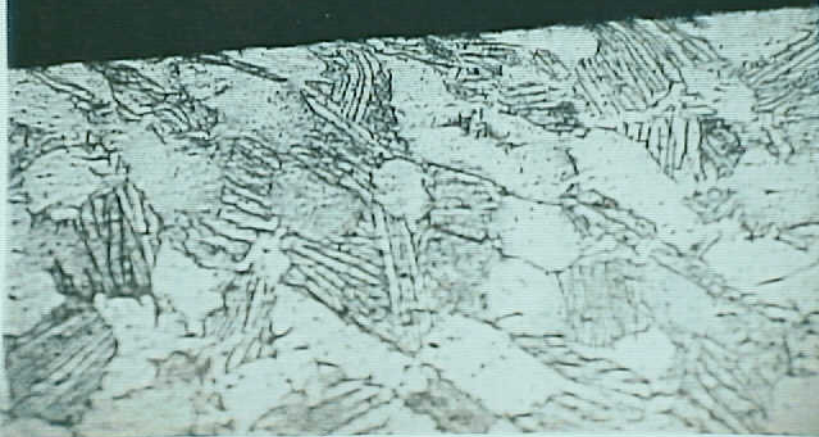
Photo 14. Cross section of hole #25 showing deformed material to a depth of 5 μm (0.20 mills). Mag 500X.
