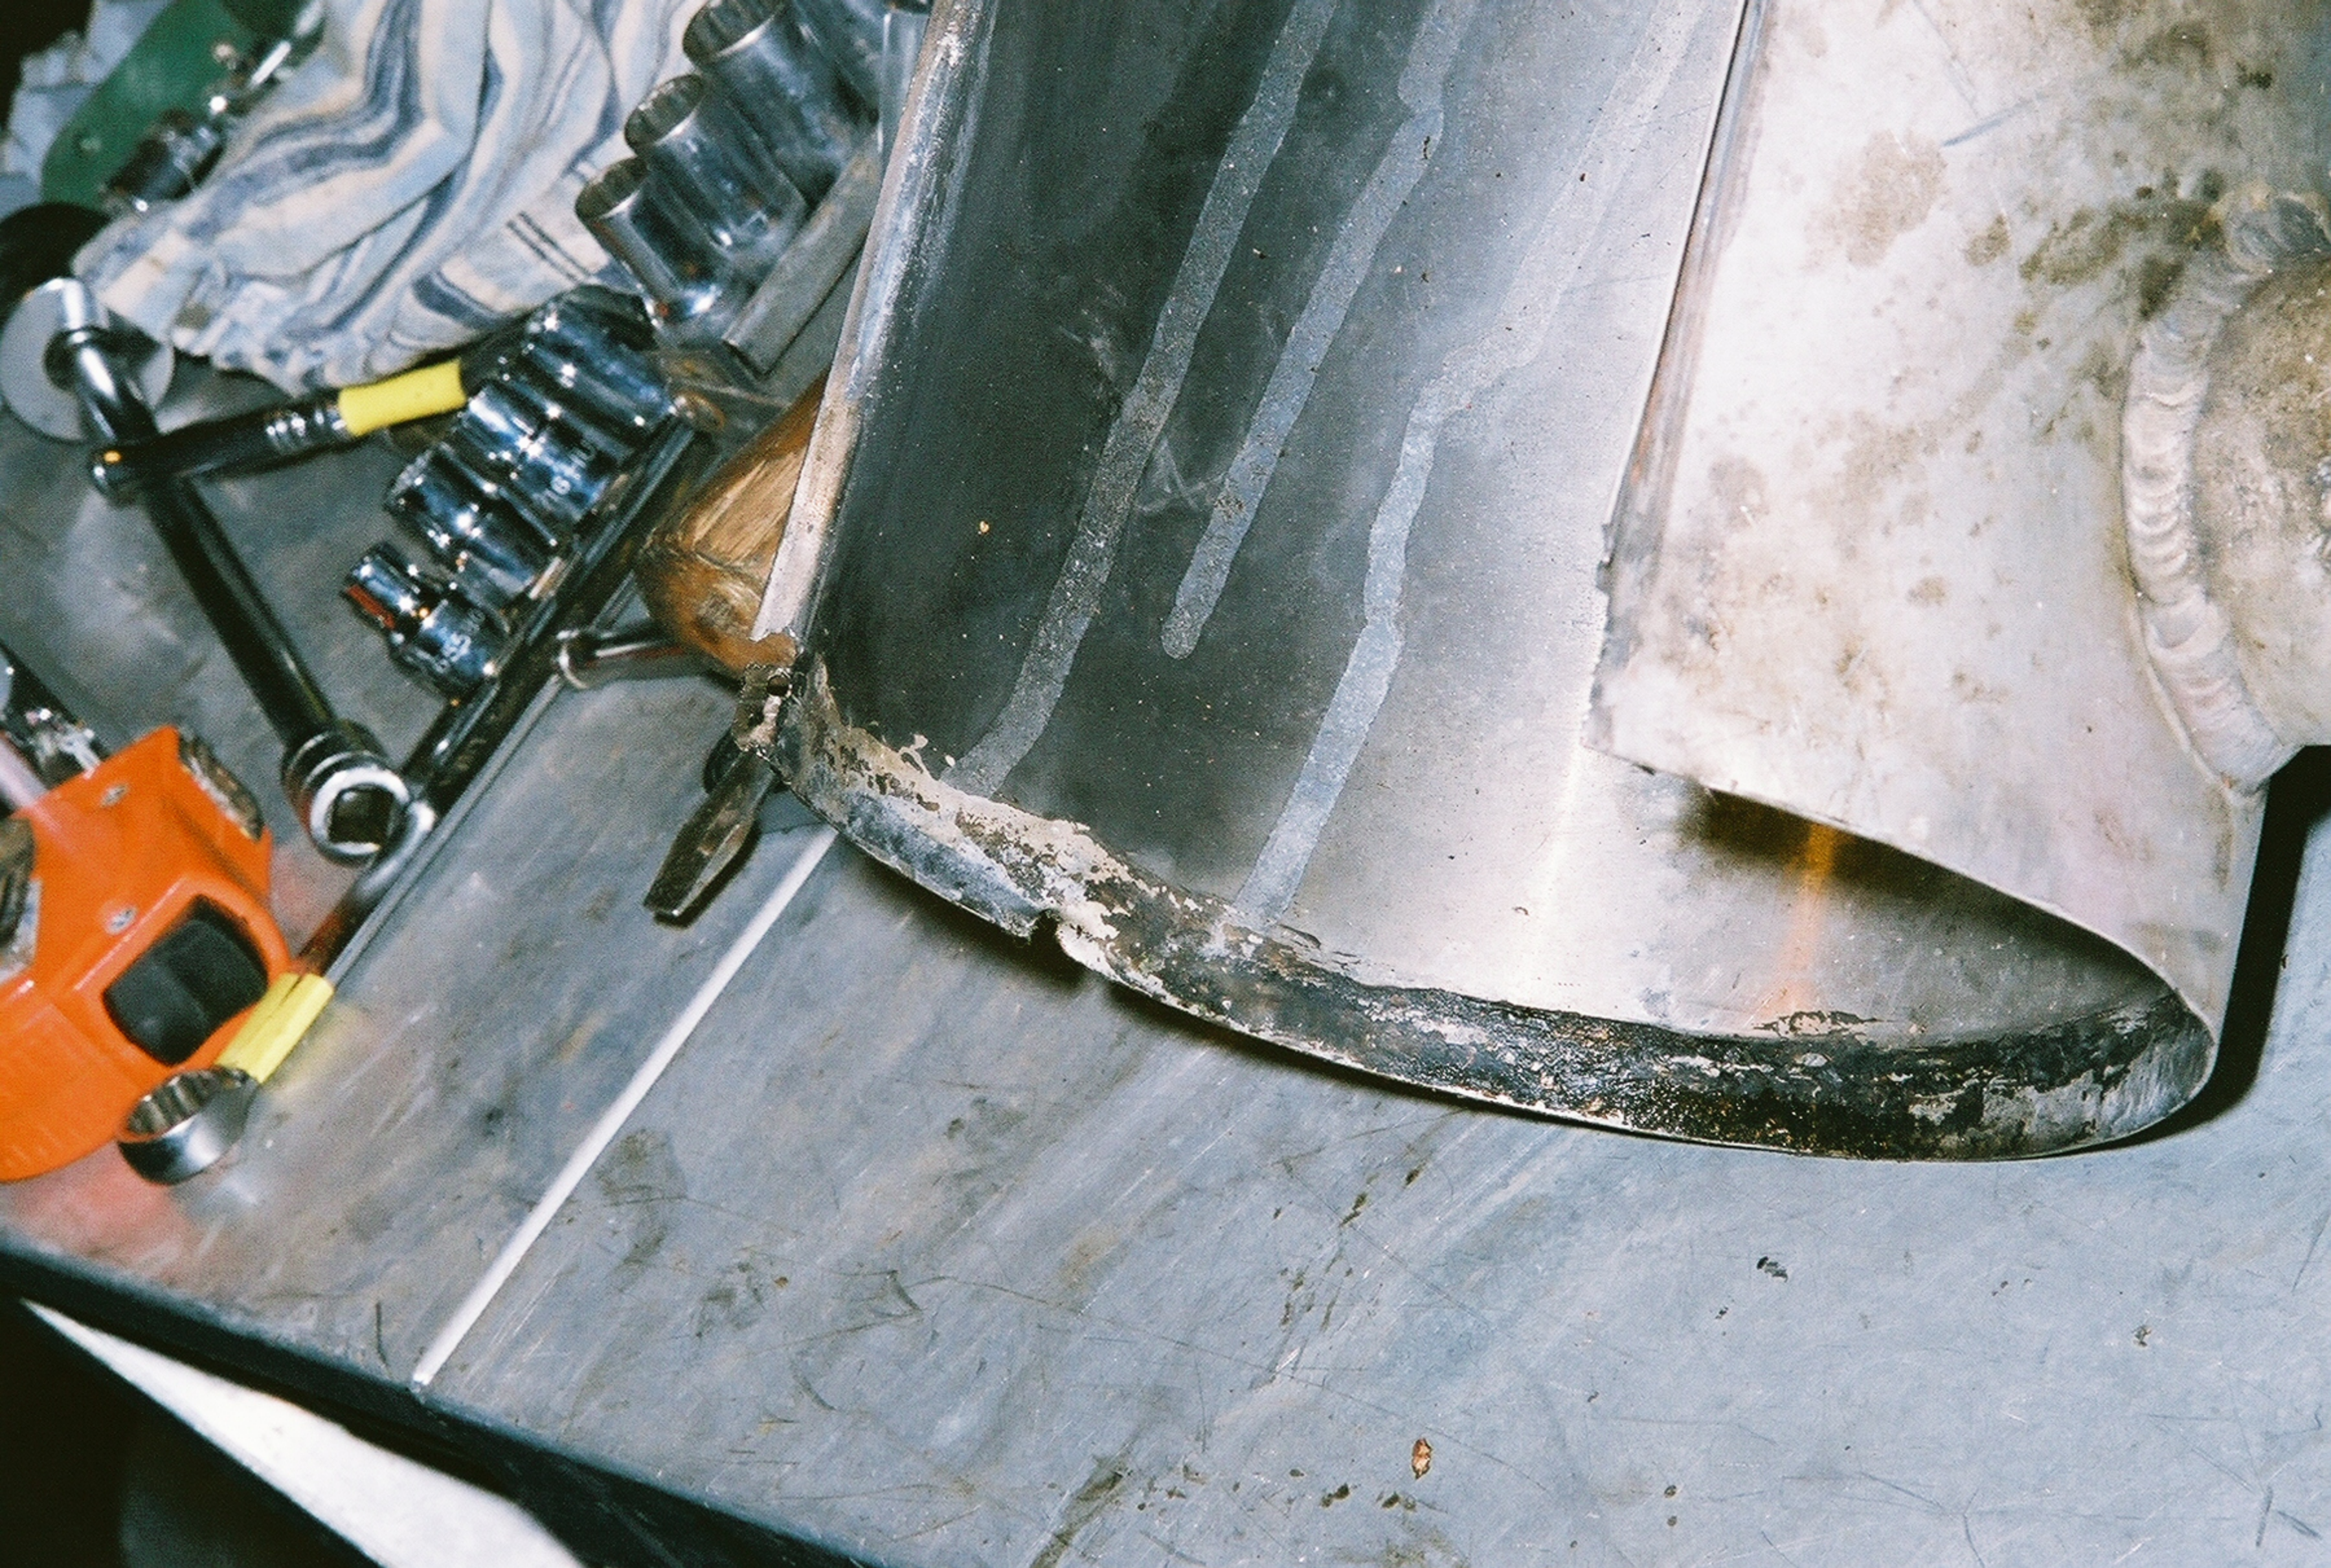
Photo 14. Heater muff showing location where material had been attached.
