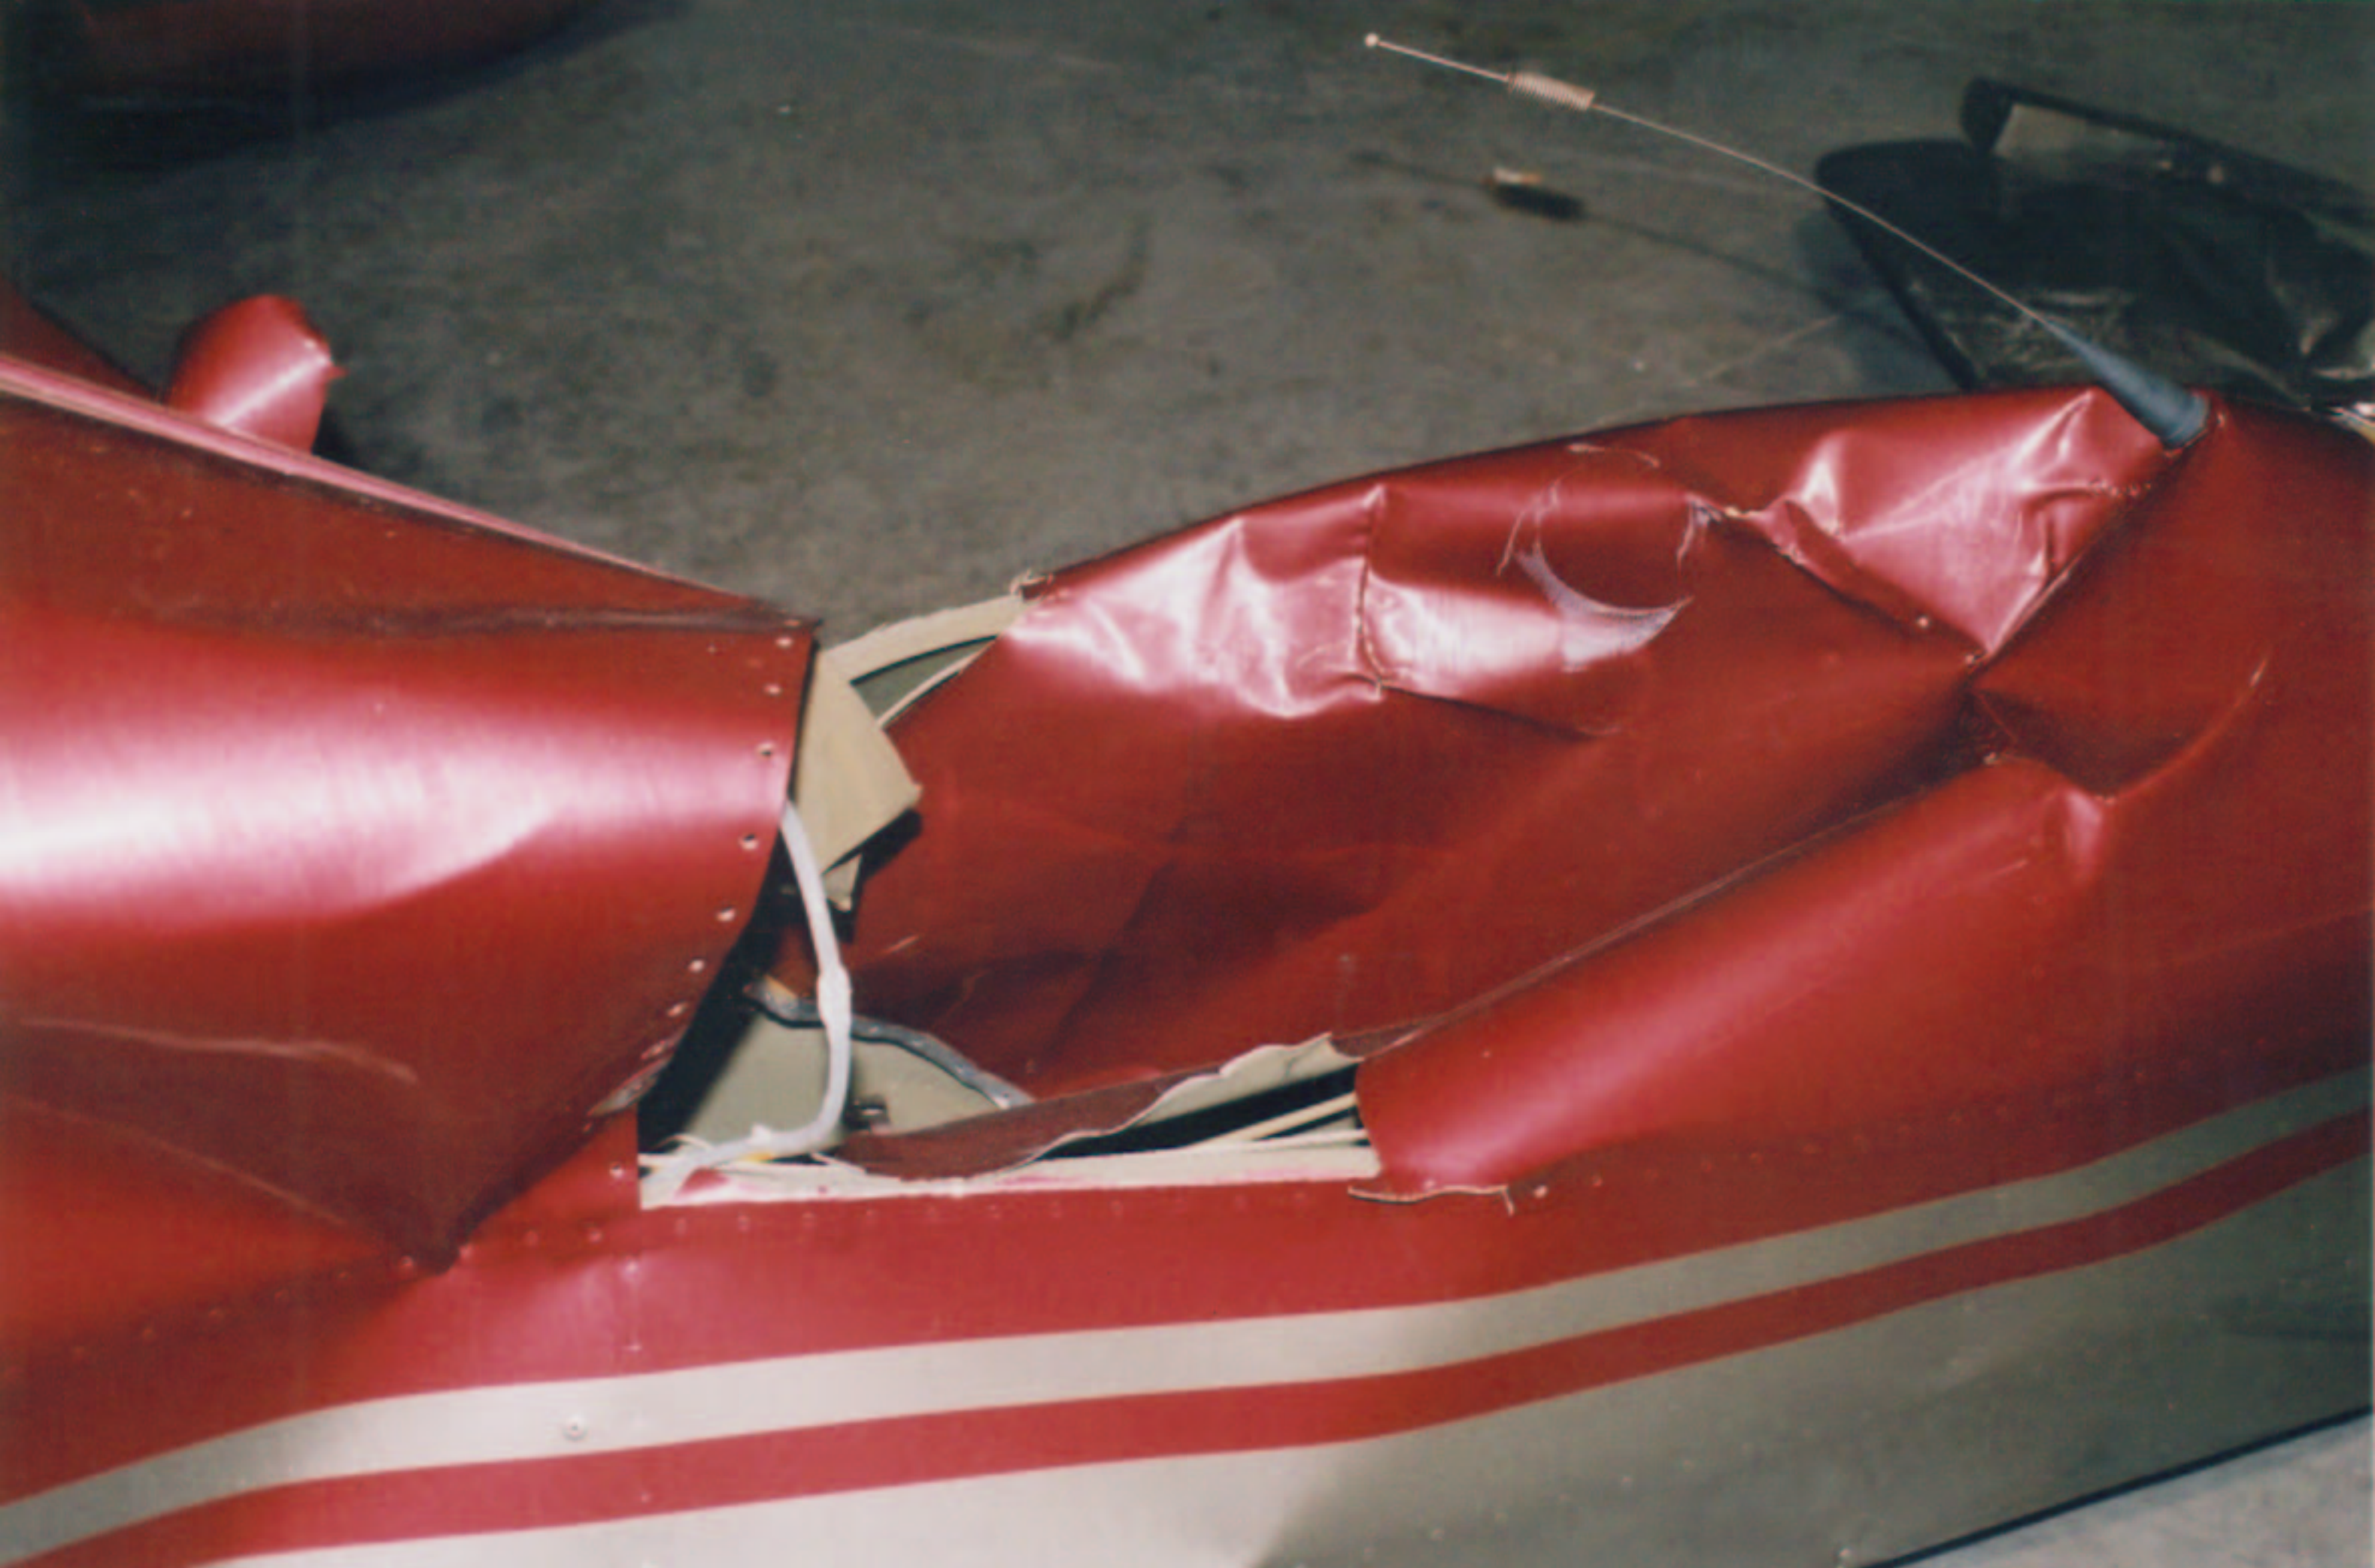
Photo 17 - View of N3333S upper surface of the empennage located behind the cabin area. Note a gray paint transfer.
