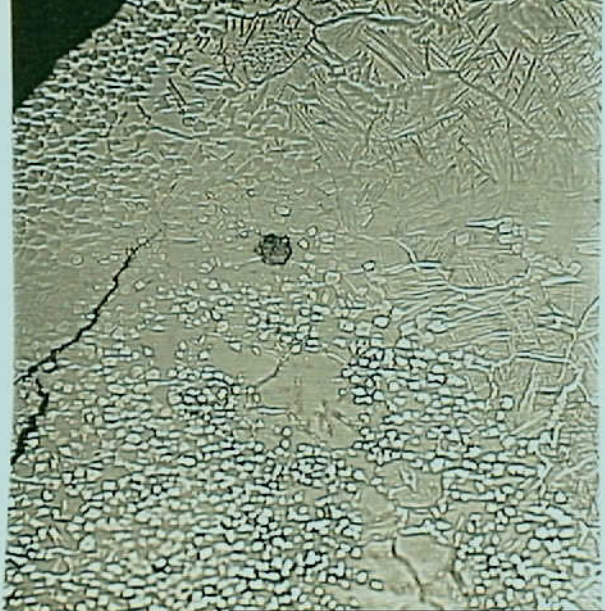
Photo 17. Hole #1A. Longitudinal section showing remelt material with cracks and overheated material (above B-transus) with transformed B. The section is located at arrow A in photo 16. Mag 500X.
