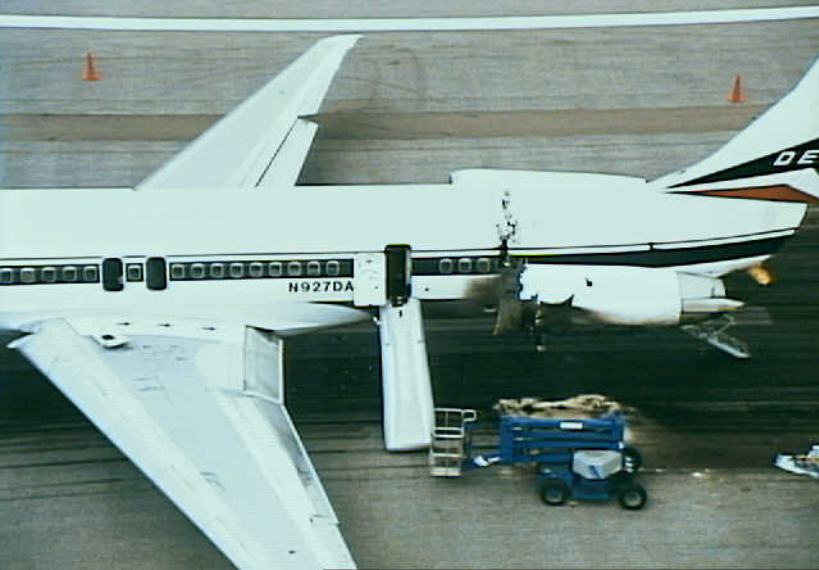
Photo 2. Aerial view showing damage to left fuselage and left engine.
