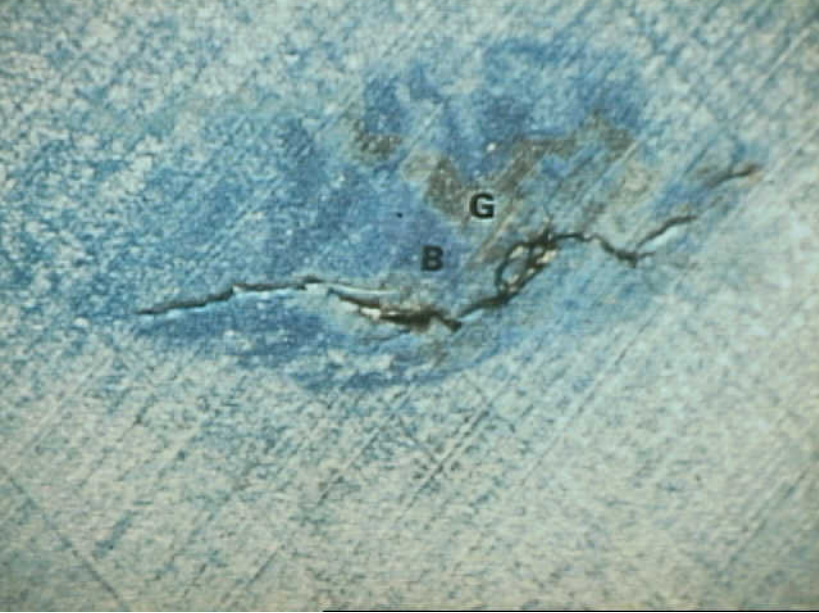
Photo 21. A close up of the center of the BEA indication in hole #1B. The grey area G is contaminated with iron (Fe) in difference with the blue area B. Notice the crack in the area.
