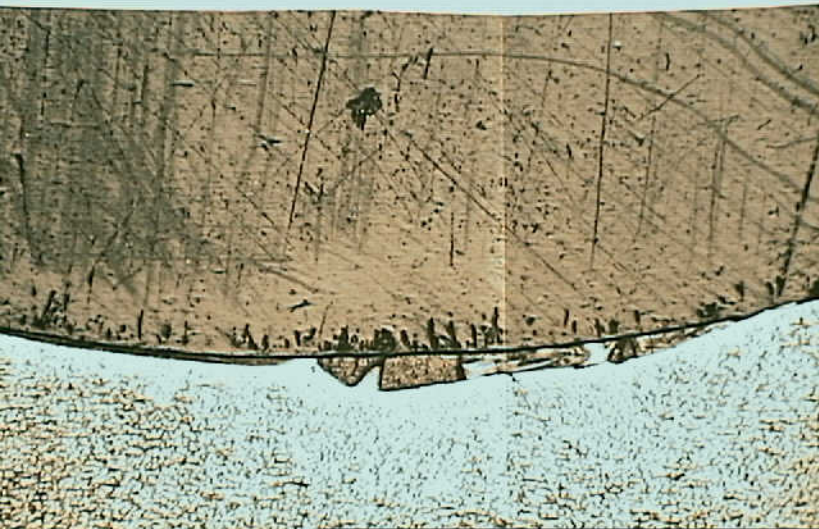
Photo 24. Cross section of the indication area in hole #57. The microstructure shows deformation to a depth of 0.2 mm (0.0079 inch). Mag. 32X.
