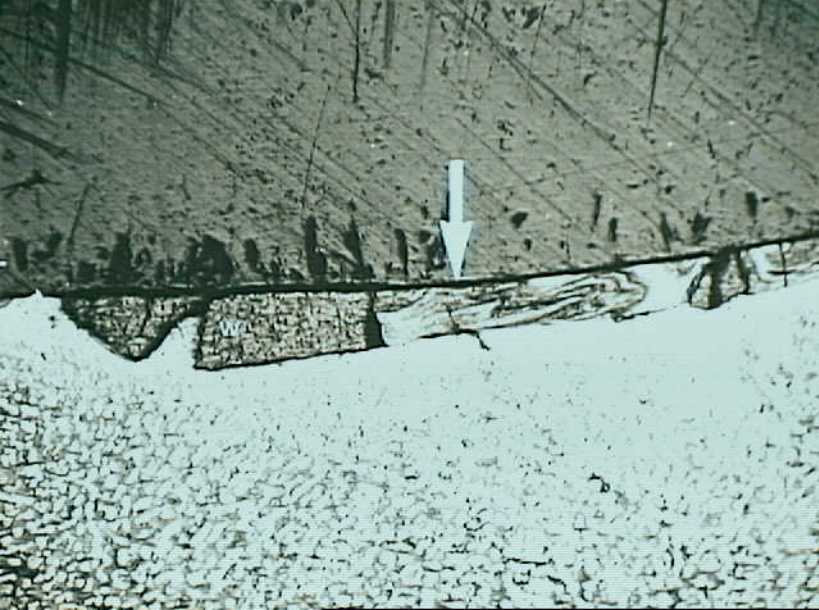
Photo 25. A close up on the indication area in hole #57 in previous photo. During the drill breakdown particles on tungsten (W) have been pressed into the ID.
