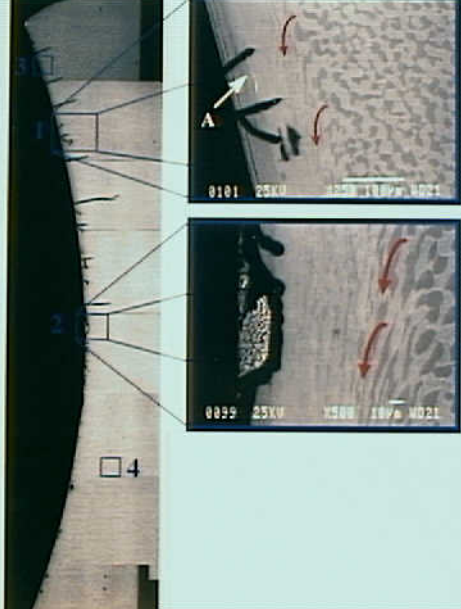
Photo 4. Backscatter electron image photomicrograph of polished surface containing "hardened layer" and at least 29 cracks. The red arrows in Regions 1 and 2 identify observed plastic deformation under the "hardened layer".
