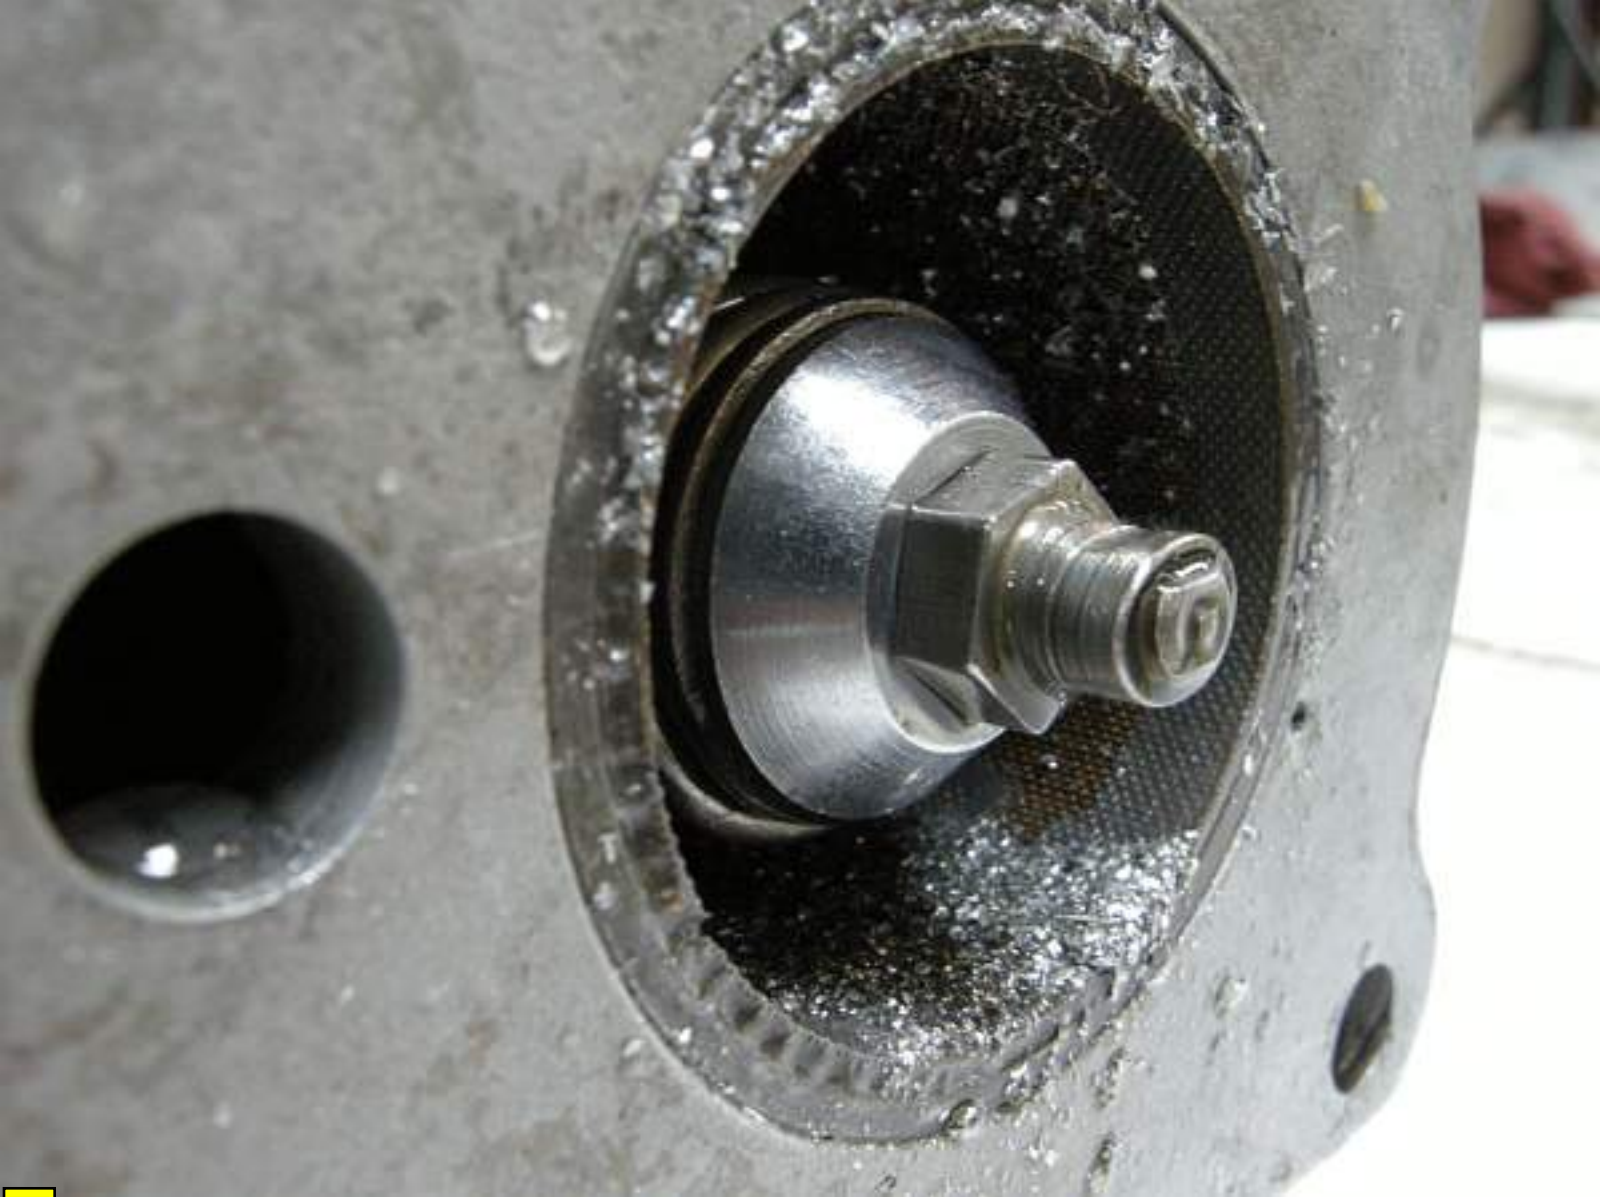
Photo 5 - Metal Shavings in the Vernatherm and Housing
