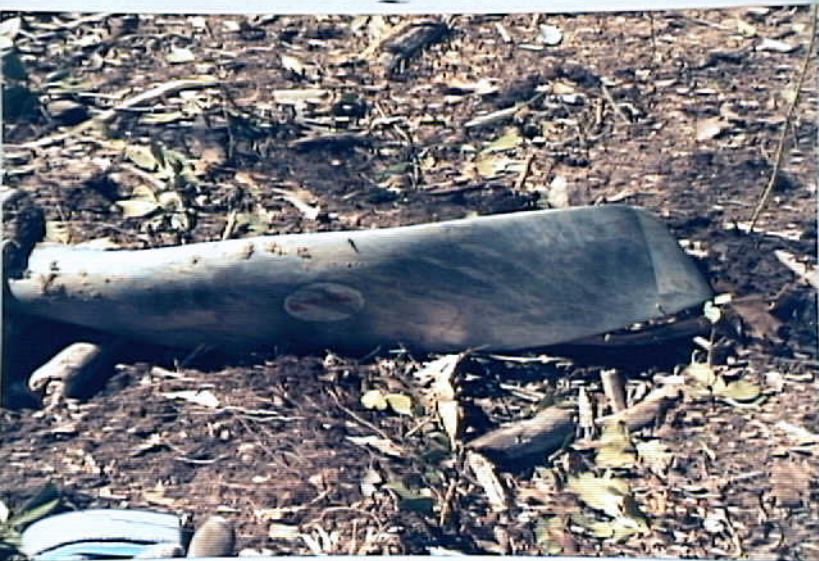
Photo 8: View of other propeller blade. Note spanwise and chordwise scratches.
