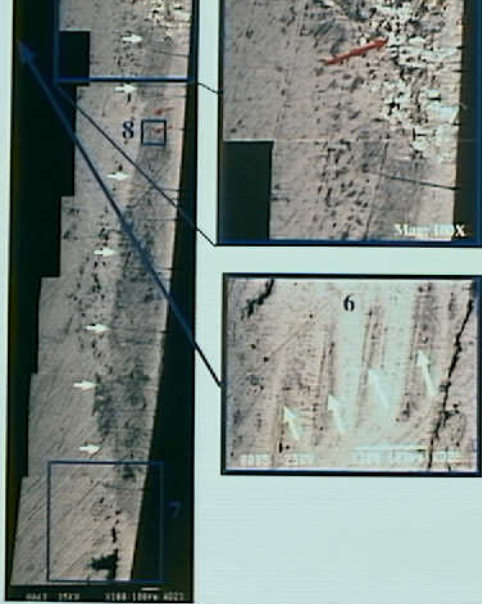
Photo 8. Backscatter electron image of the tierod hole surface. The red arrows identify patches of high intensity electron return. The yellow arrows identify the directional marring. White arrows outline the changed surface morphology near the cracks.
