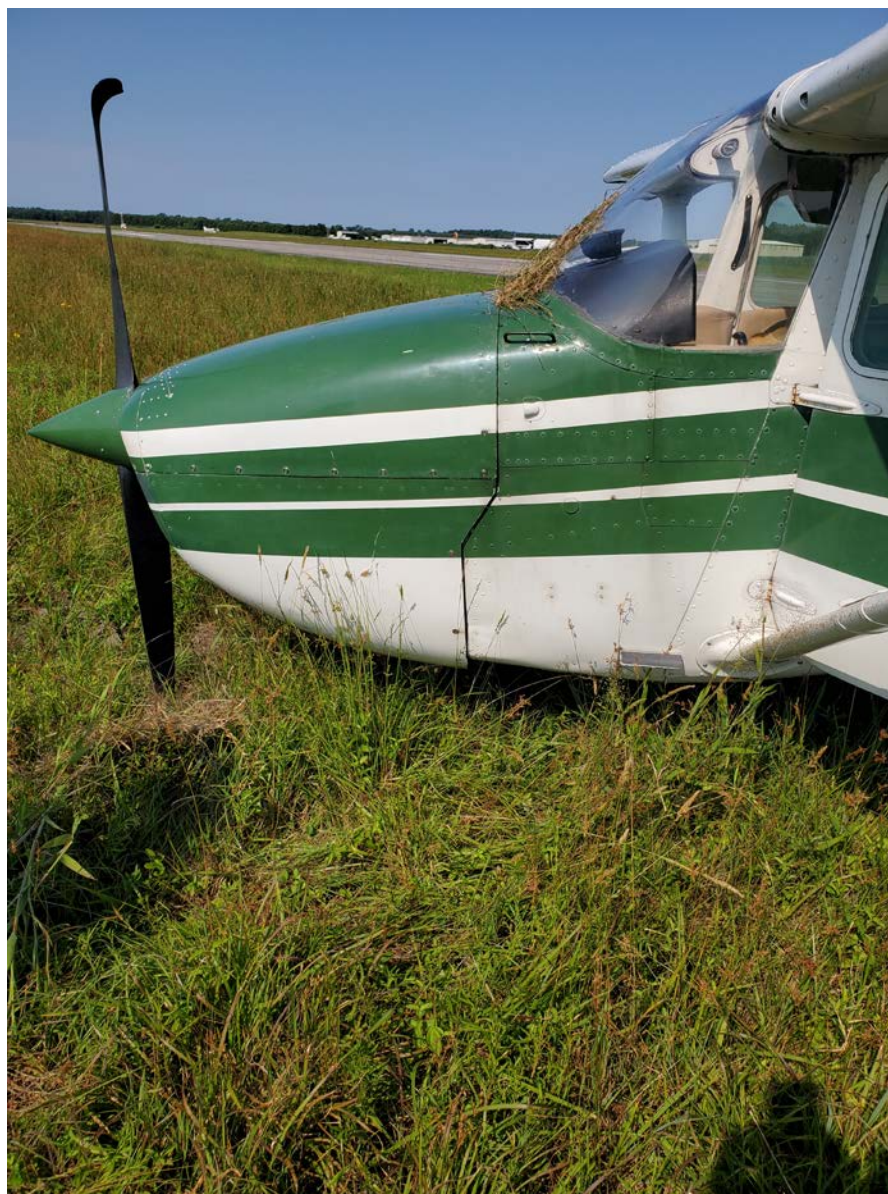
**Photo 1 – Left front view of airplane in grass. (Courtesy of Operator)**

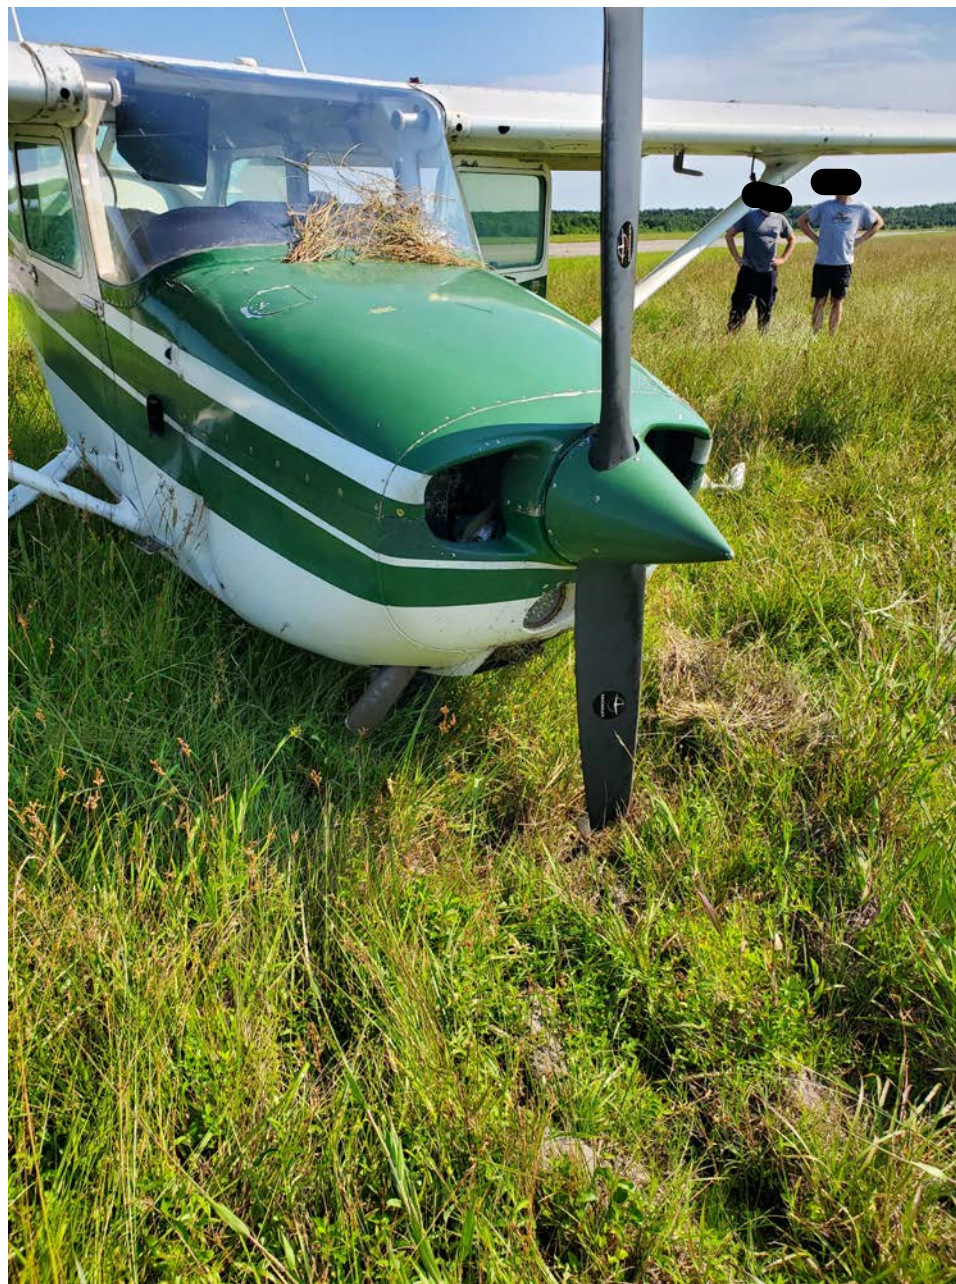
**Photo 2 – Right front quarter view of airplane showing substantial damage to fuselage. (Courtesy of Operator)**

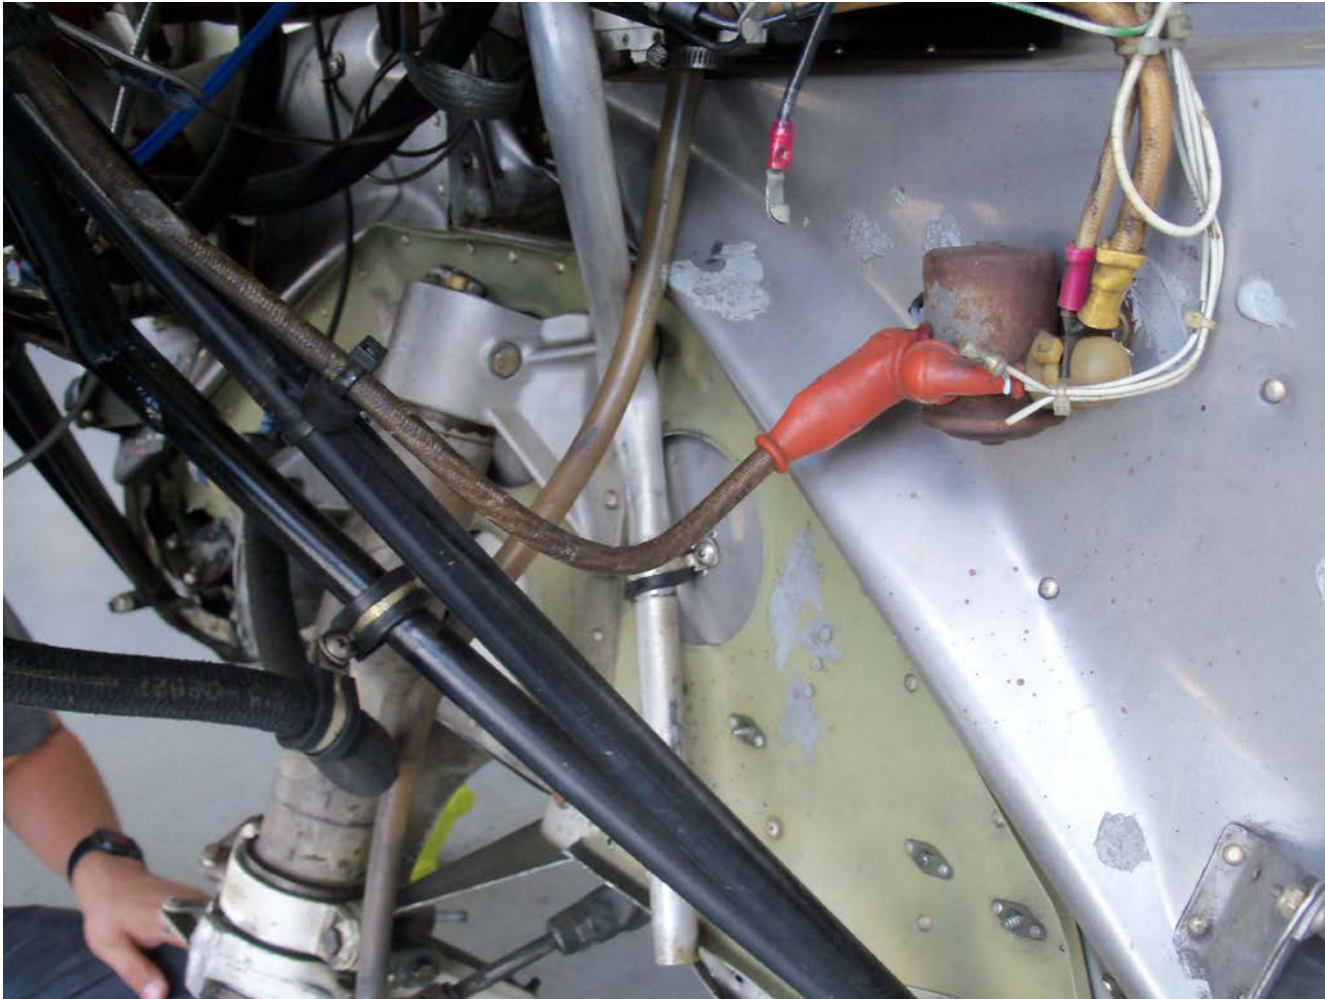
**Photo 3 – View of buckled firewall and a bent engine mount. (Courtesy of Operator)**
