Pedestrian SIR-Highway Accident Brief

Scene photographs

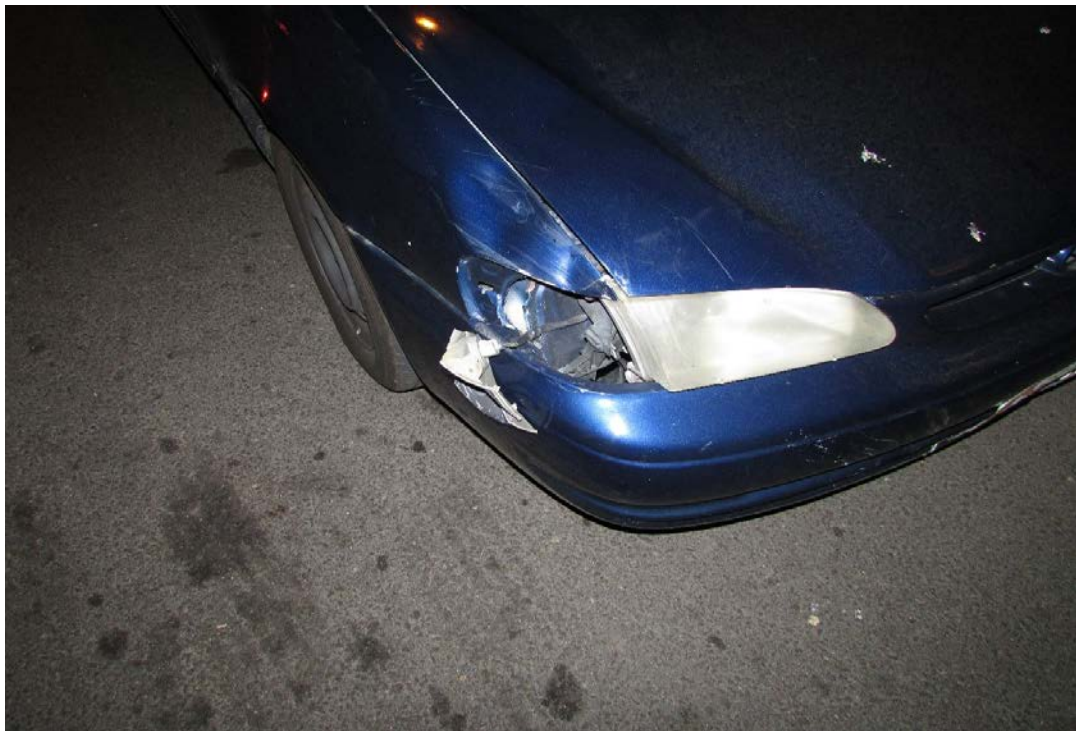
Photo #2: Closeup of impact damage to the striking vehicle

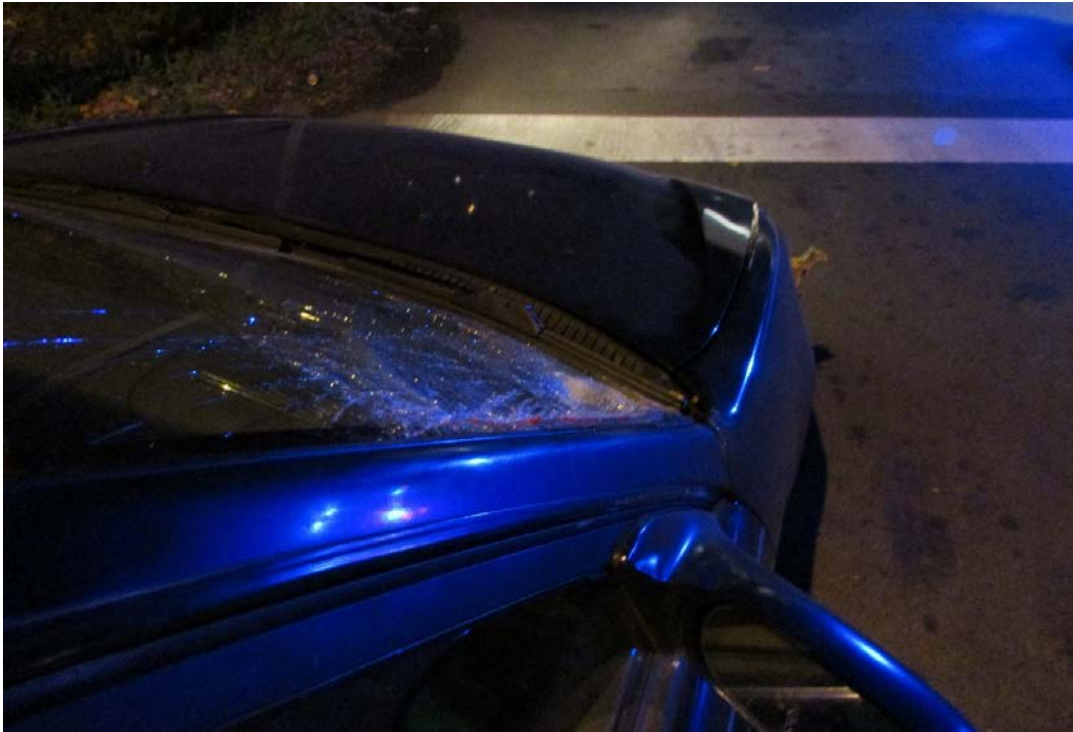
Photo #3: Overhead view of damage to windshield caused by impact with pedestrian

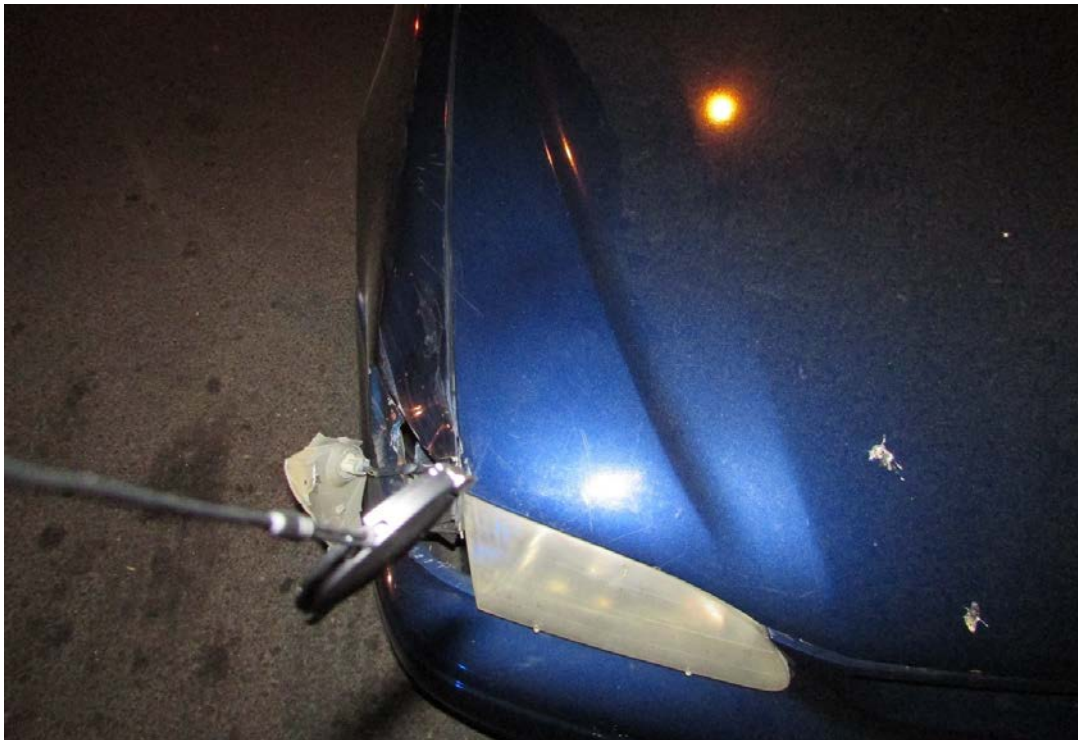
Photo #5: Closeup of scratches on hood of striking vehicle
