HIGHWAY ACCIDENT BRIEF

Photographs

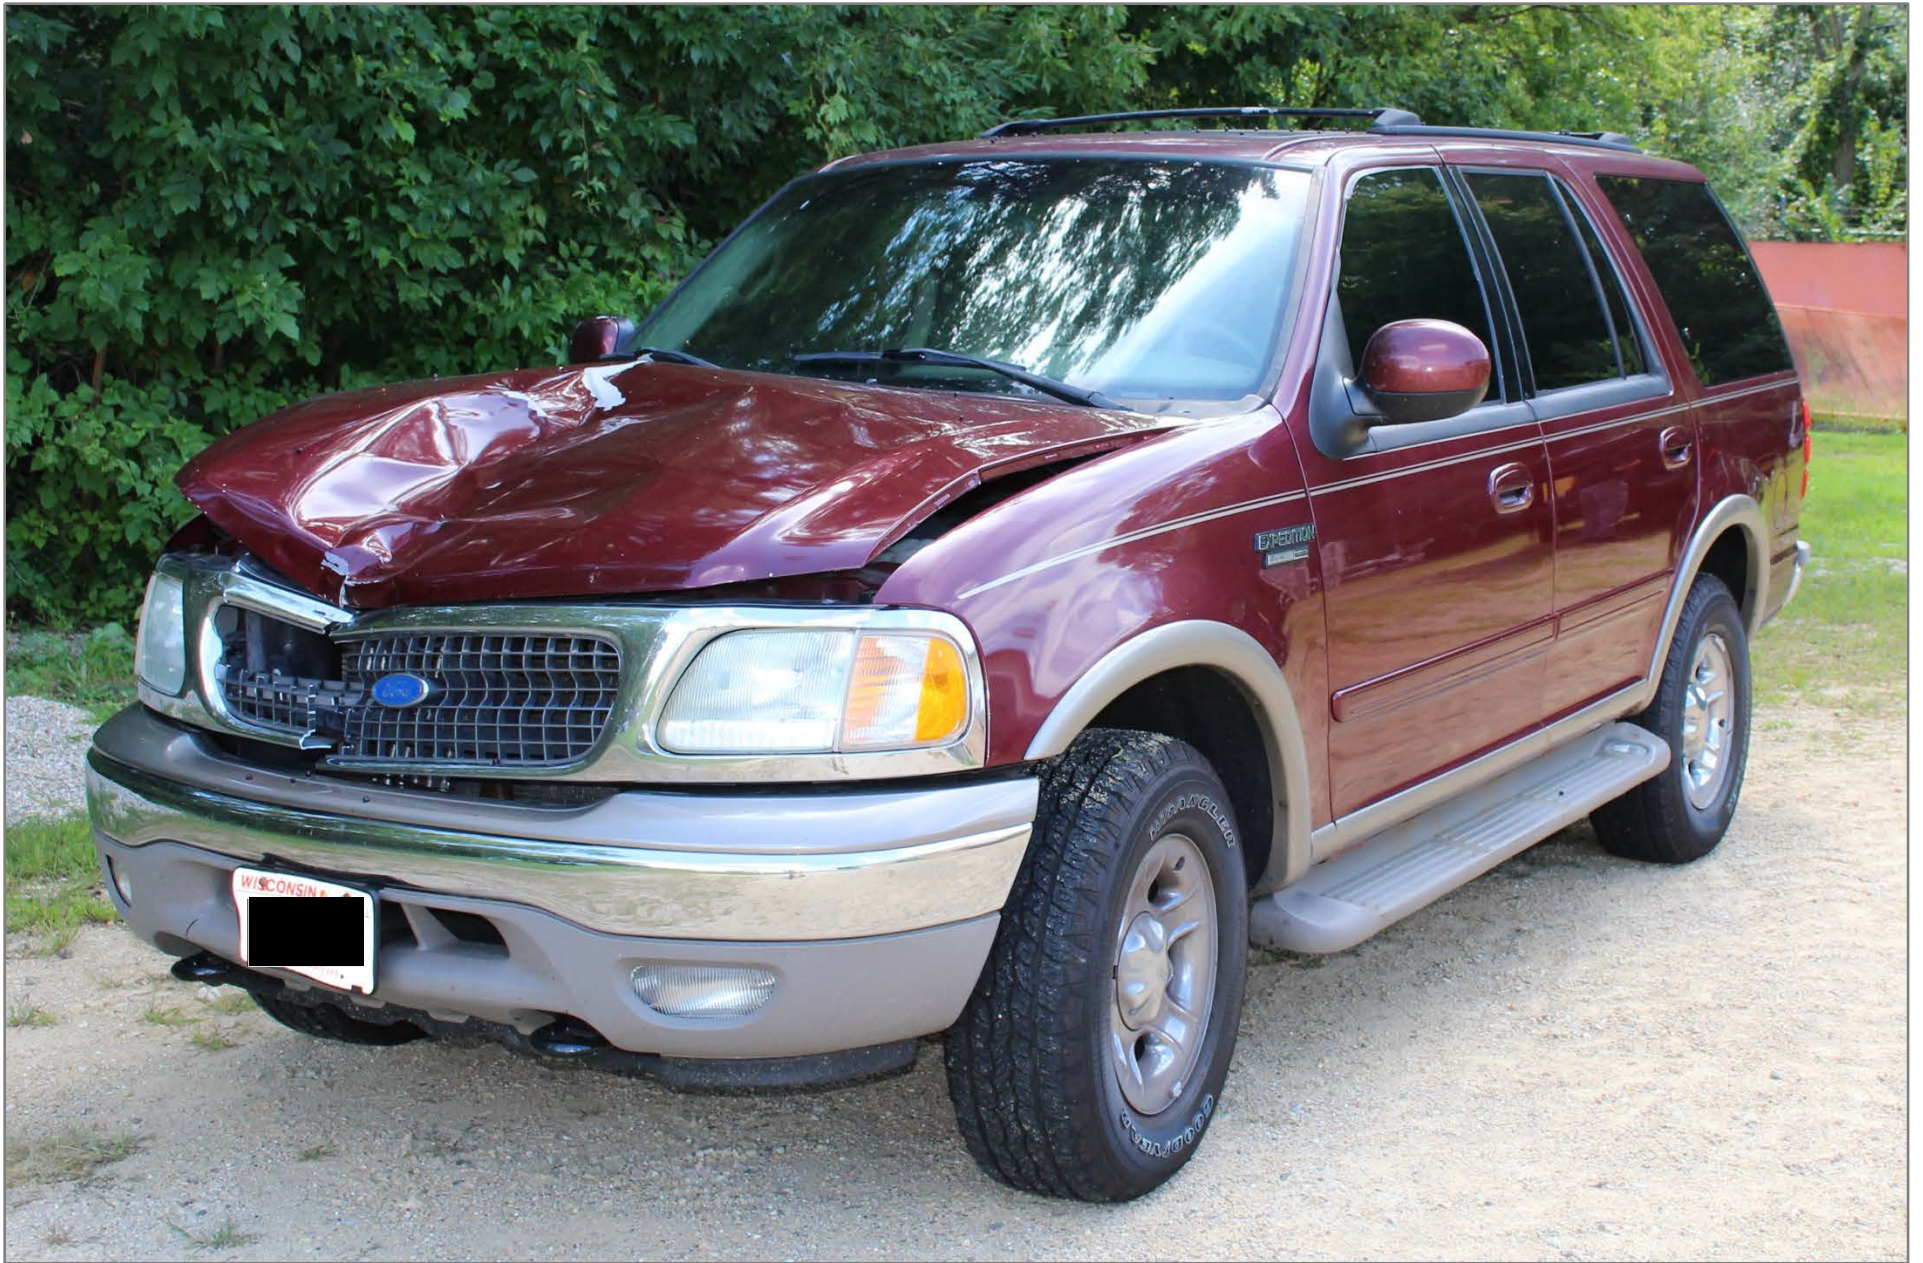
Photograph 4 – Front Driver's Side Corner of Ford Expedition Showing Contact Damage

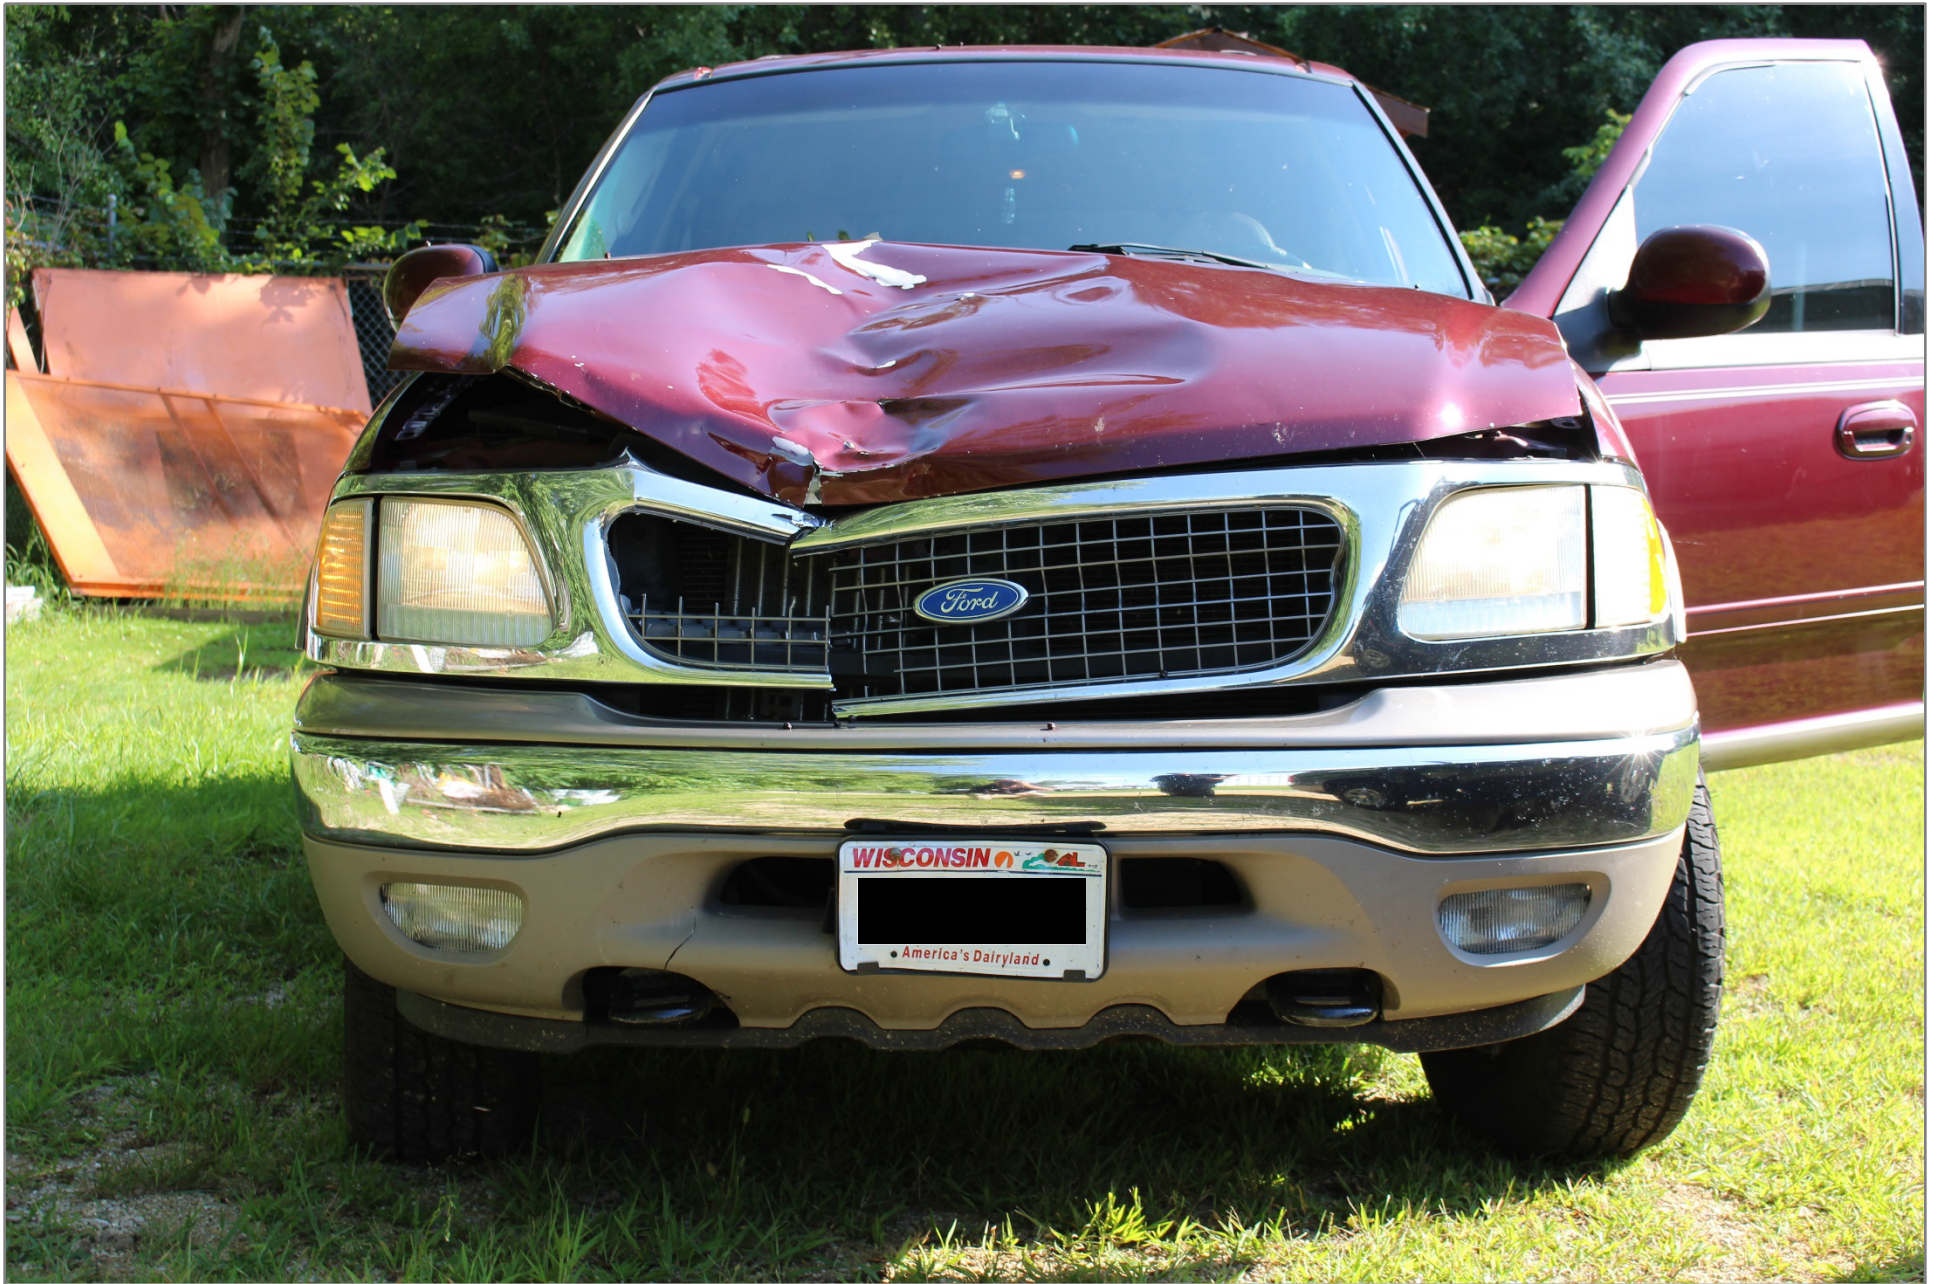
Photograph 5 - Front of Ford Expedition Showing Contact Damage

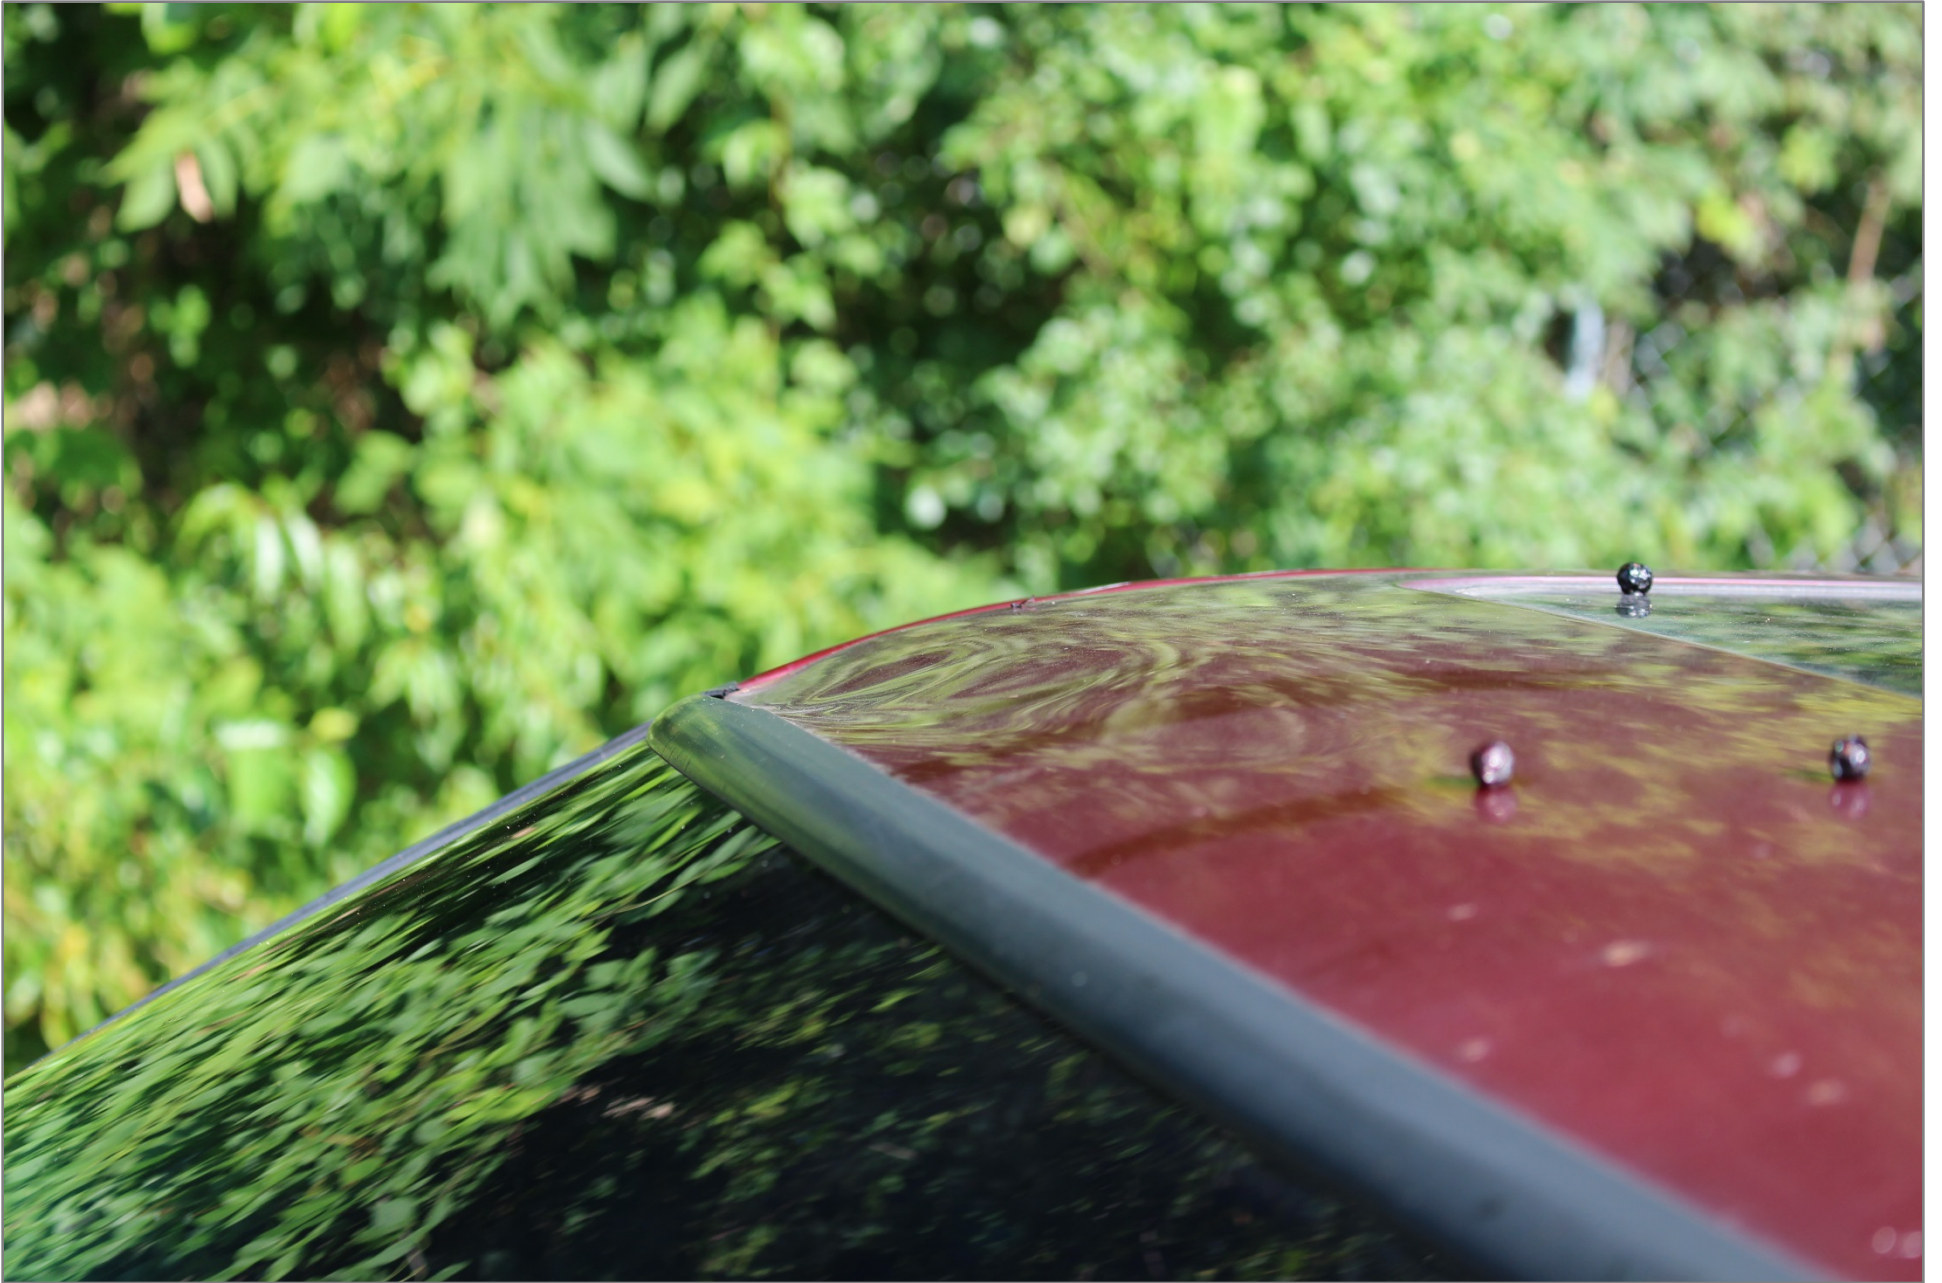
Photograph 6 – Contact Damage to Roof of Ford Expedition
