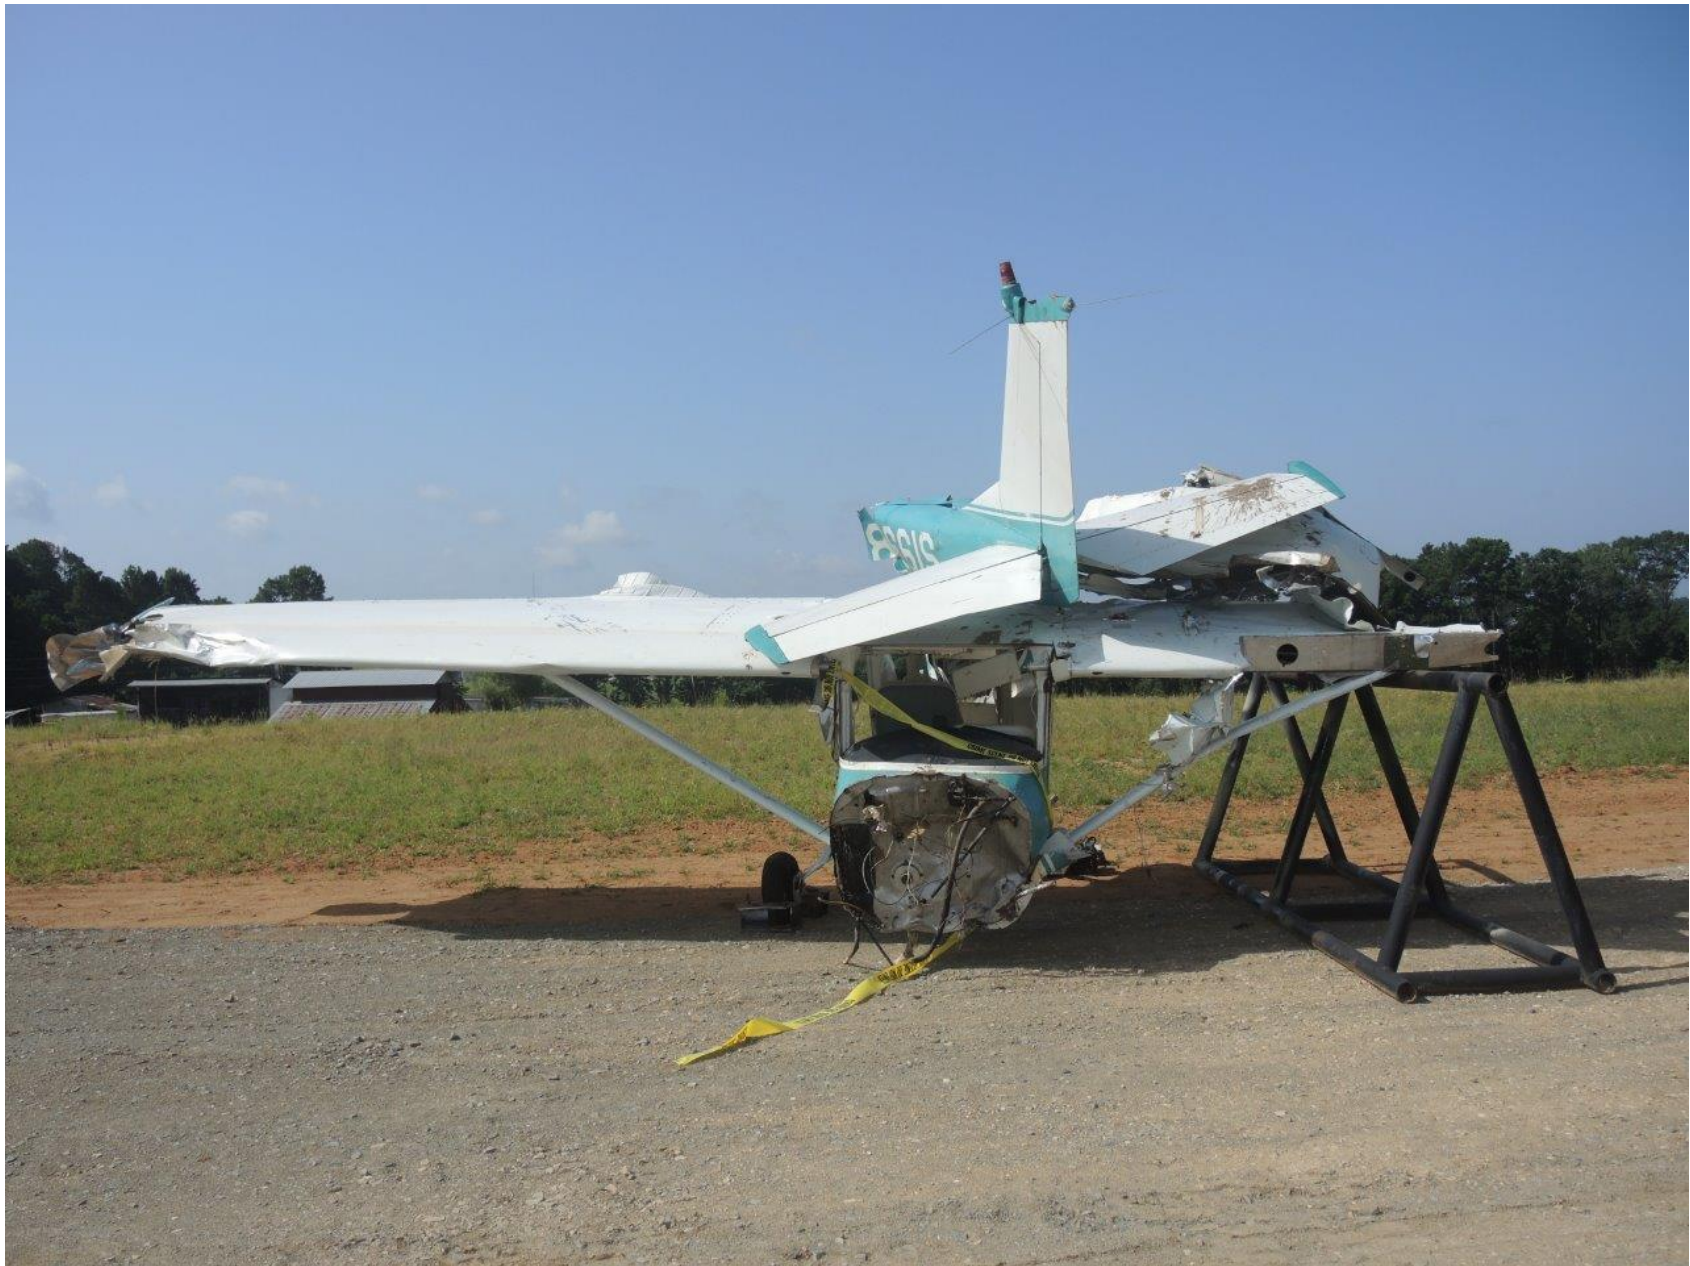
Photo 1 – View of the front of the airplane.

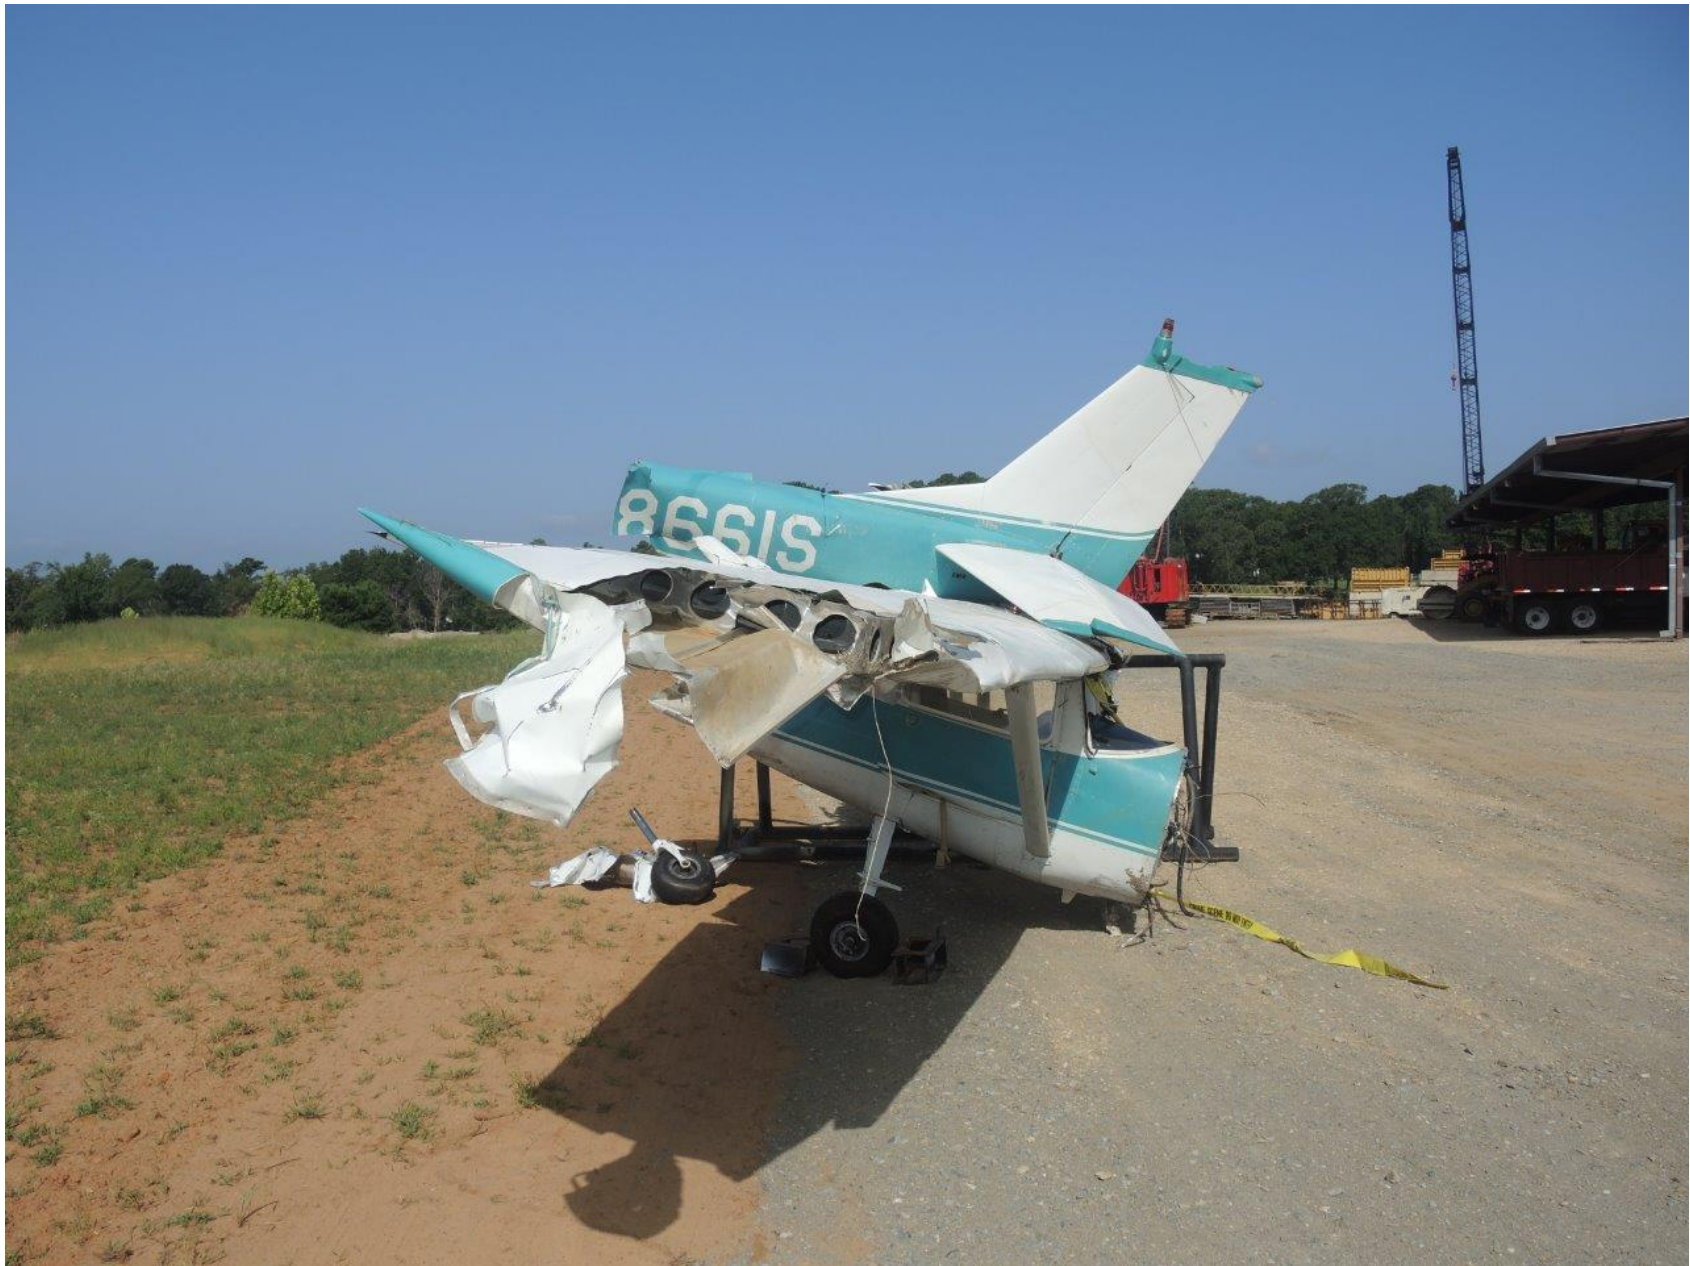
Photo 2 - View of the right side of the airplane.

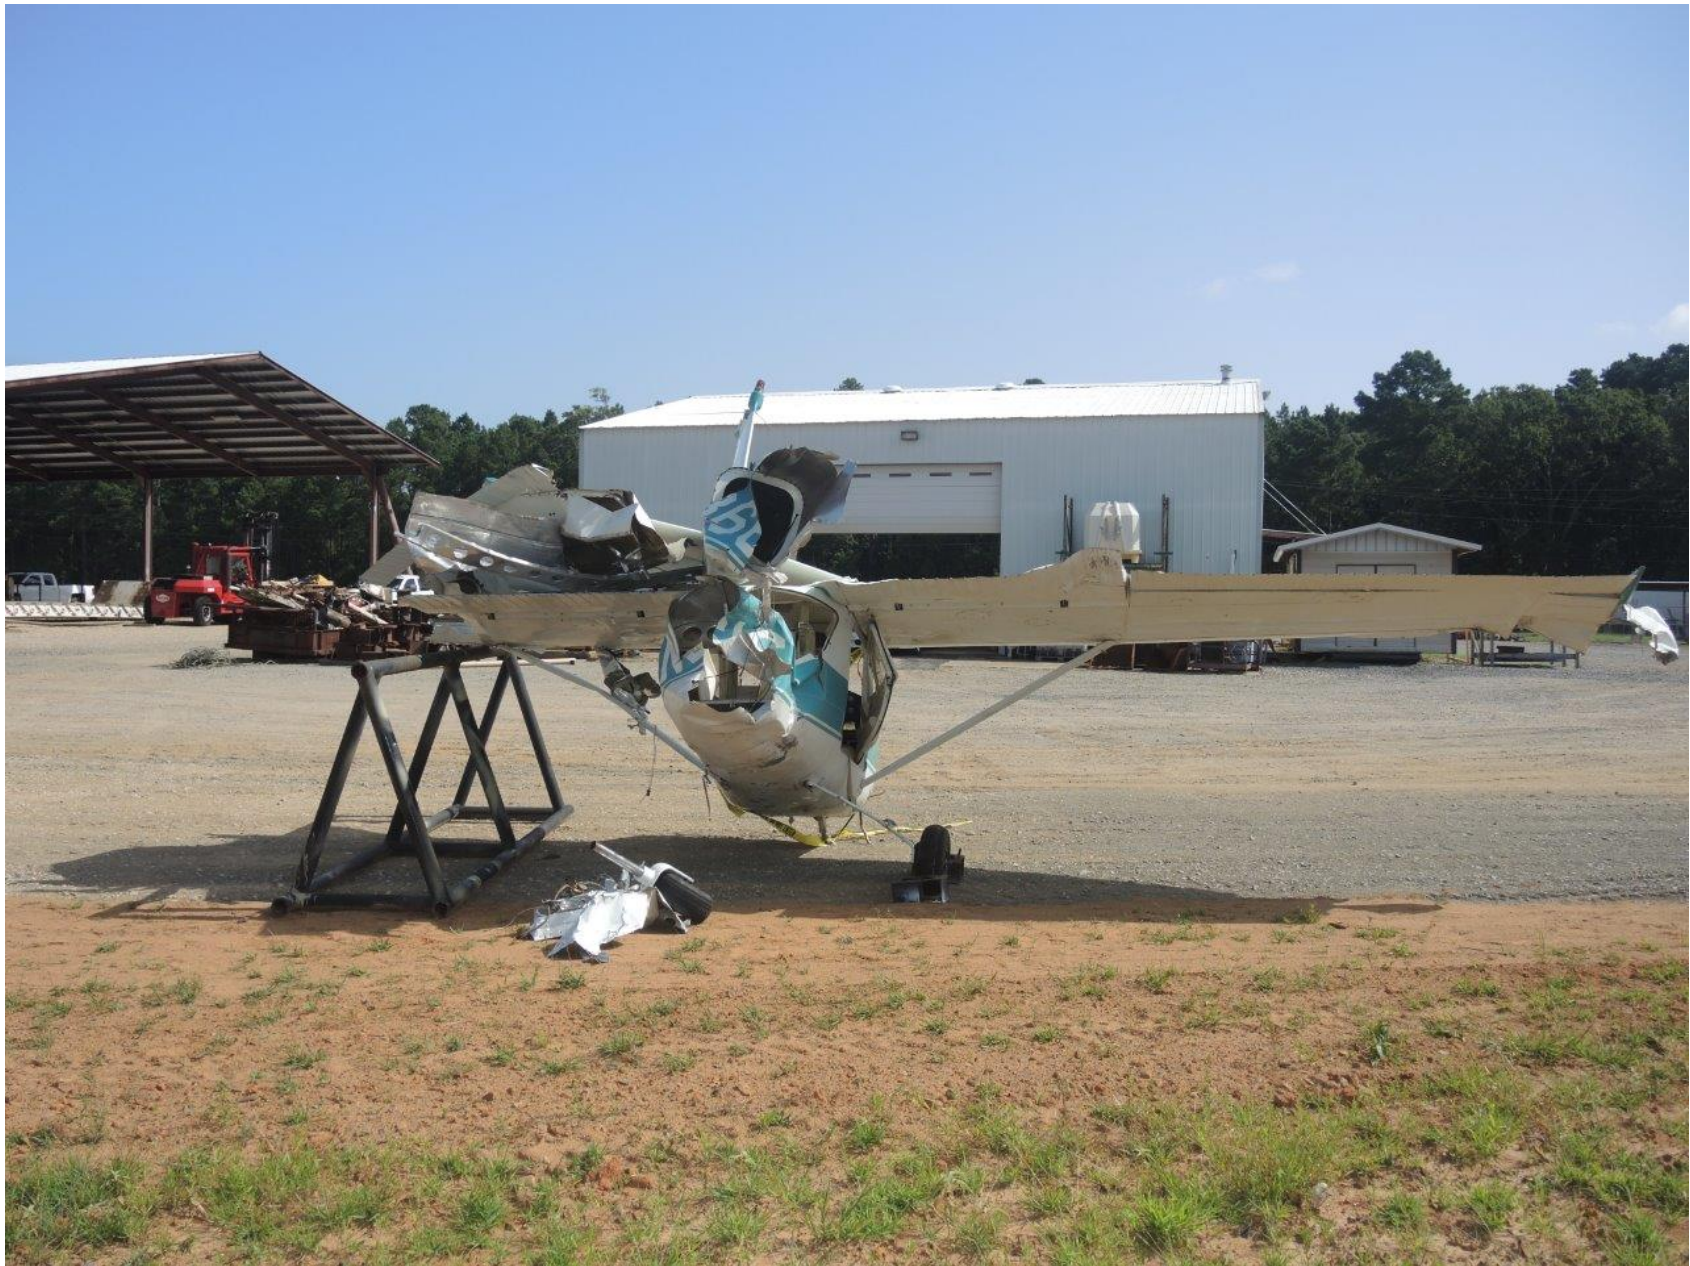
Photo 3 - View of the rear side of the airplane.

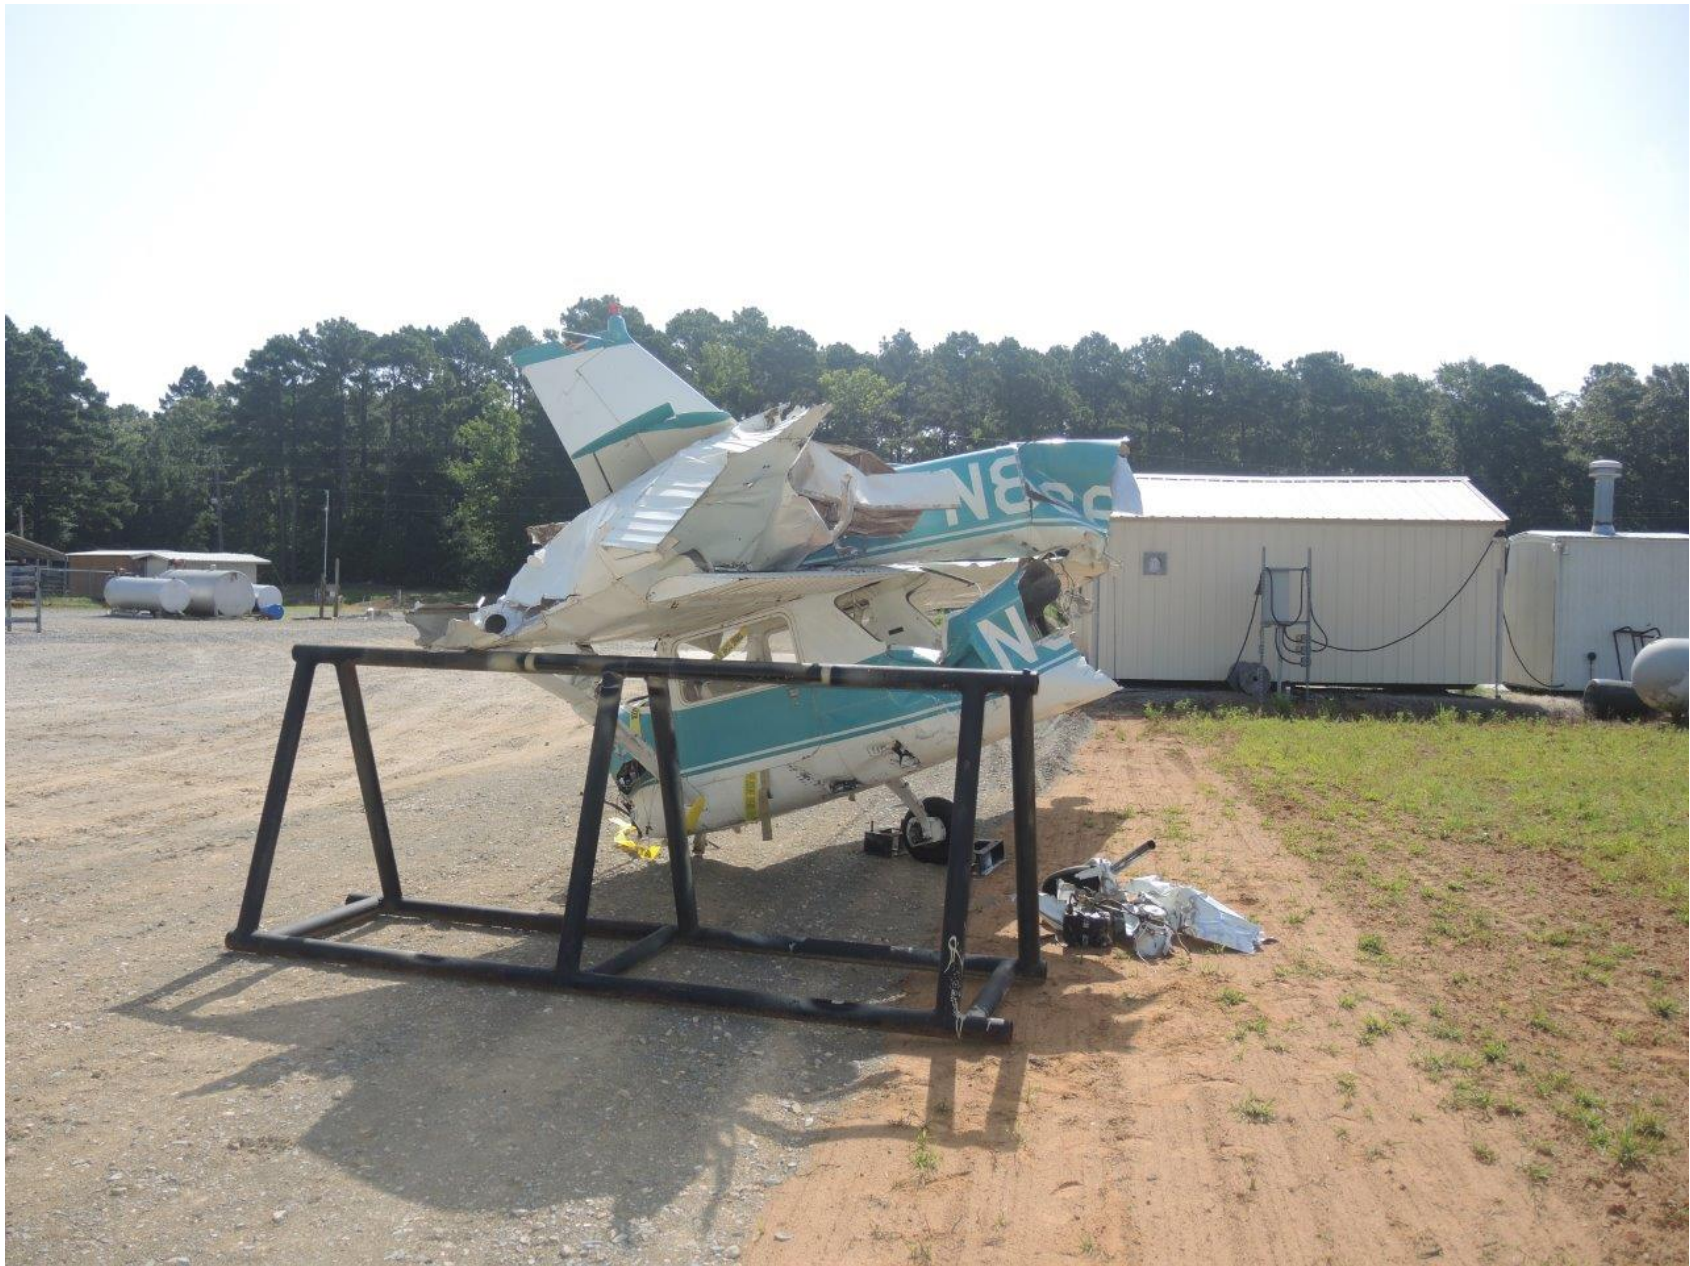
Photo 4 - View of the left side of the airplane.

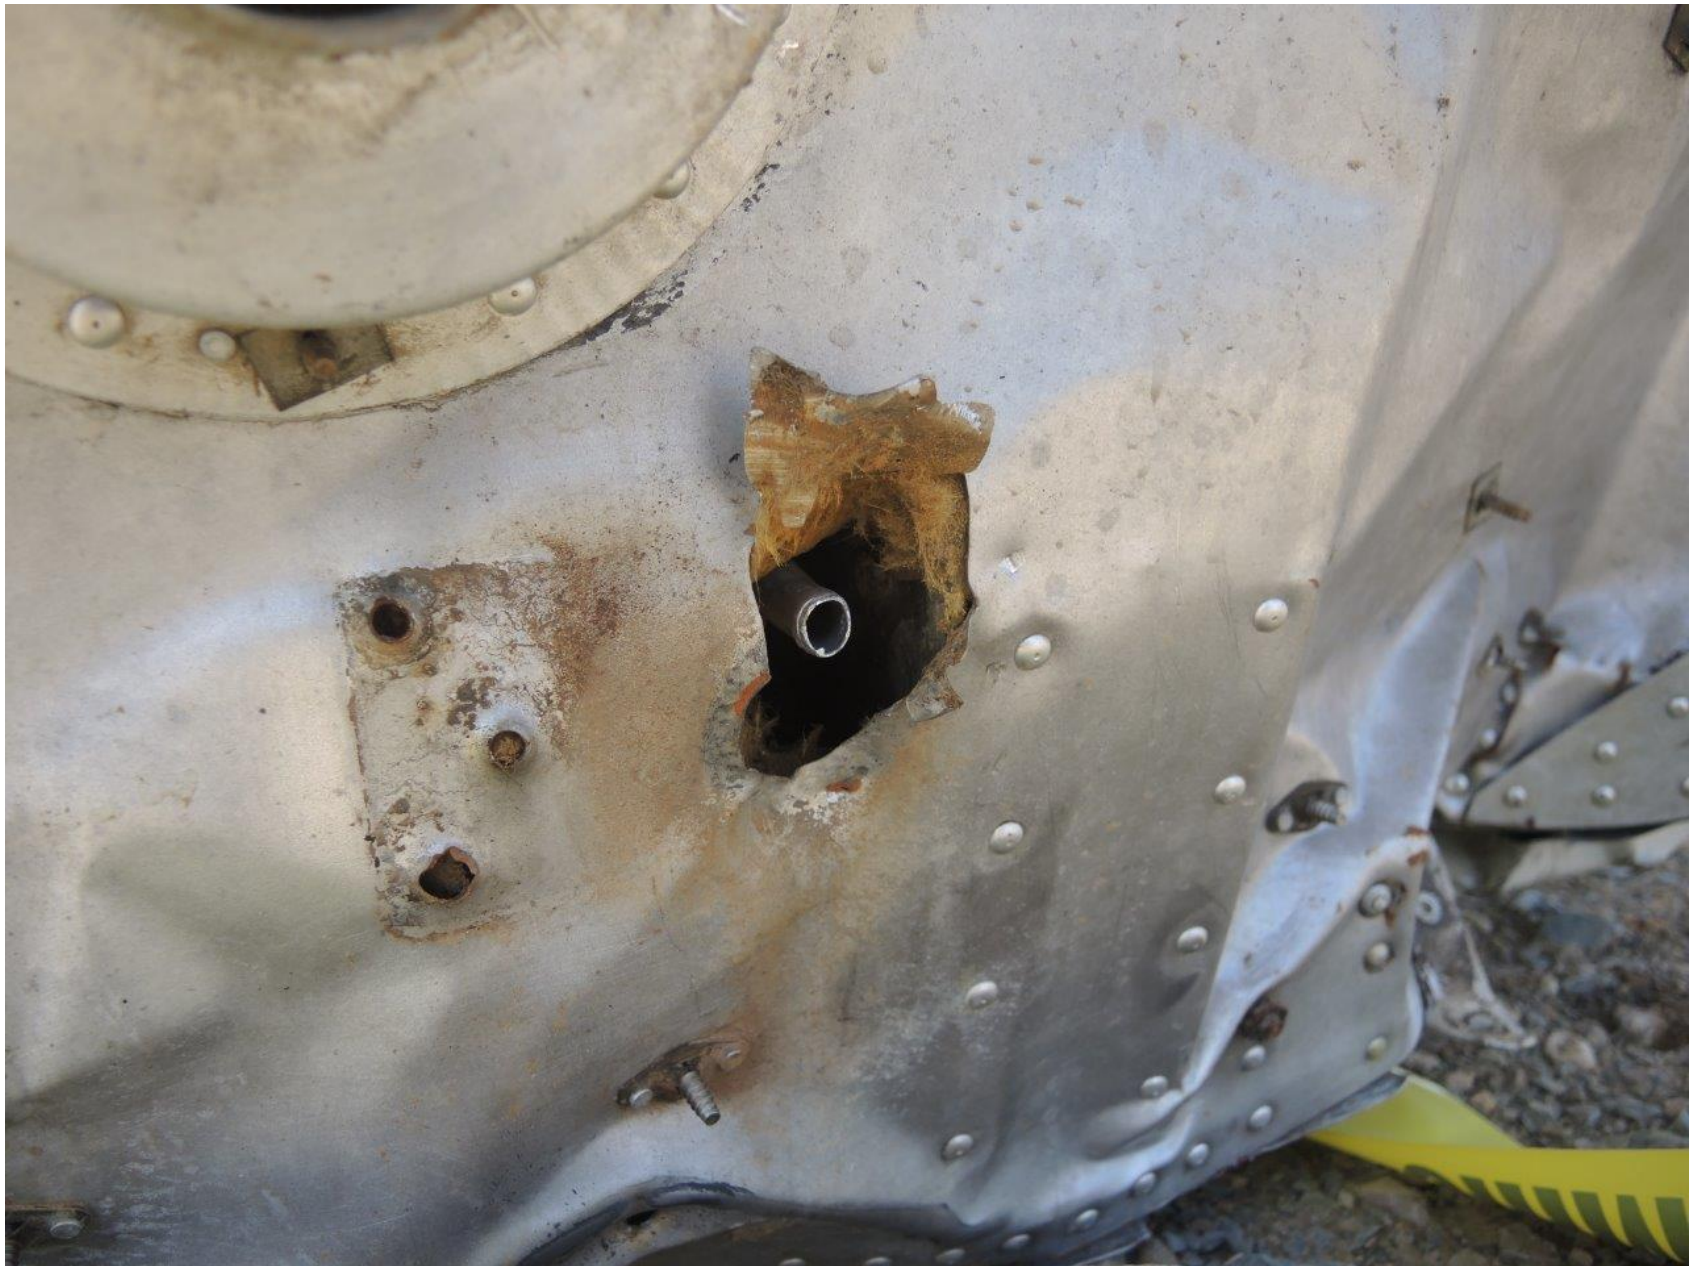
Photo 5 - View of the fuel line where pressurized air was applied.

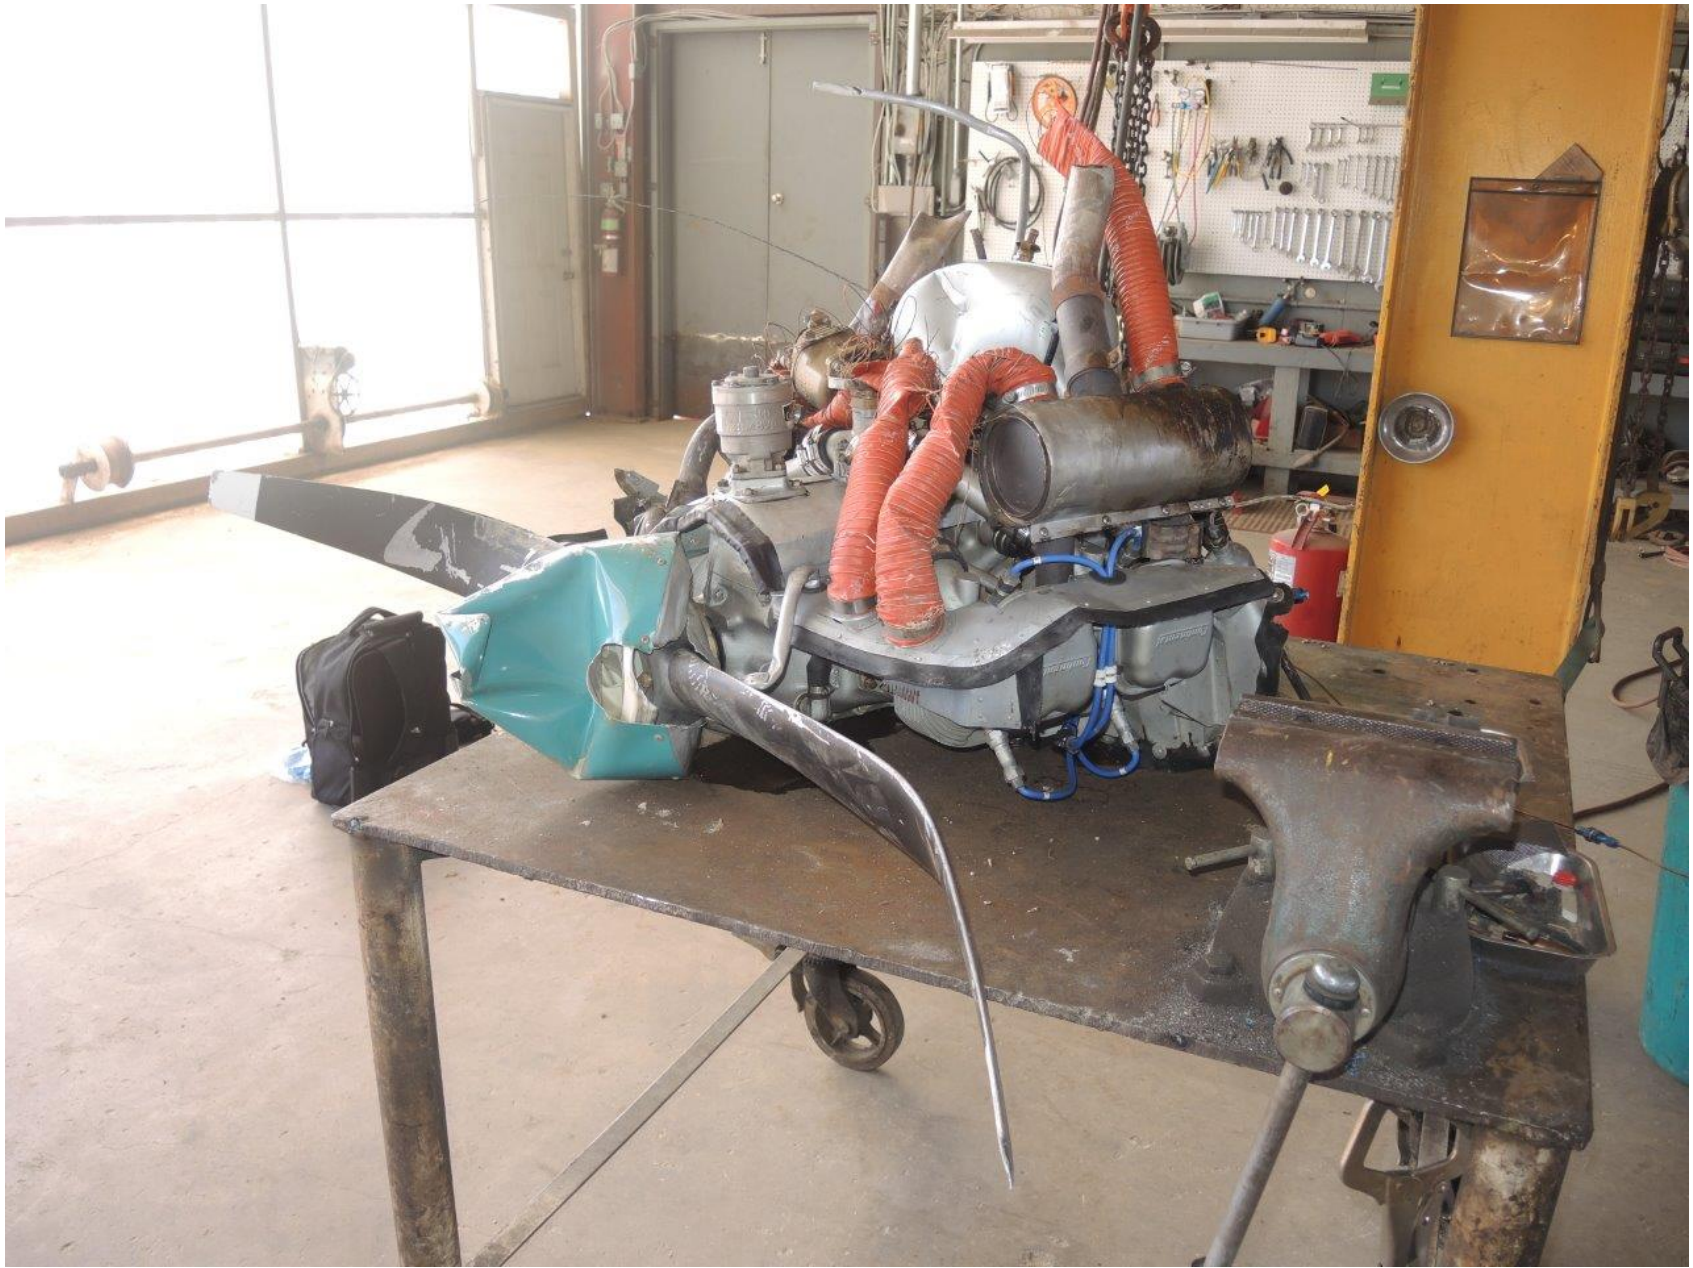
Photo 6 - View of the engine and propeller.

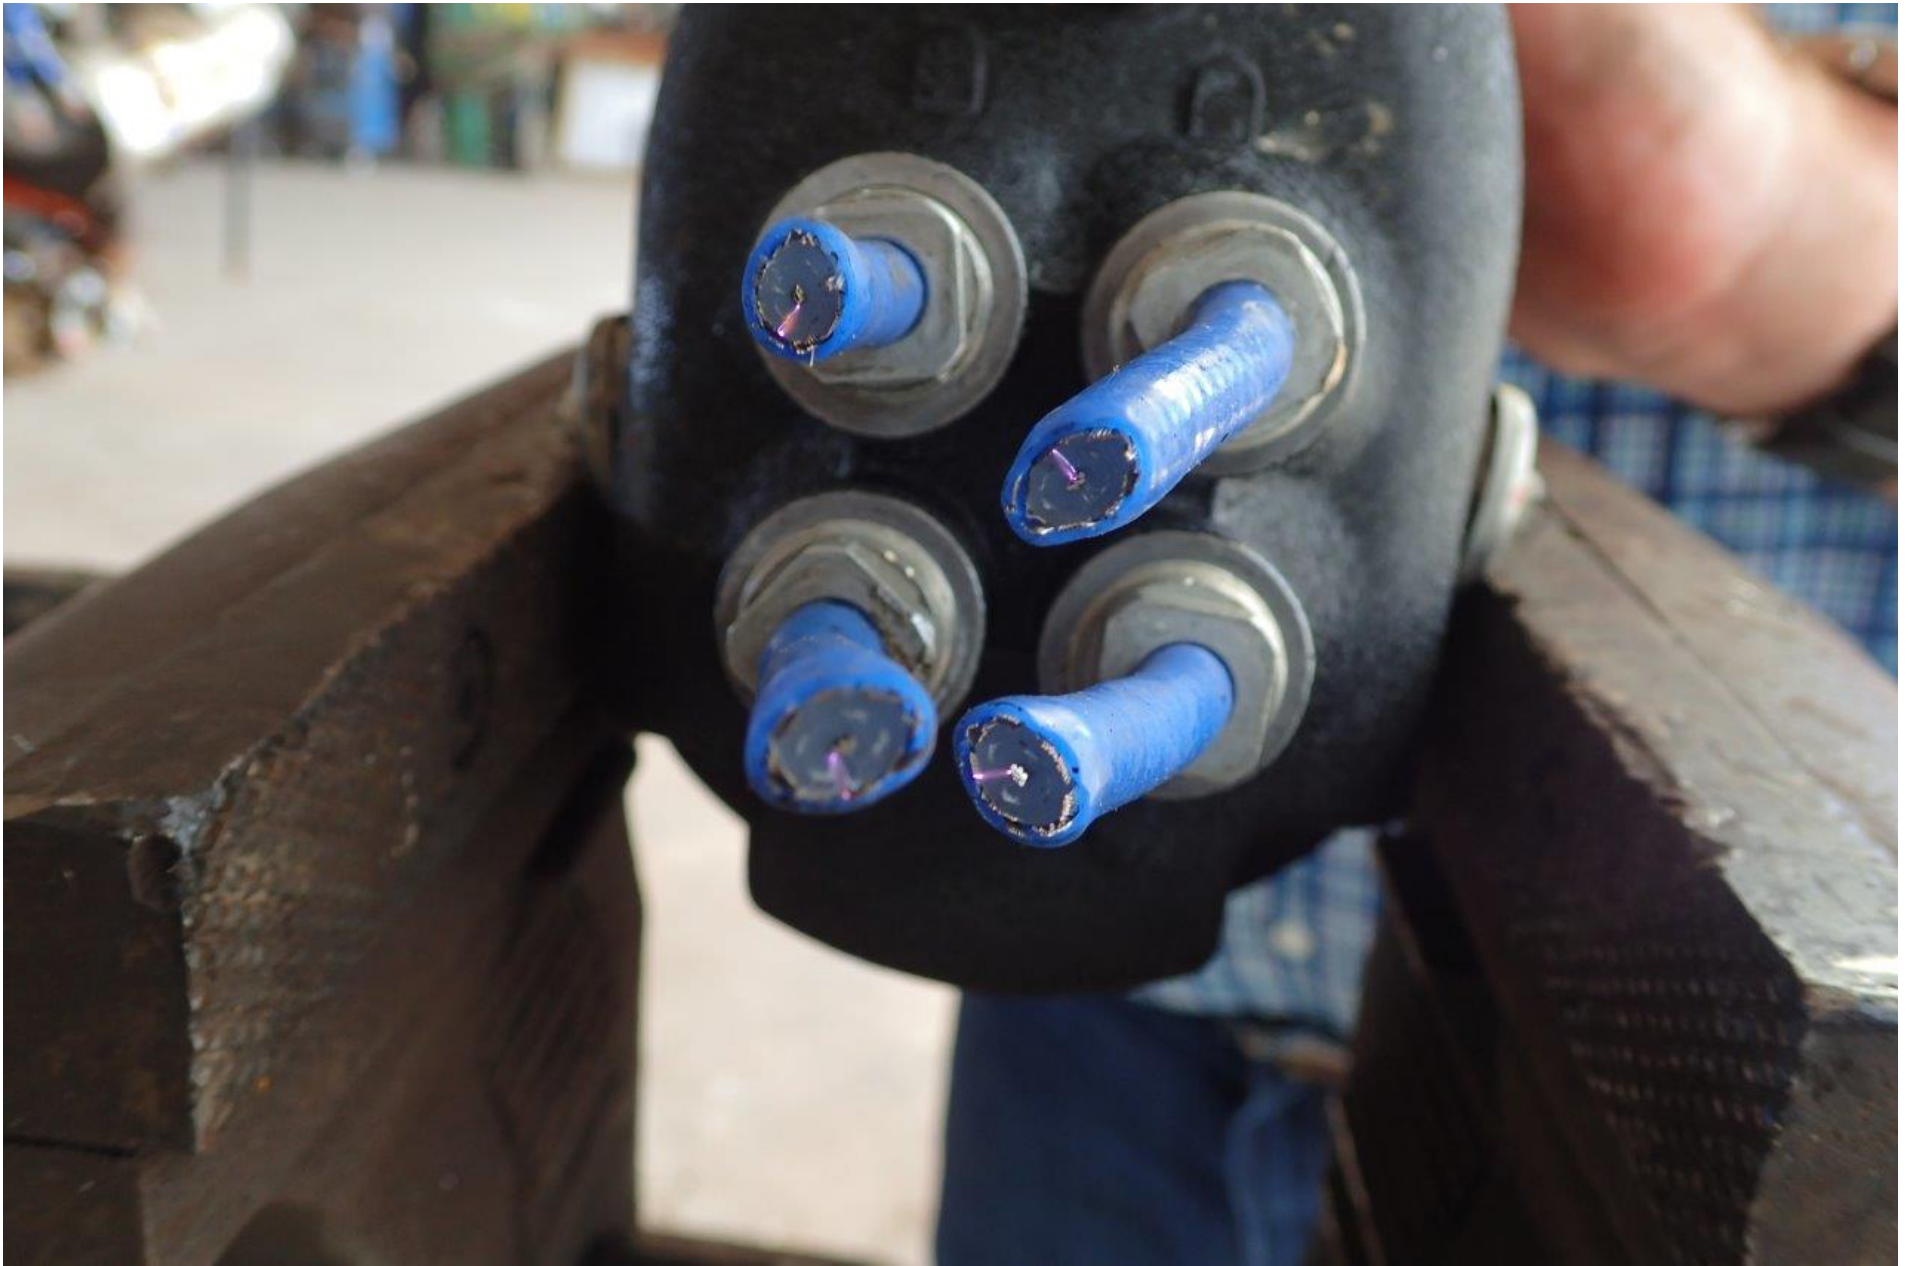
Photo 7 - View of a magneto exhibiting spark at all leads.

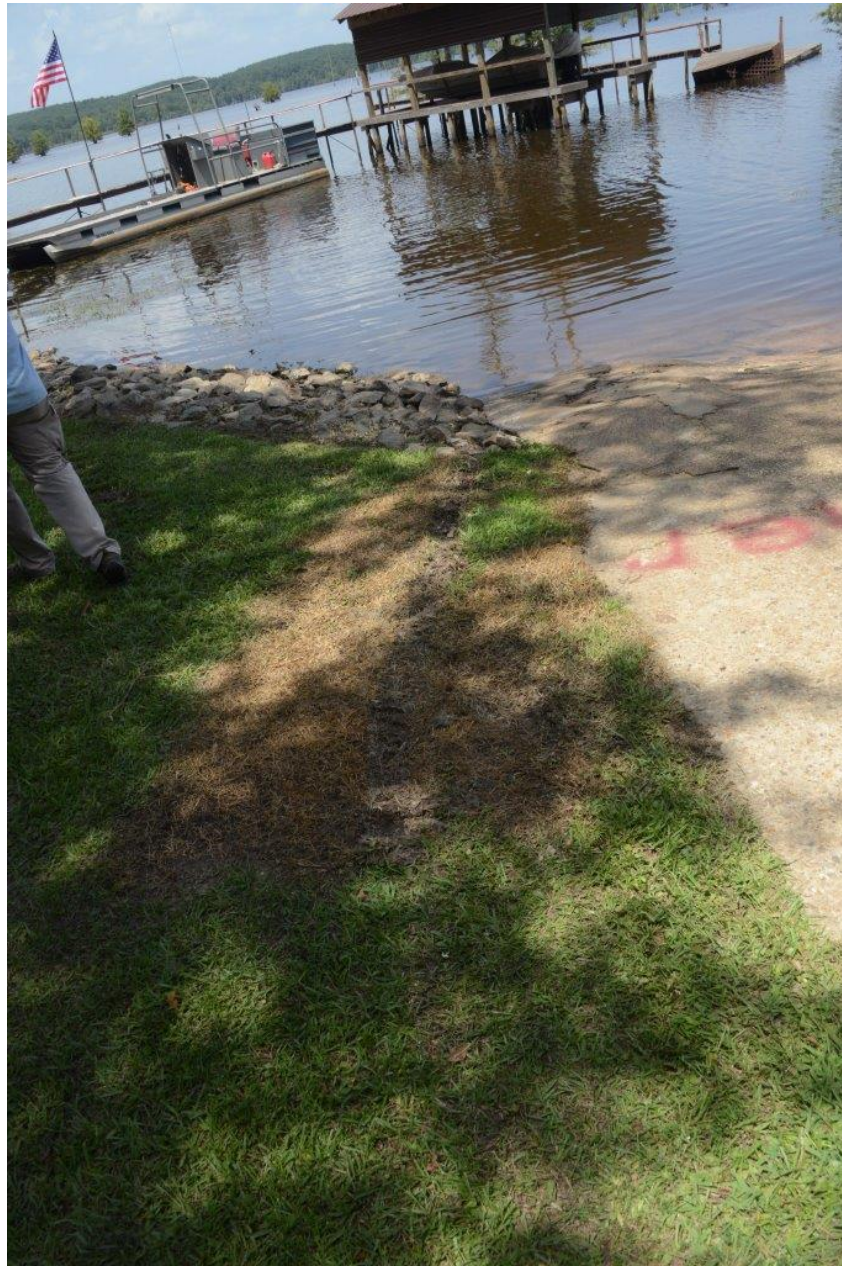
Photo 8 - View of the boat ramp area where blight was present.

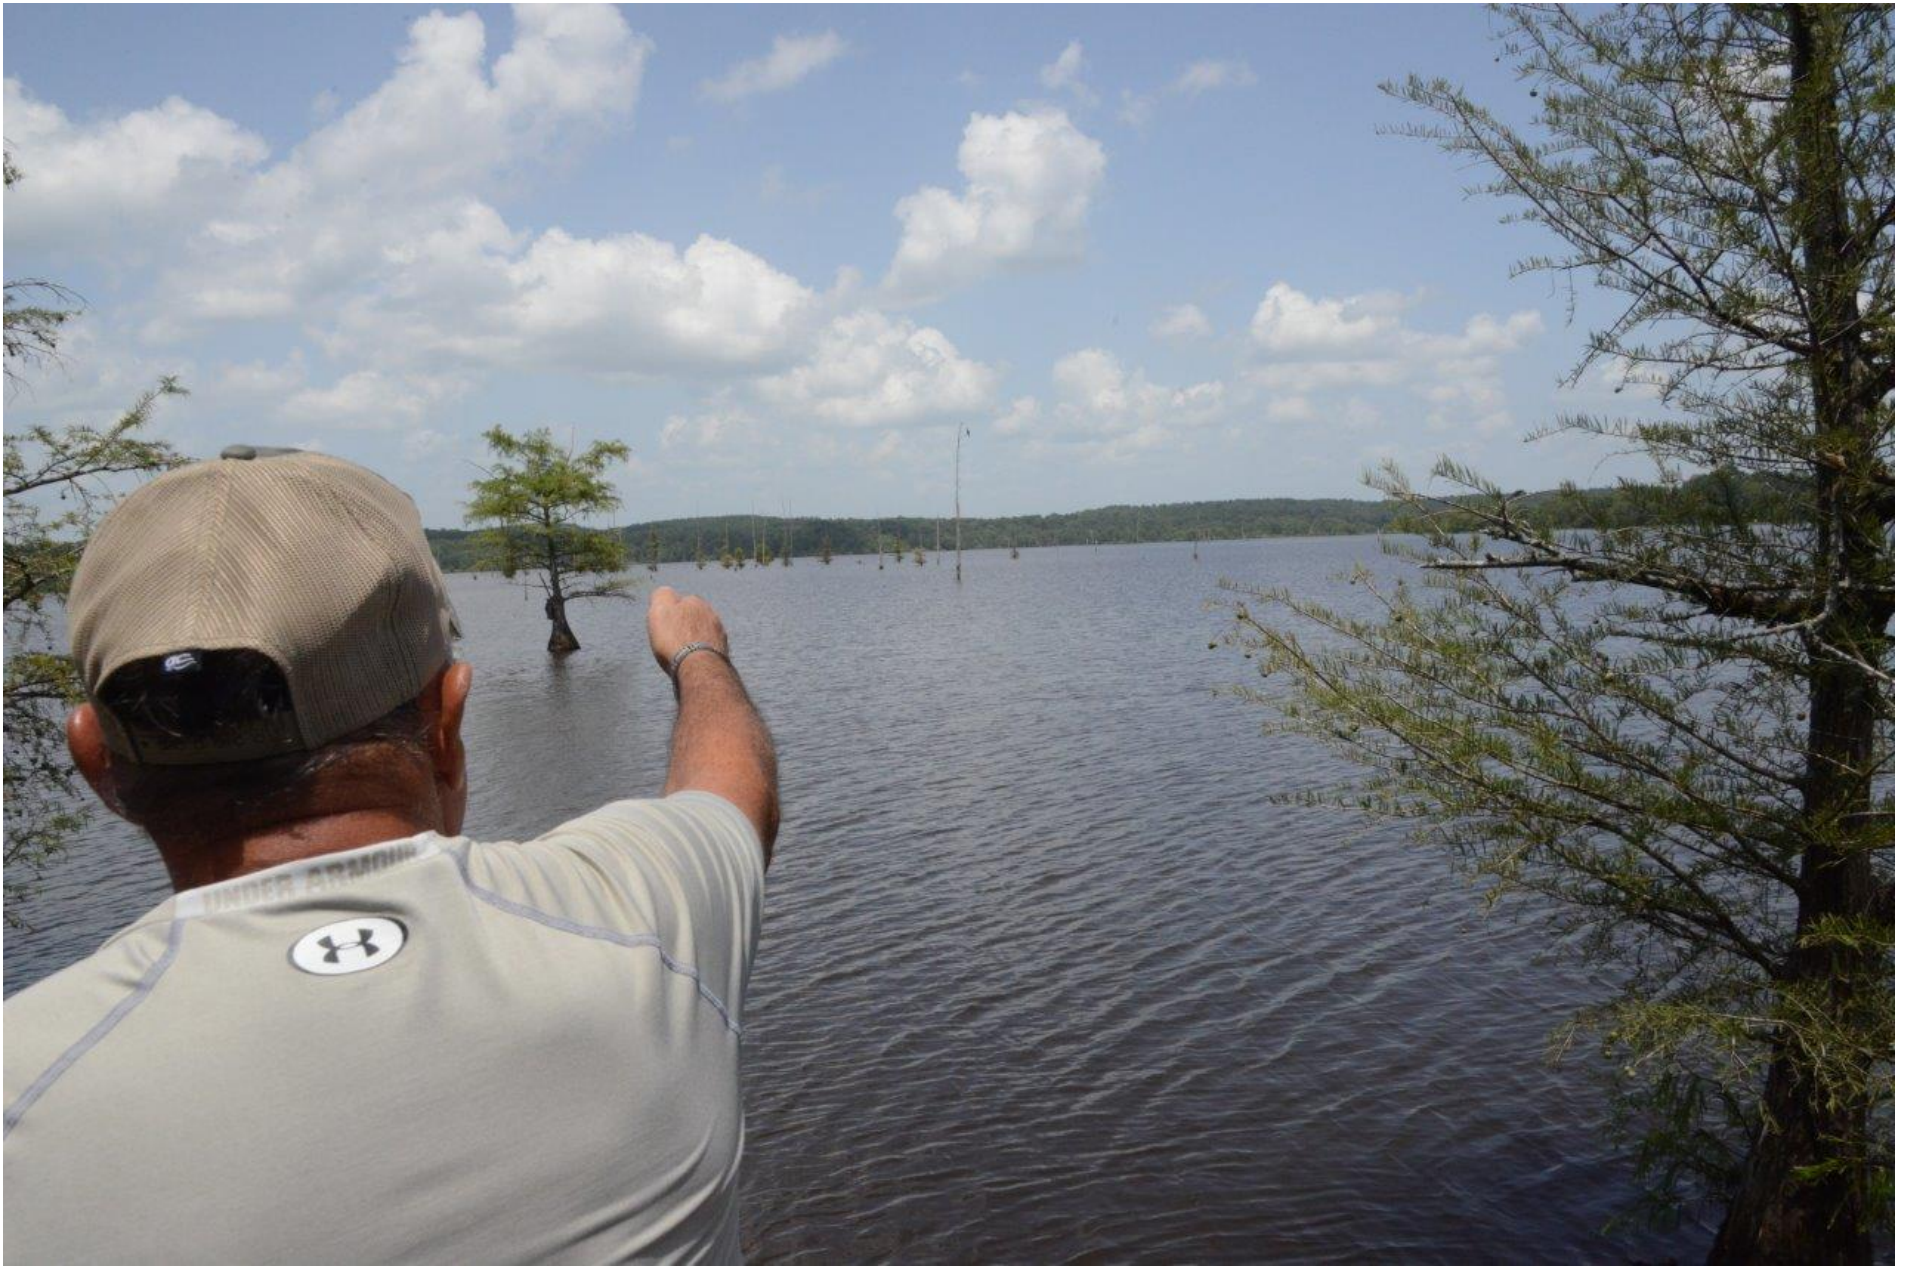
Photo 9 - View of a witness pointing to where the airplane impacted the lake.

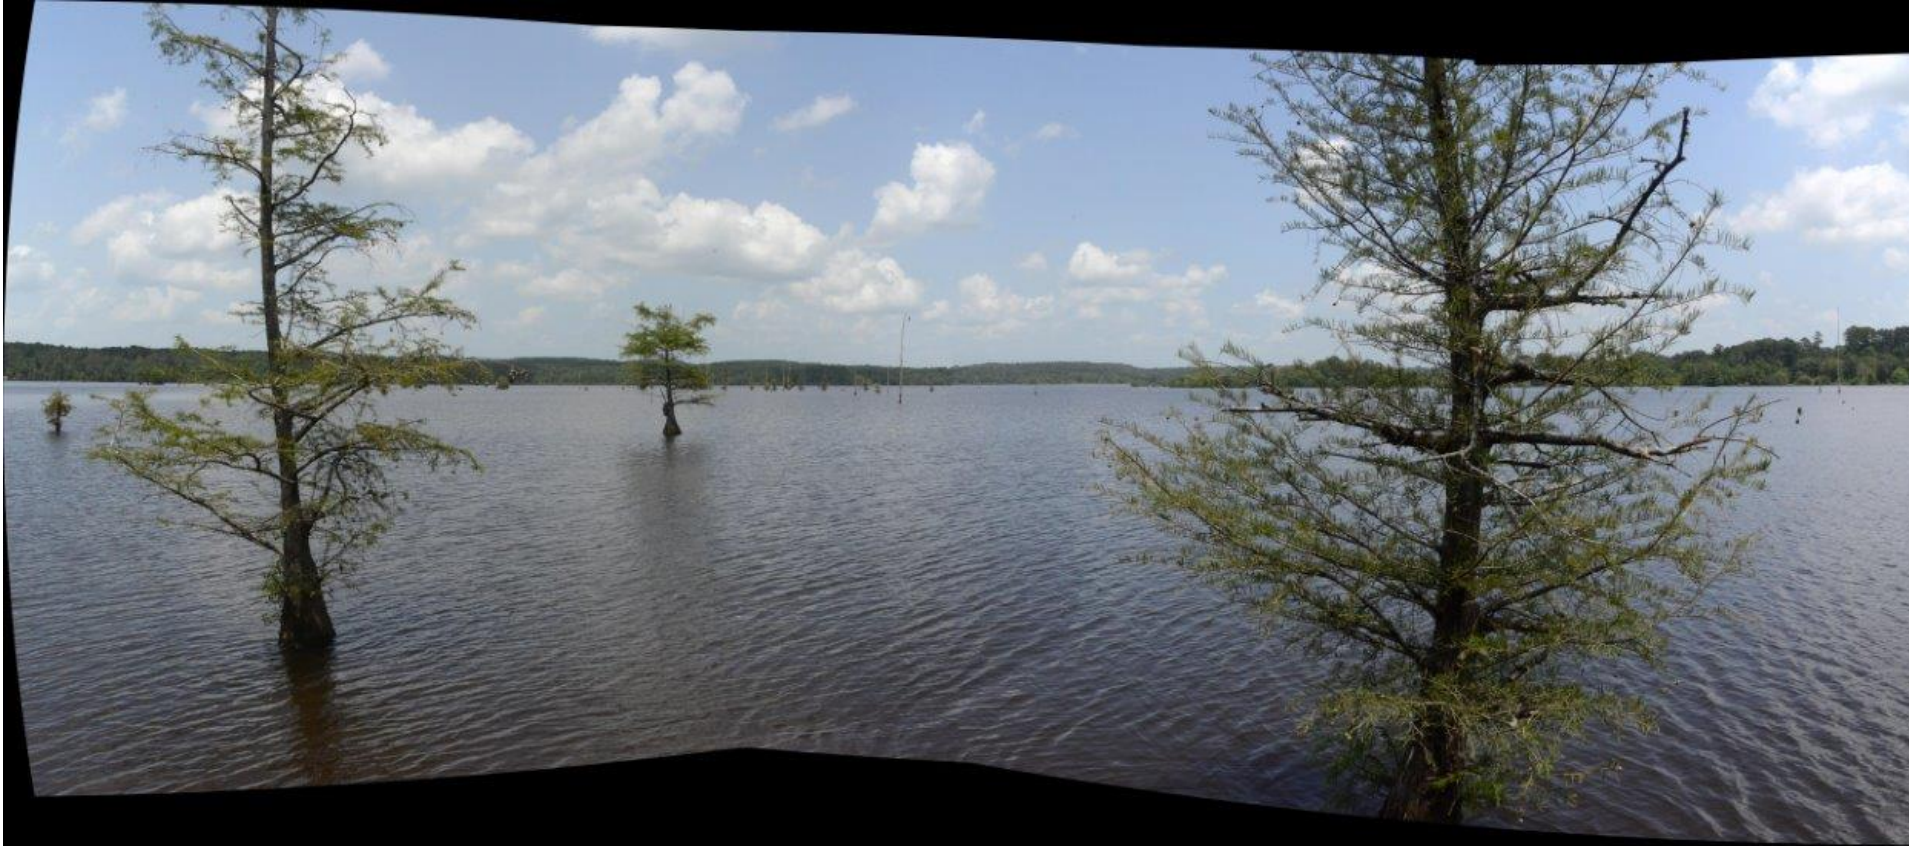
Photo 10 - Wide angle view of the lake where the airplane impacted.
