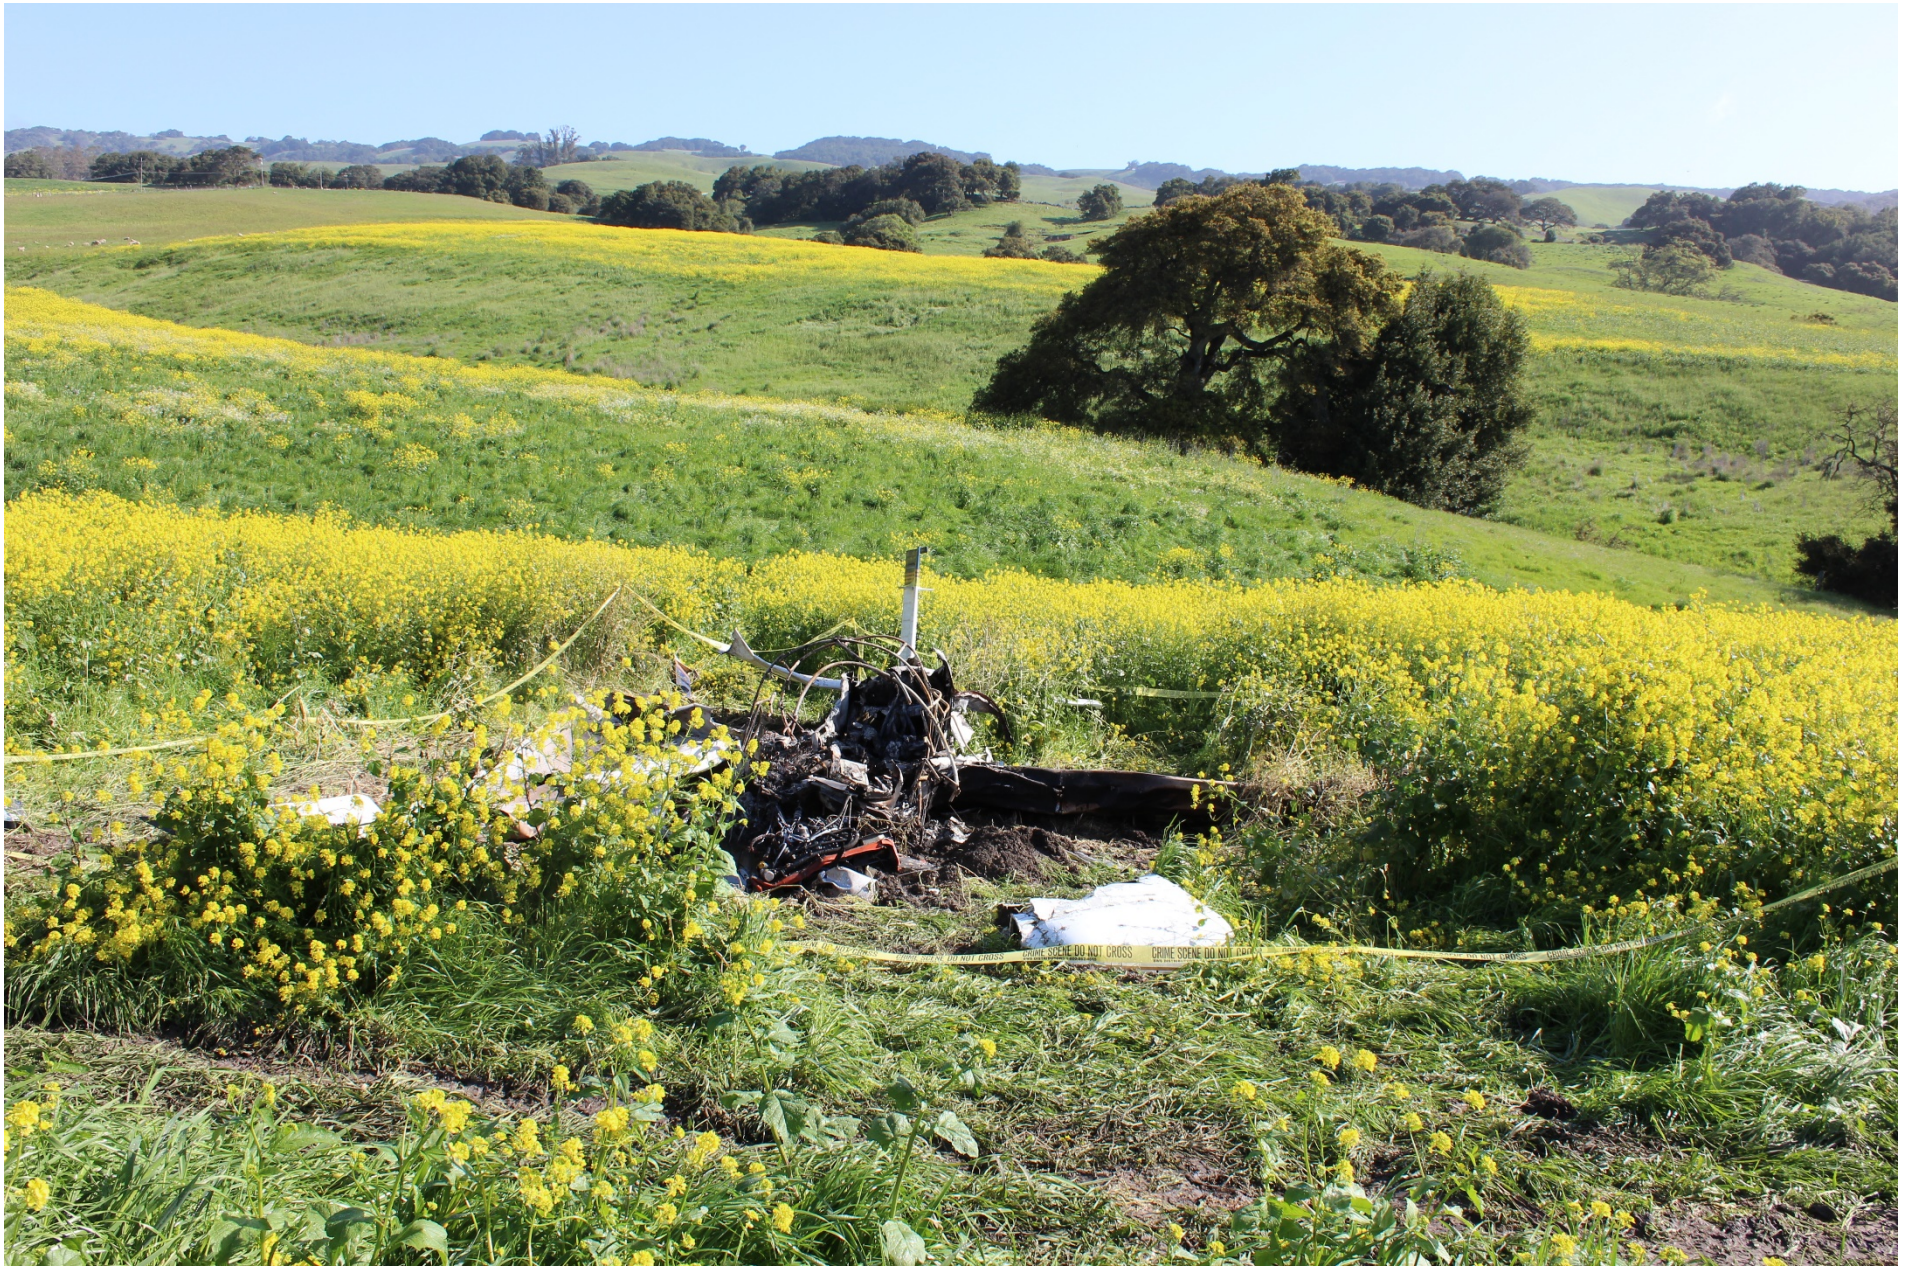
Photo 1 – Accident airplane at accident site.

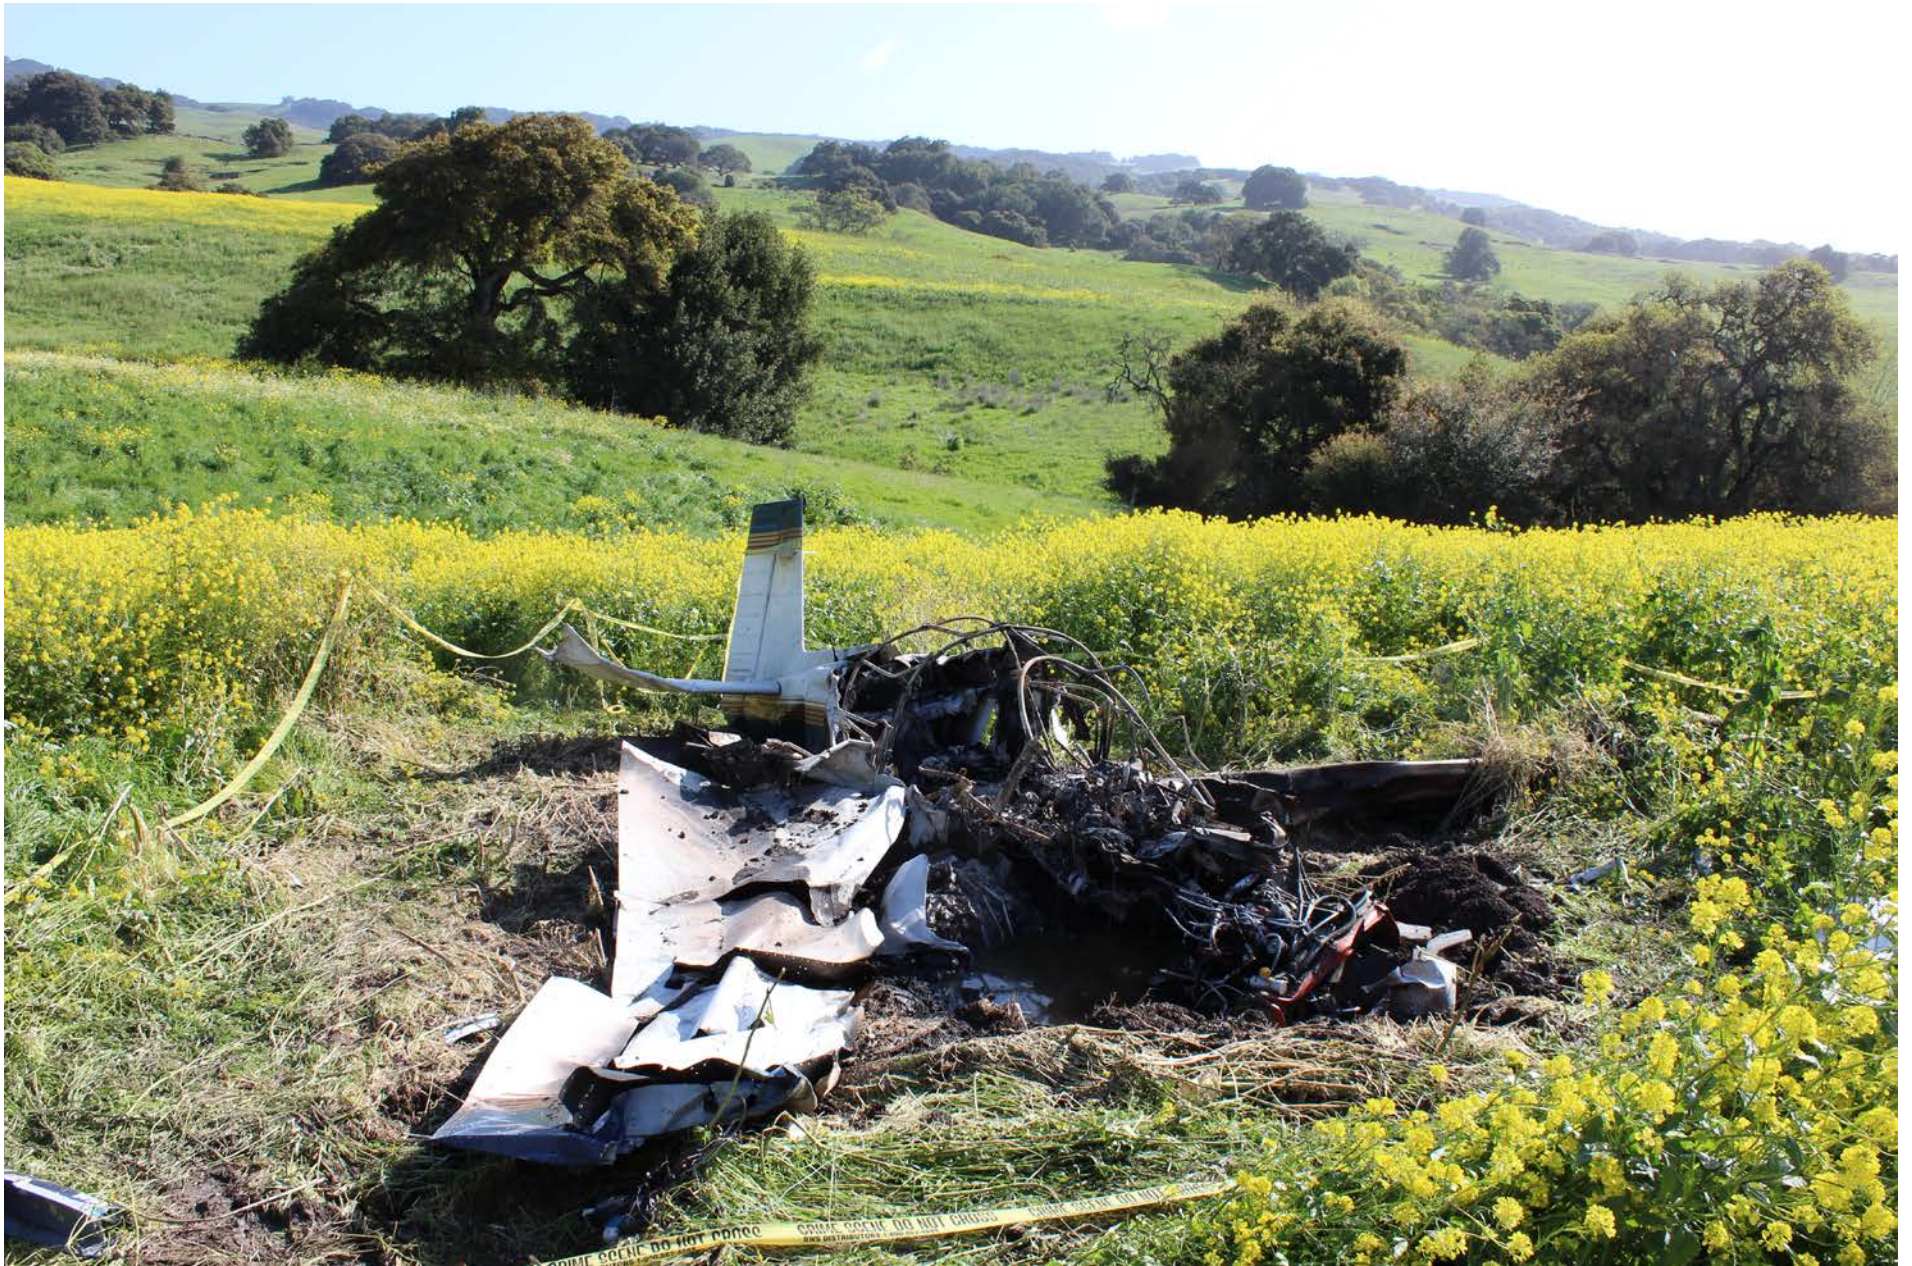
Photo 2 – Accident airplane at accident site.

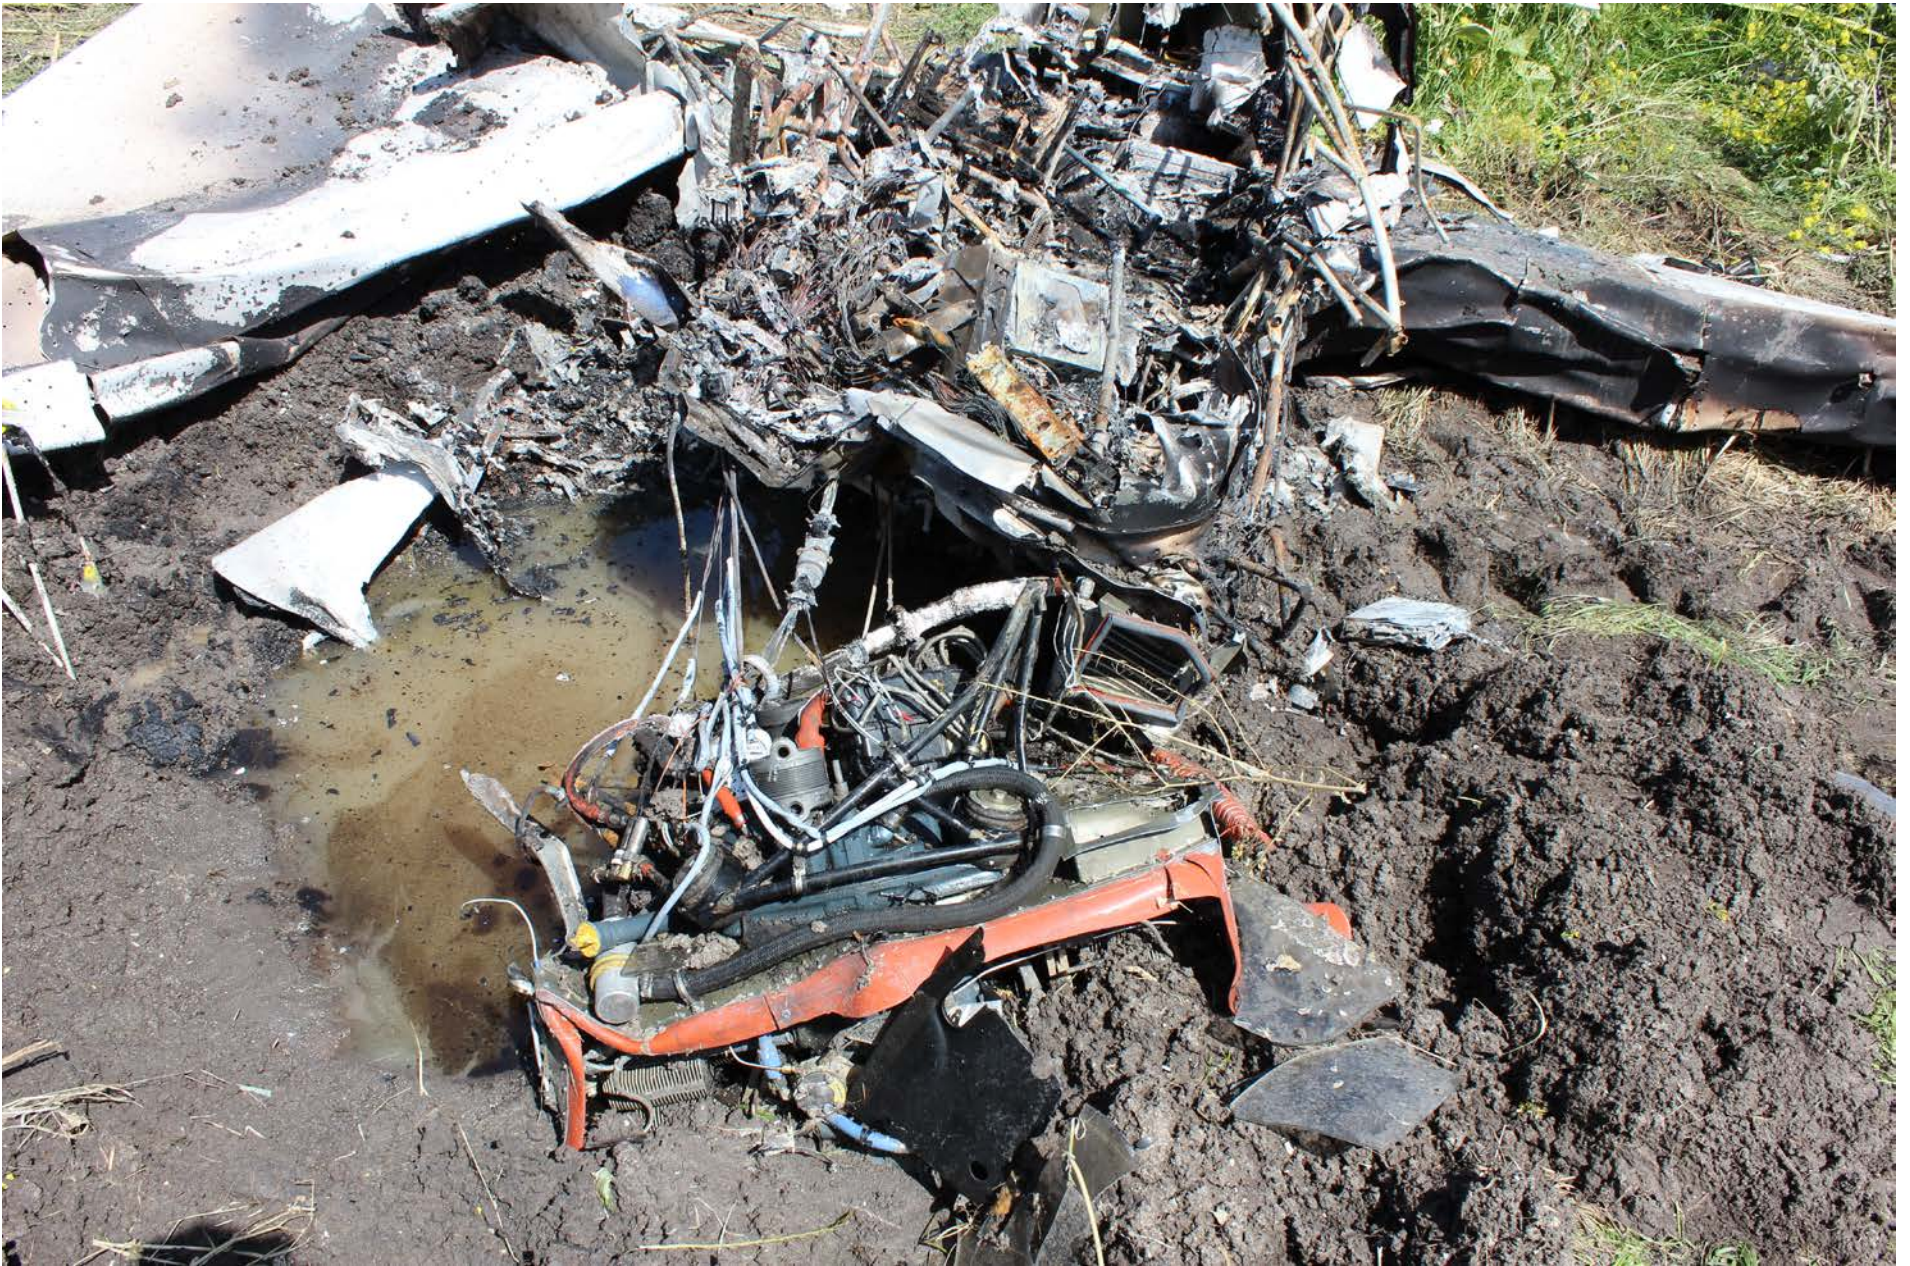
Photo 3 – Airplane's engine buried in mud at accident site.

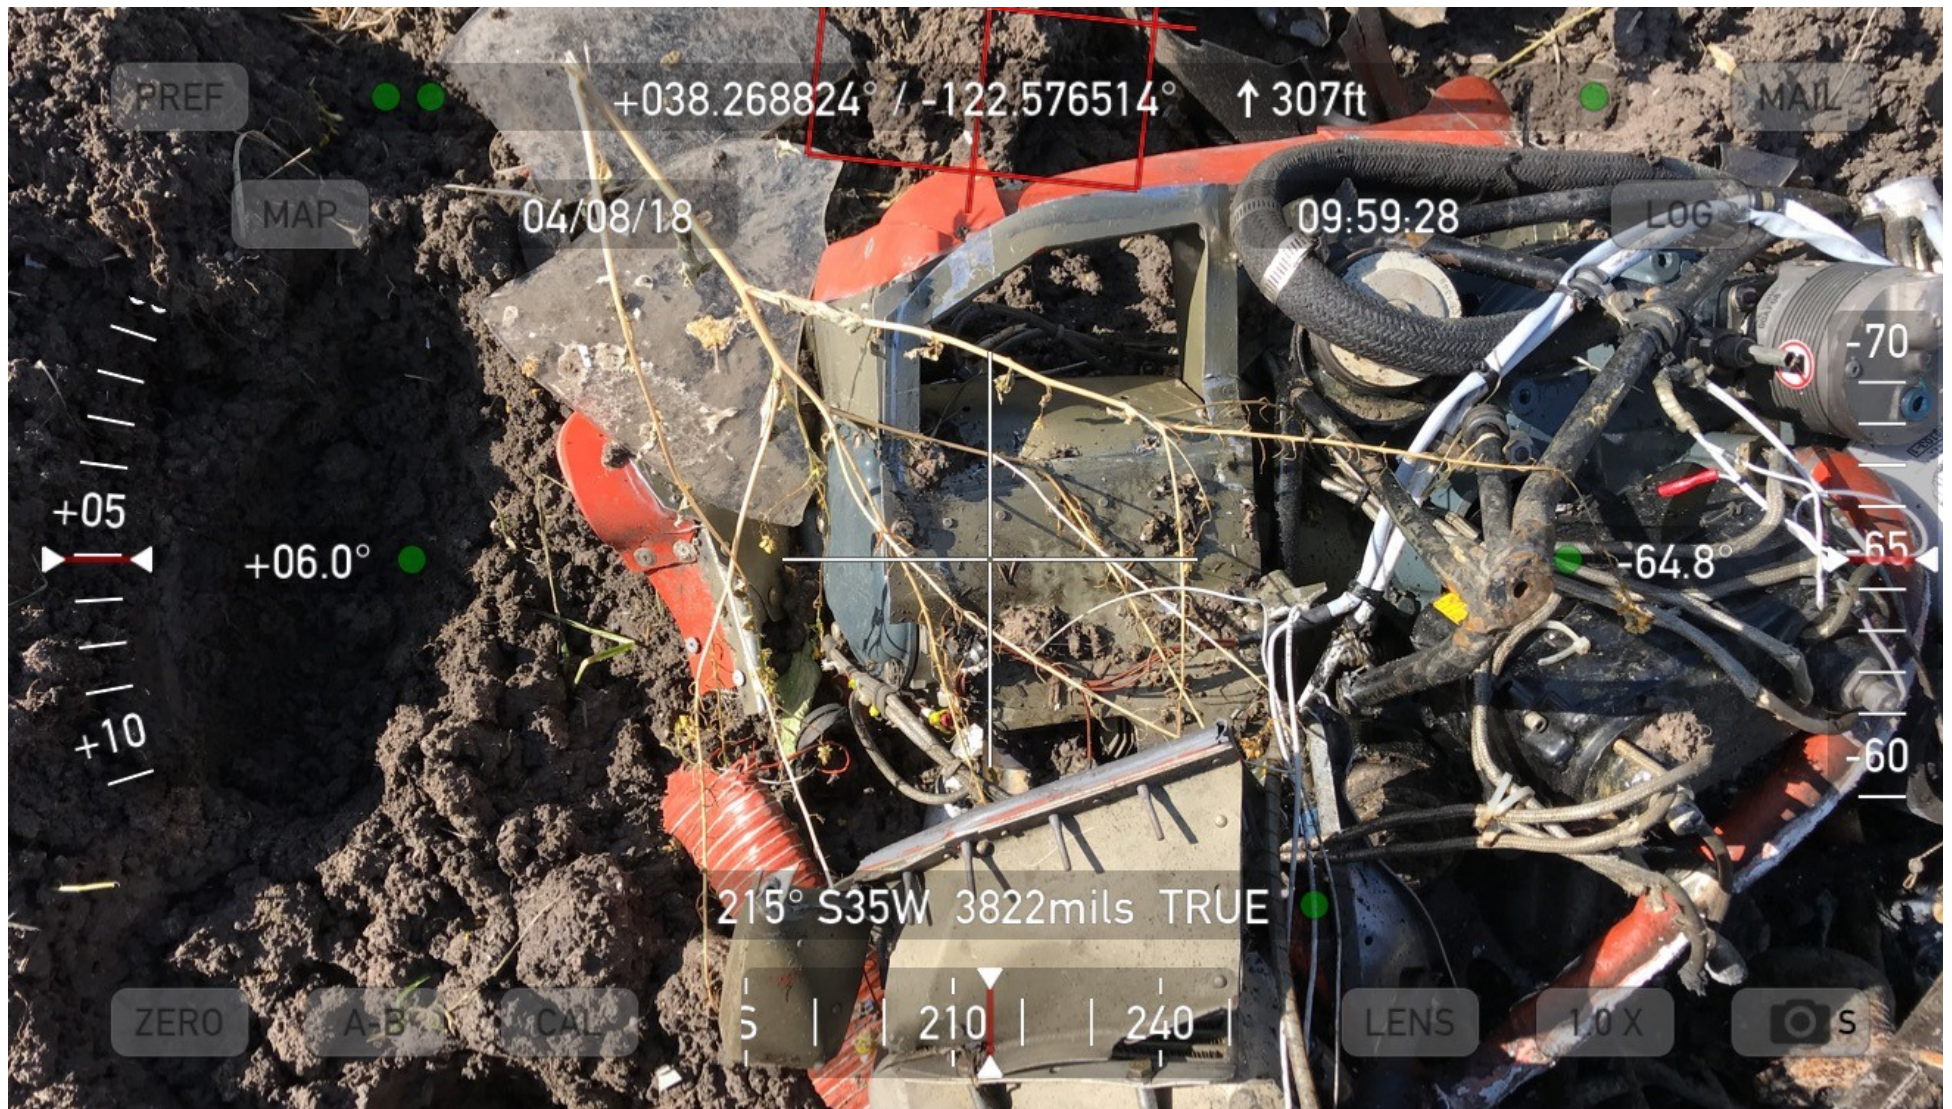
Photo 4 – Theodolite picture from rear of engine at accident site.

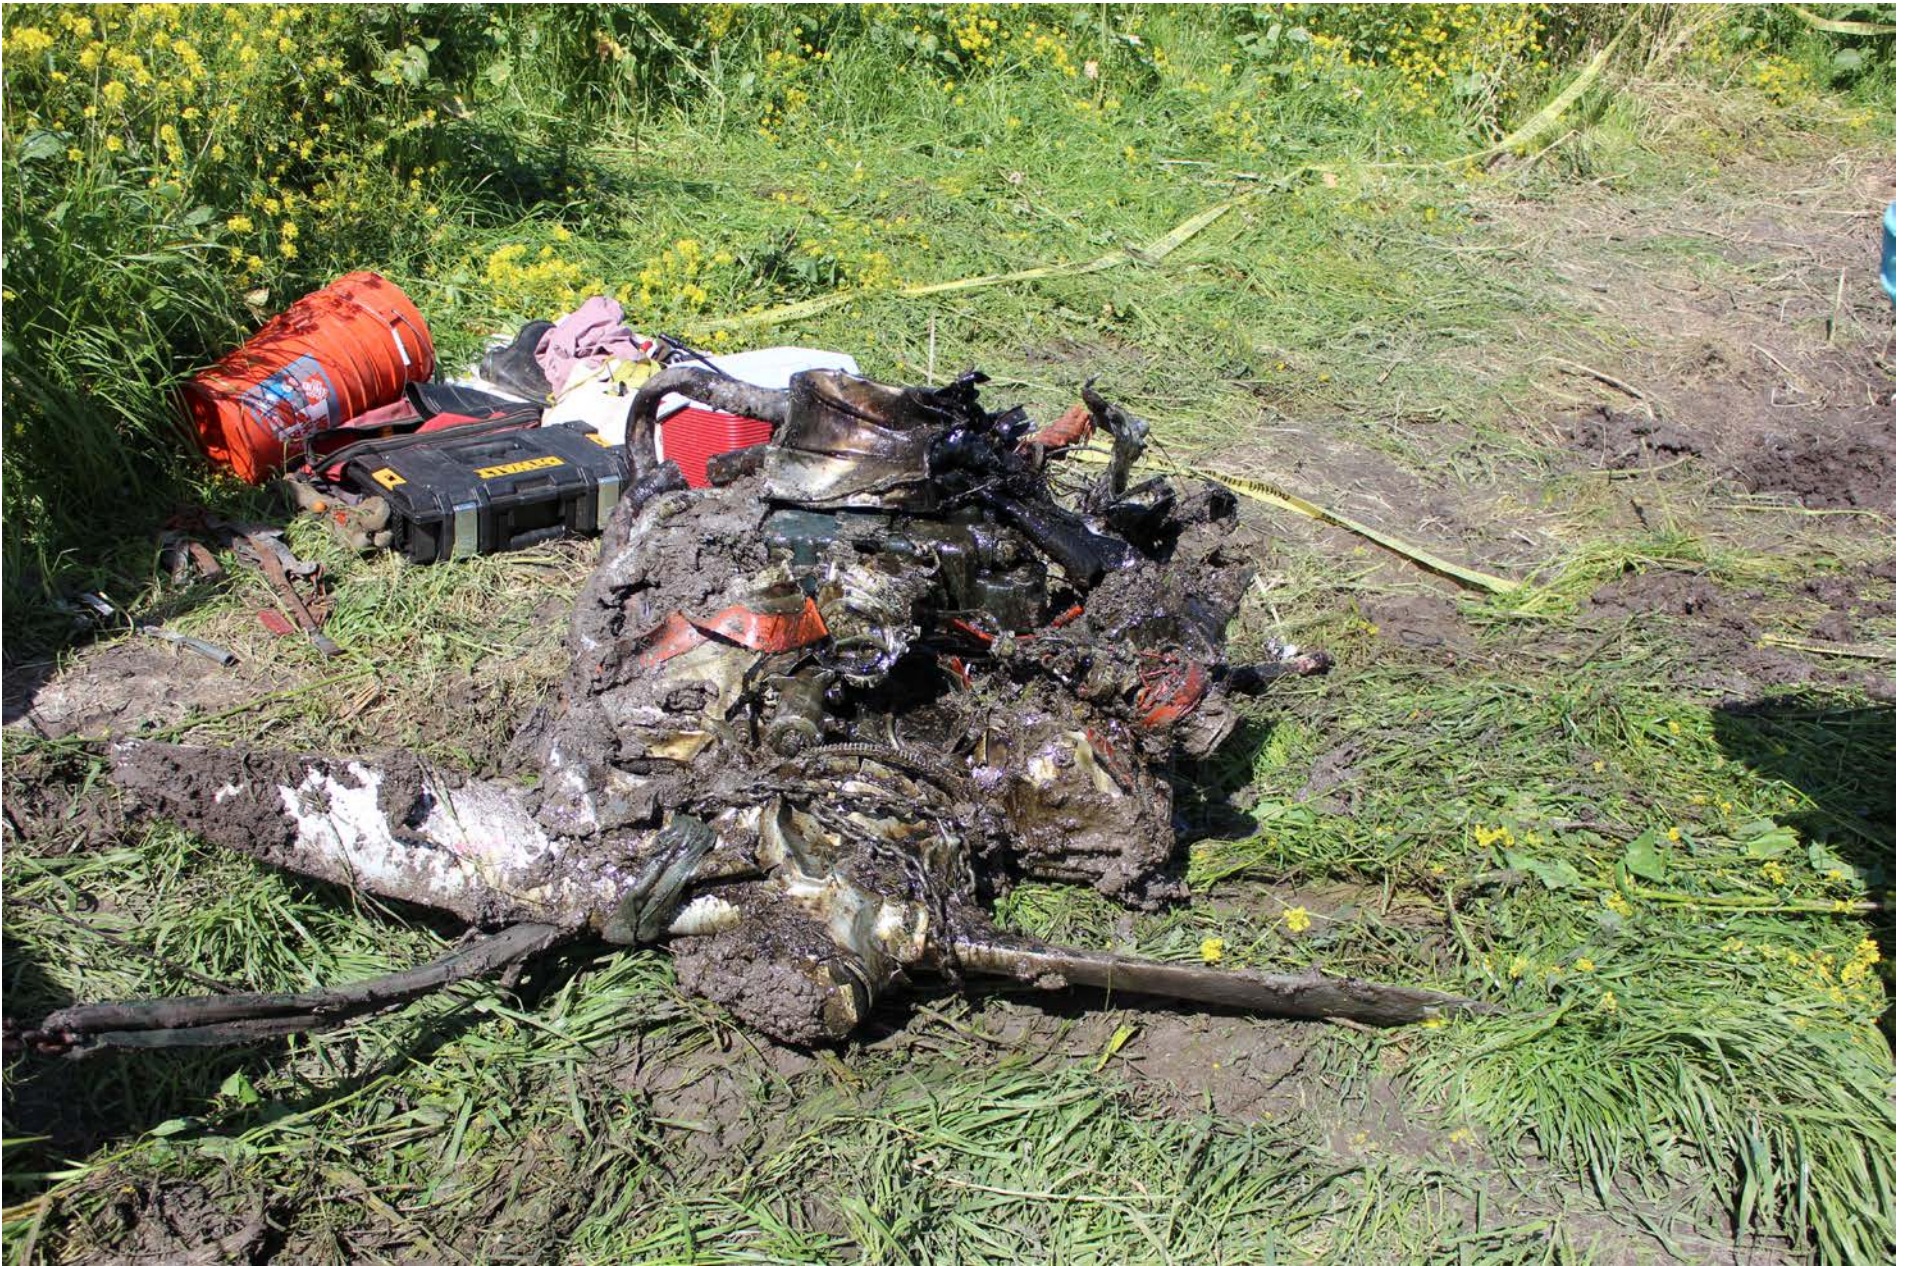
Photo 5 – Accident airplane's engine after removal from mud at accident site.

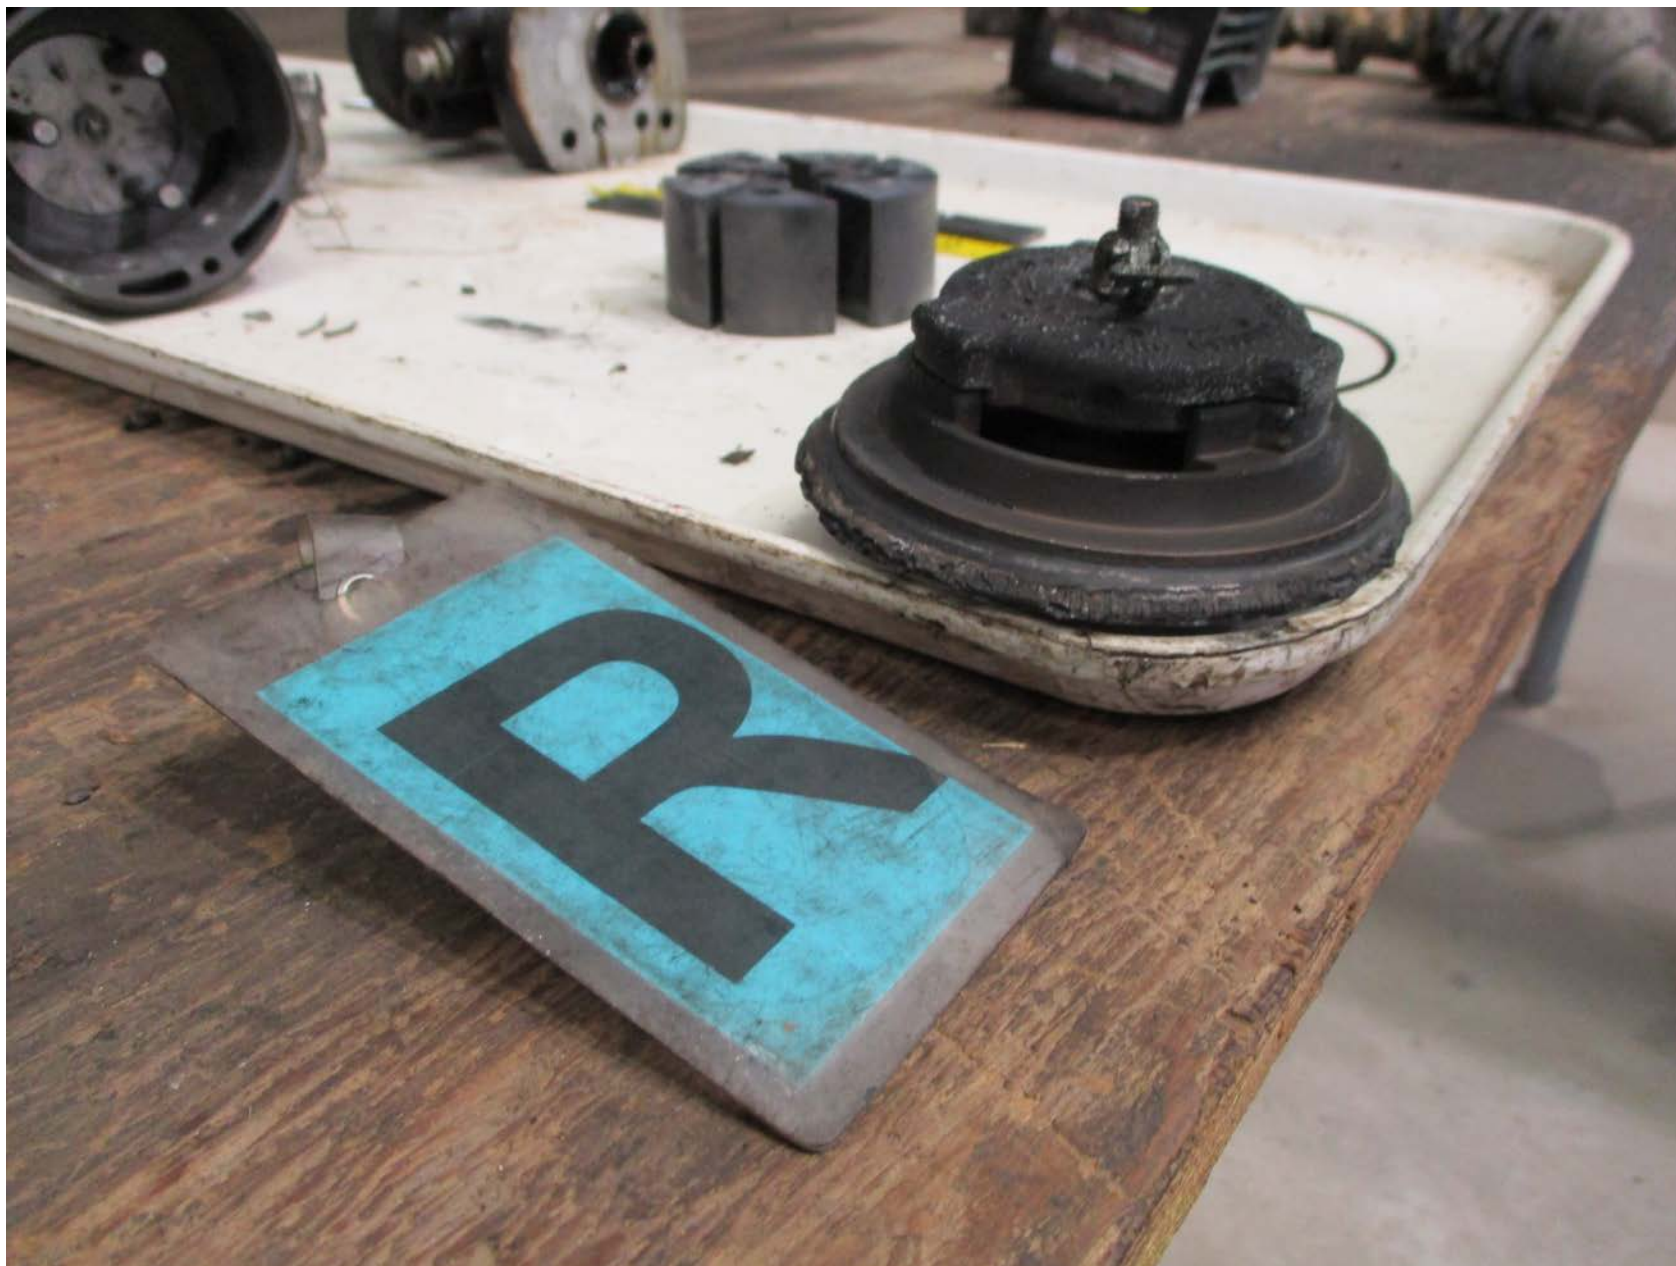
Photo 6 – Thermal damage to right fuel cap seal.

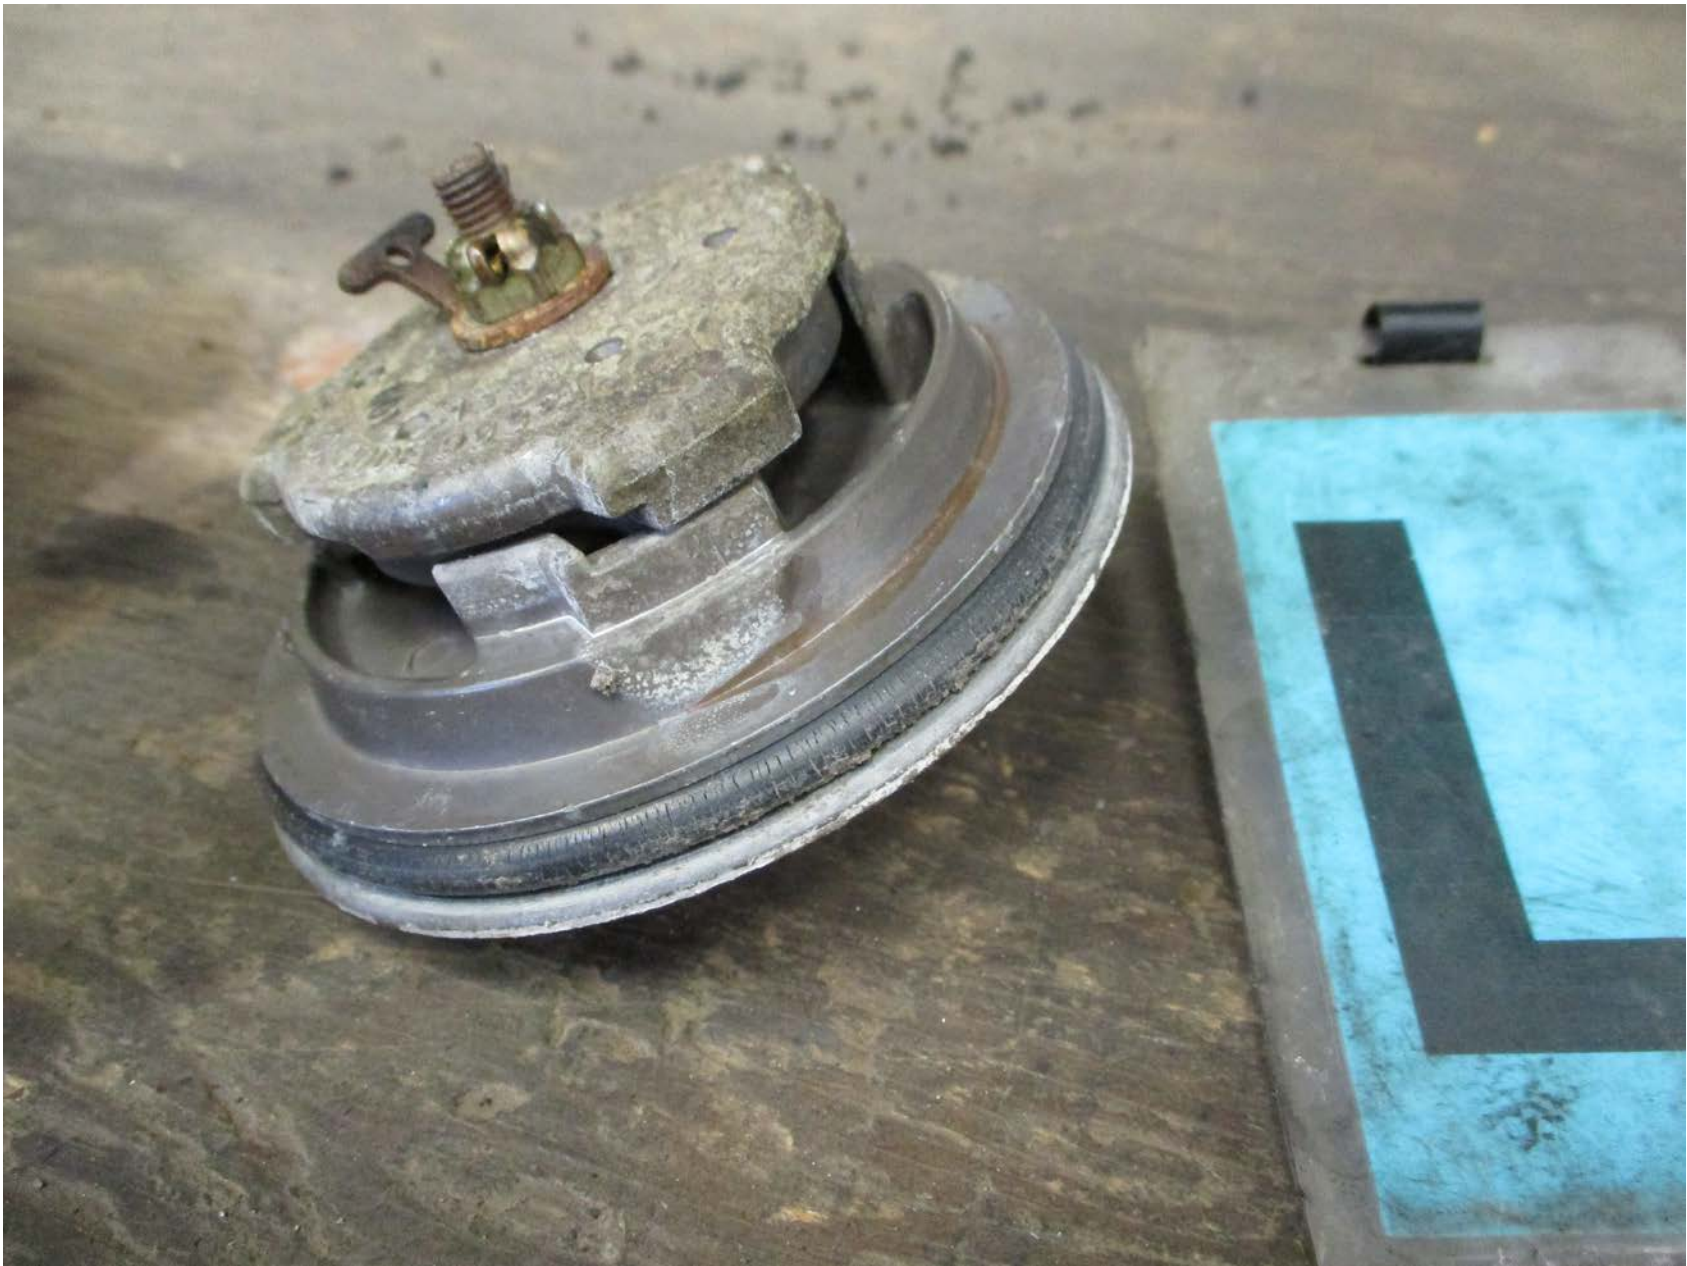
Photo 7 – Cracks around circumference of left fuel cap seal.
