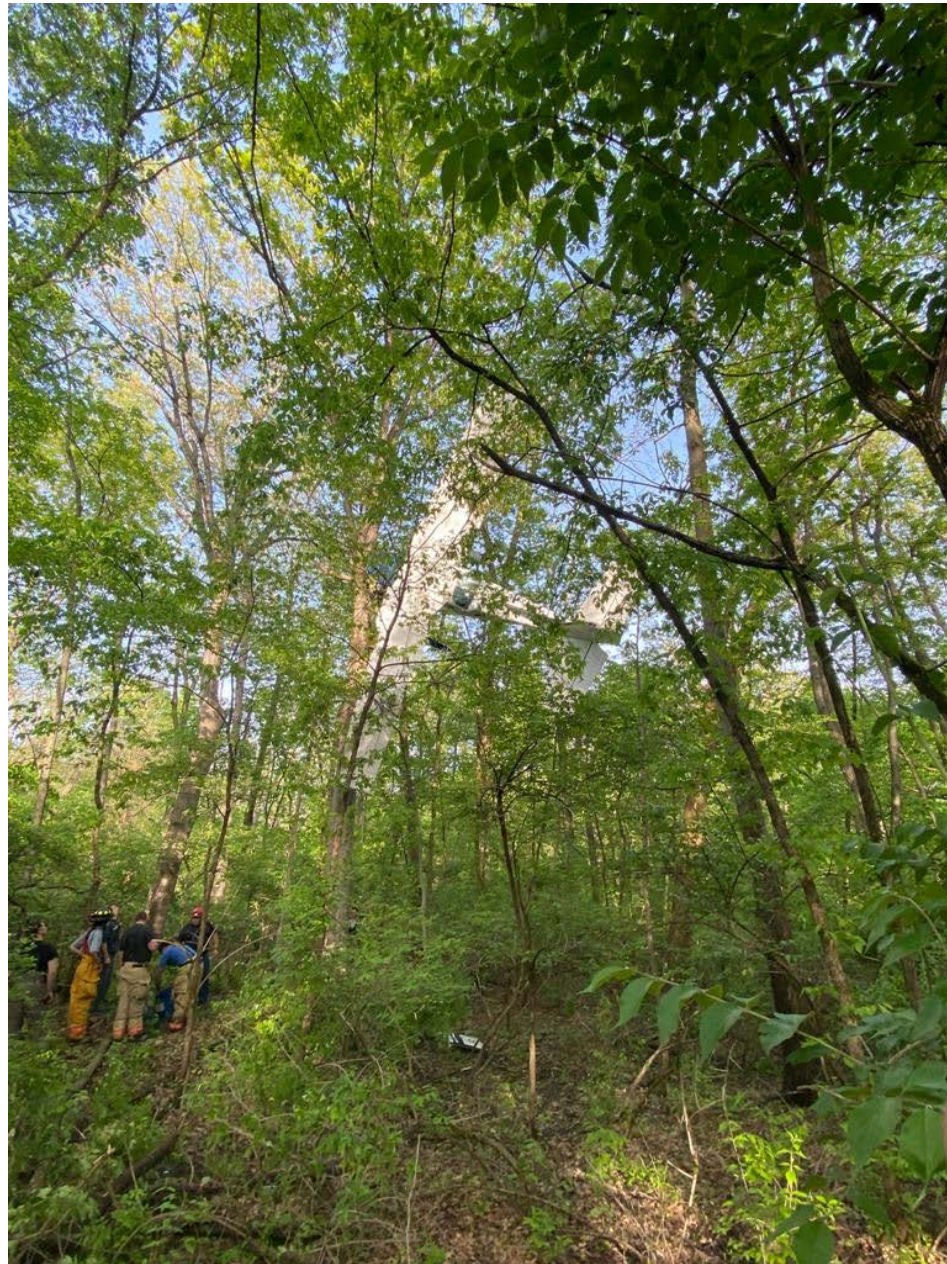
Photo 1 – Image published in a local news source of the airplane resting in tree branches in the upper background and rescue workers in the lower foreground.

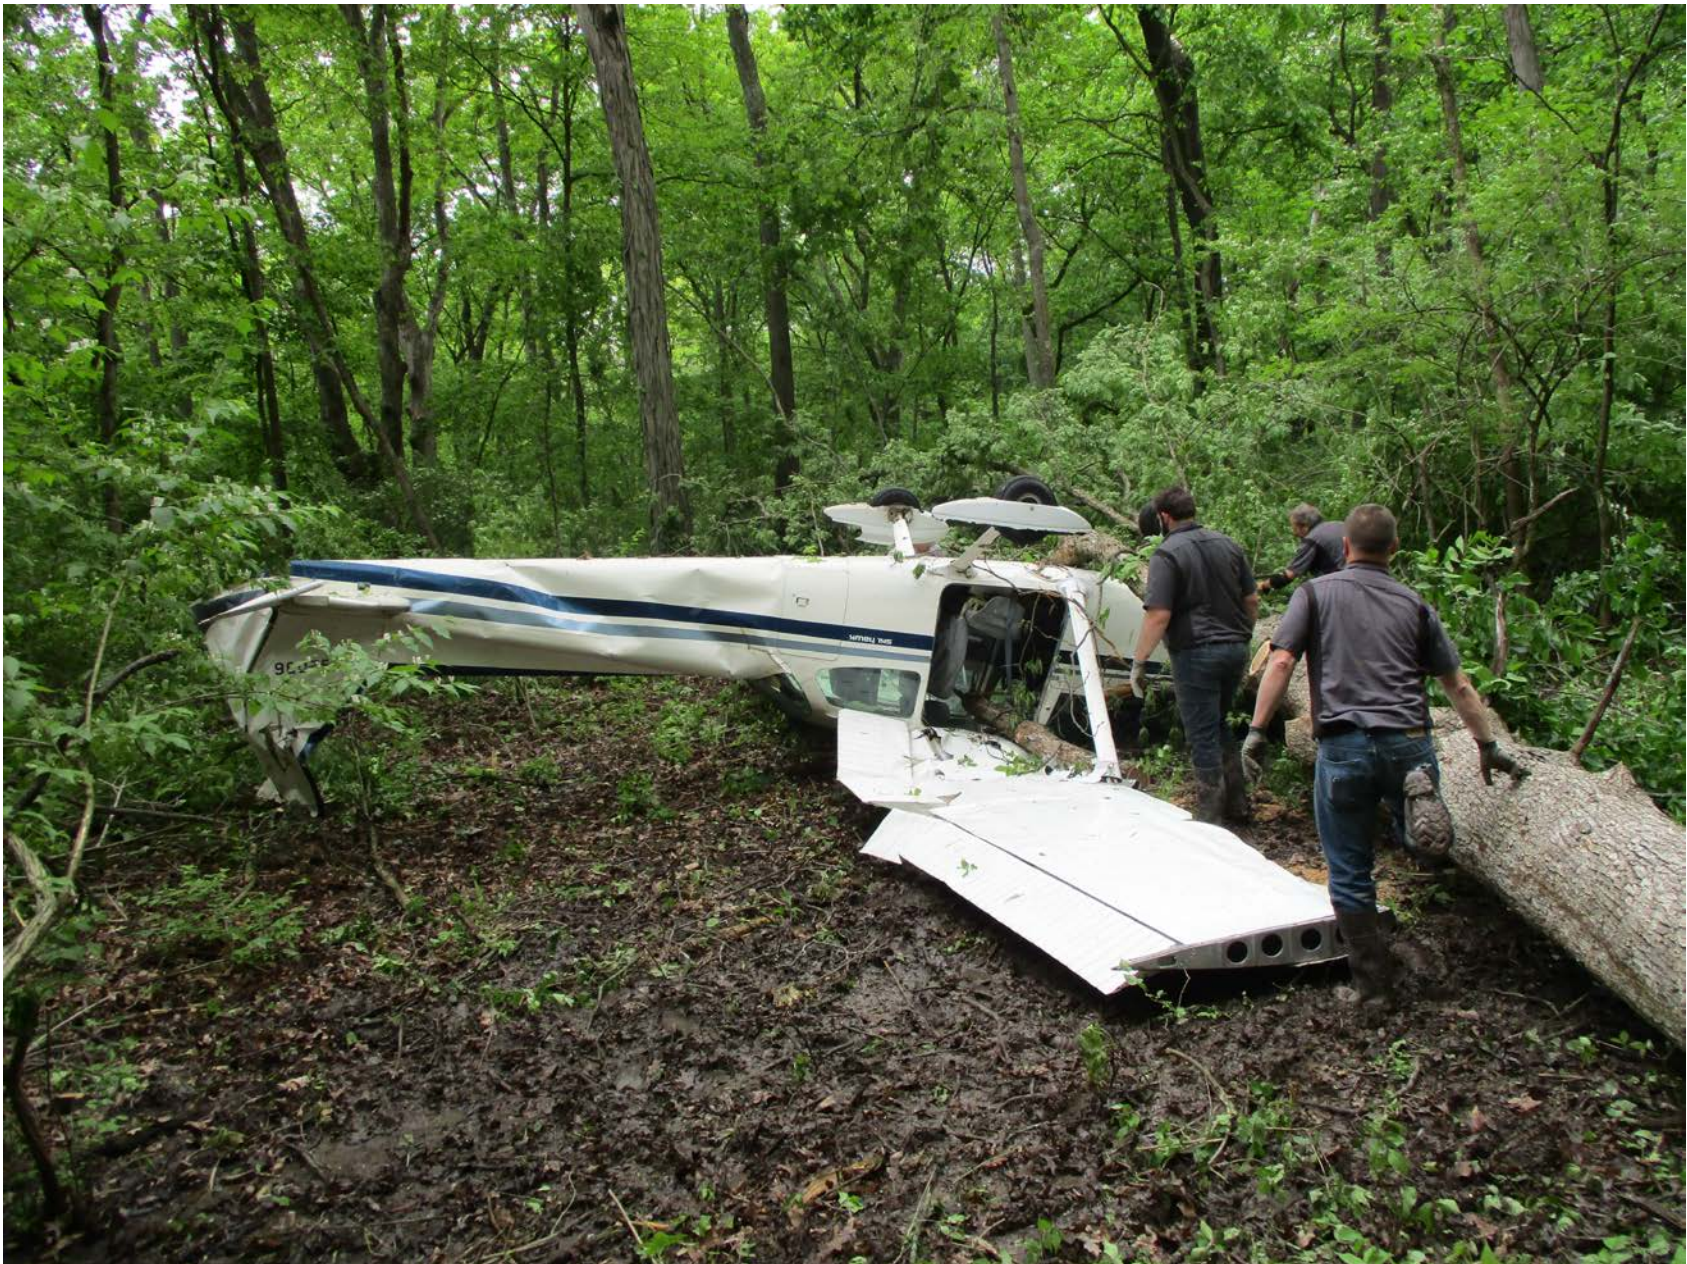
Photo 2 - FAA supplied view of the left side of the inverted airplane during recovery.

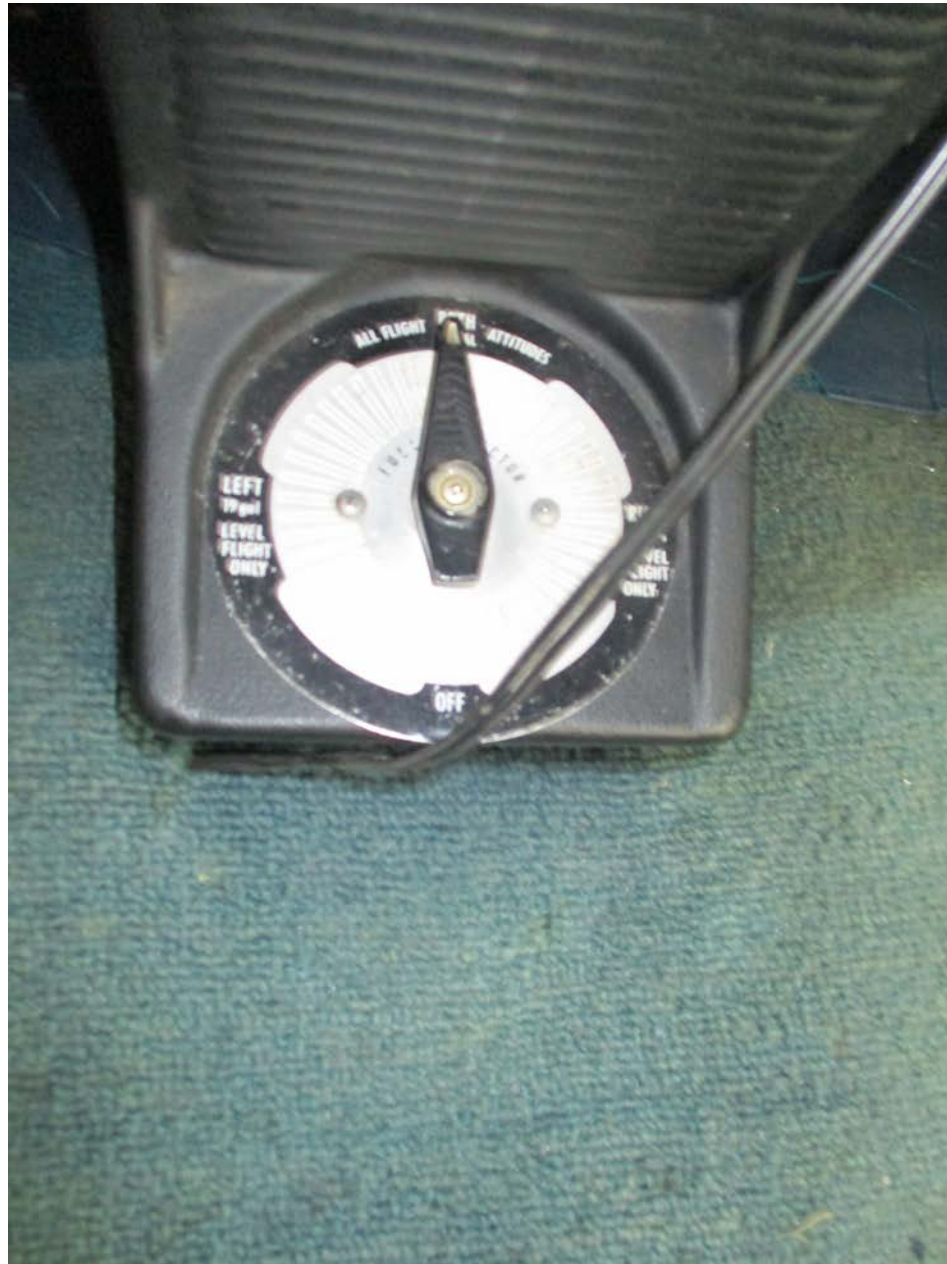
Photo 3 - FAA supplied view of the fuel tank selector. The selector is positioned to select both left and right tanks.

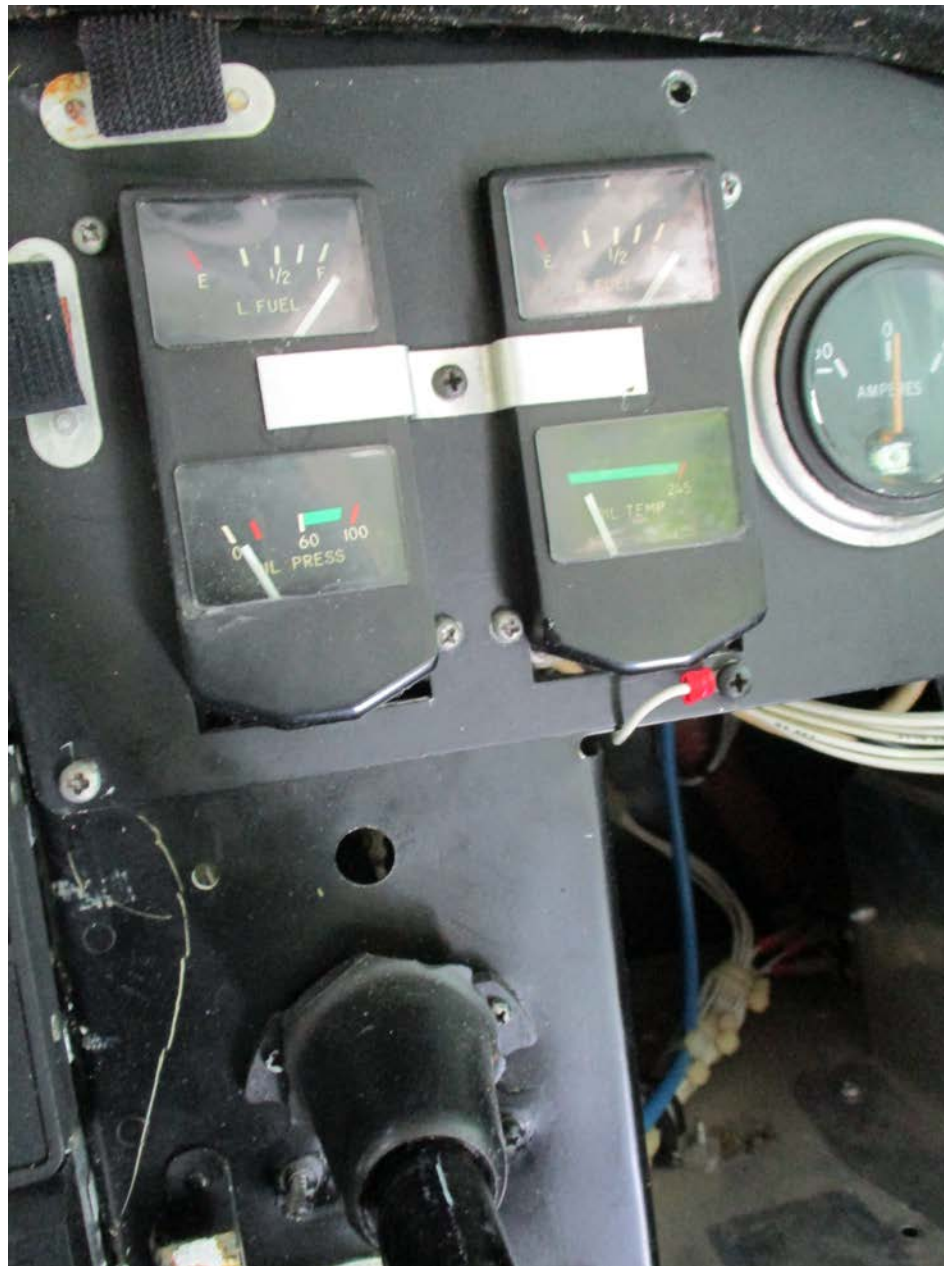
Photo 4 - FAA supplied view of the fuel tank gauges at the accident site. Both left and right fuel gauges have a full indication.

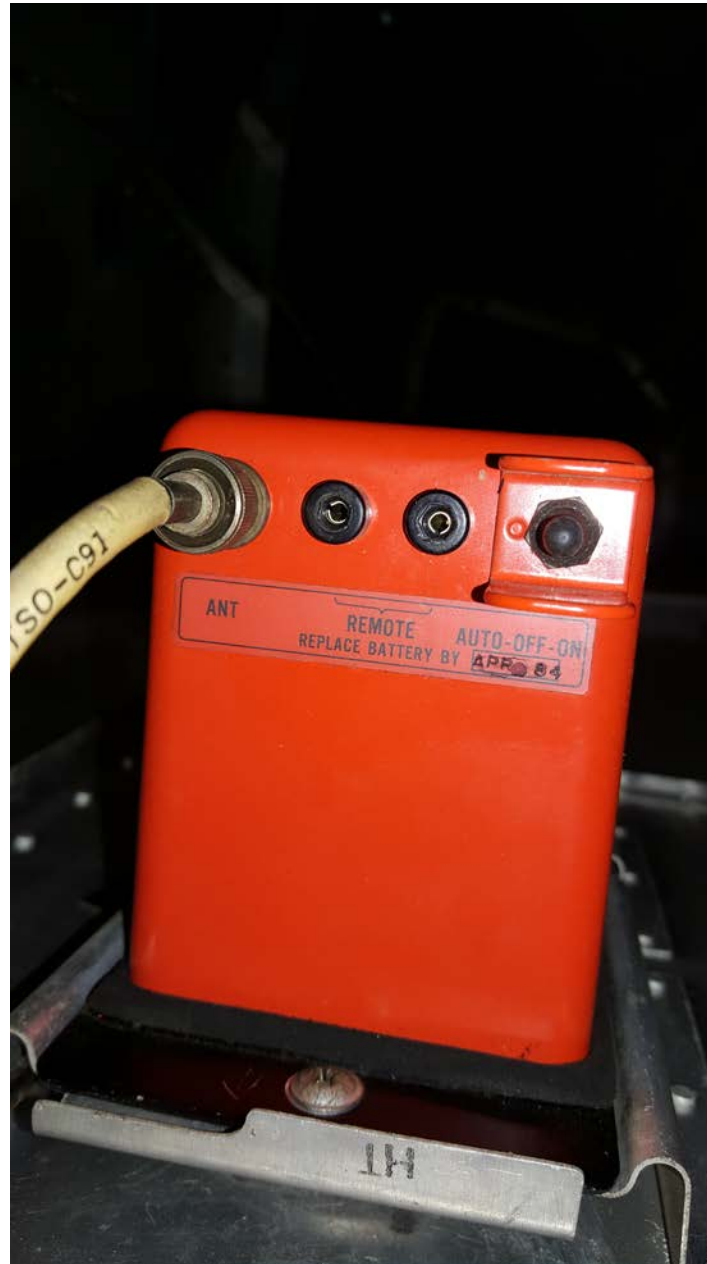
Photo 5 - FAA supplied view of the emergency locator transmitter at the accident site. The transmitter's switch is in the off position.
