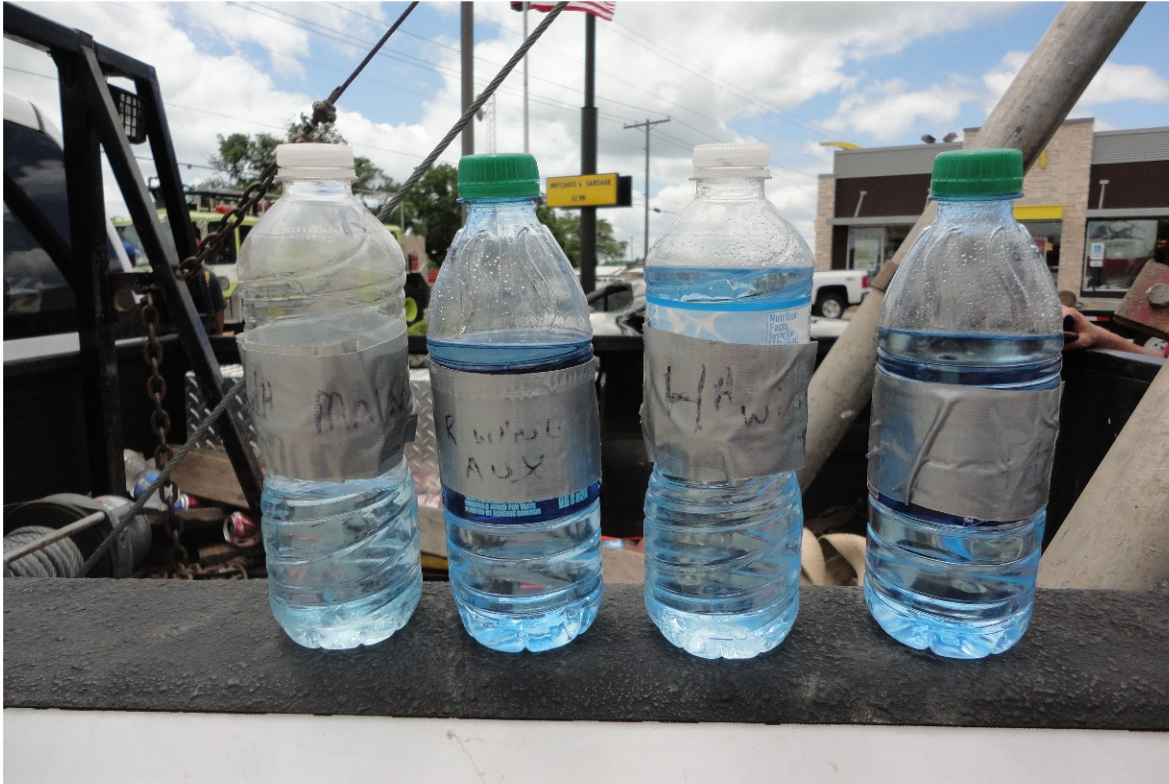
Fuel samples taken at the scene. From the left: right main tank, right aux, left aux, left main tank.

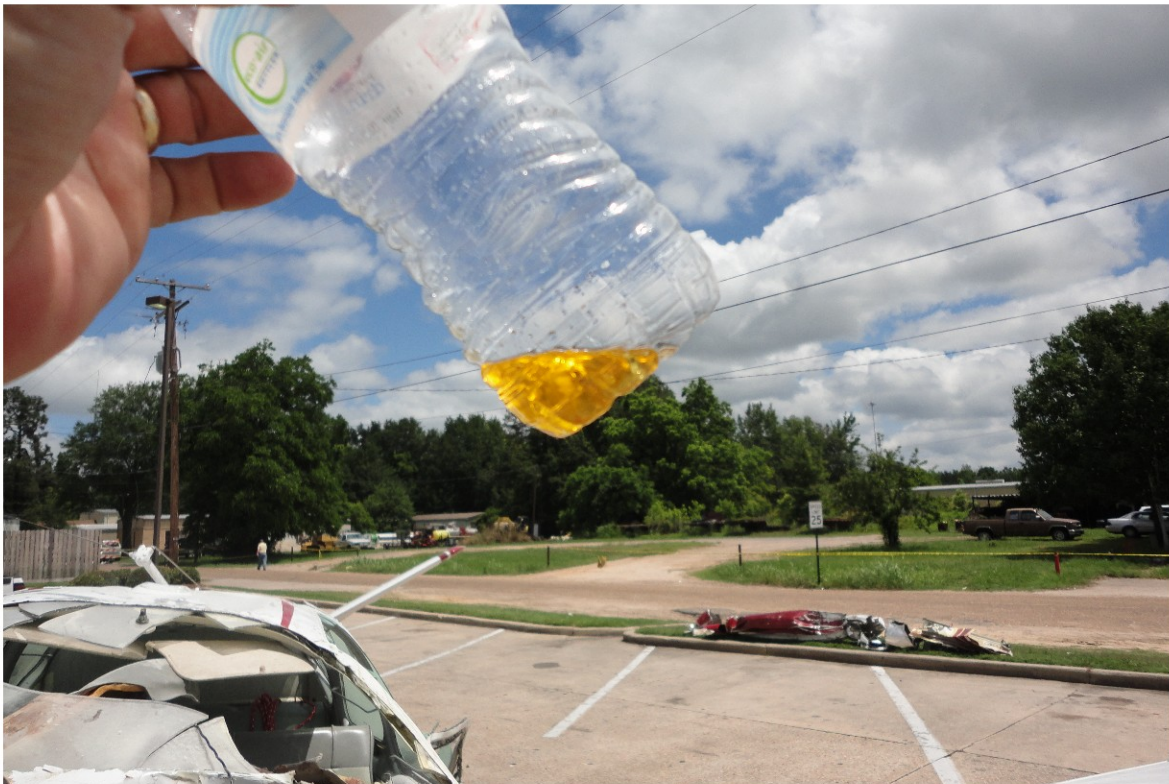
Fuel found in the fuel line headed to the engine. The fuel is discolored with an orange tint. This fuel was sent for analysis and the report is included in the public docket.
