Pipeline Rupture

Pacific Gas & Electric Company

Natural Gas Transmission Line

DCA10MP008

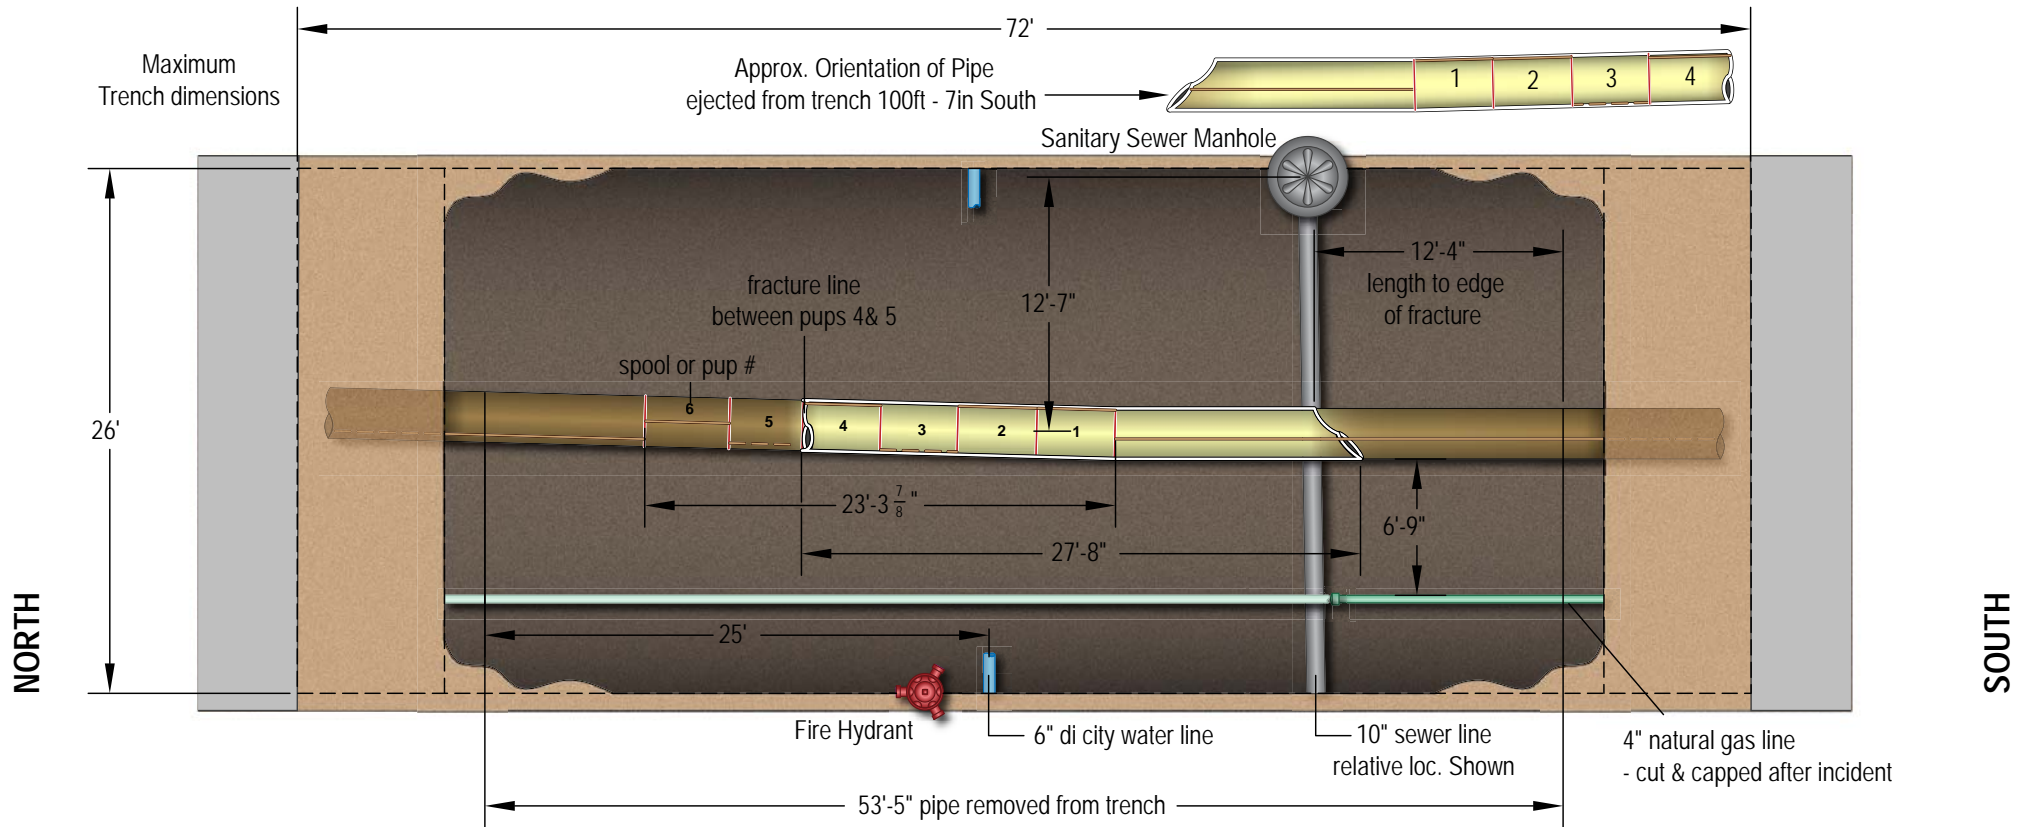
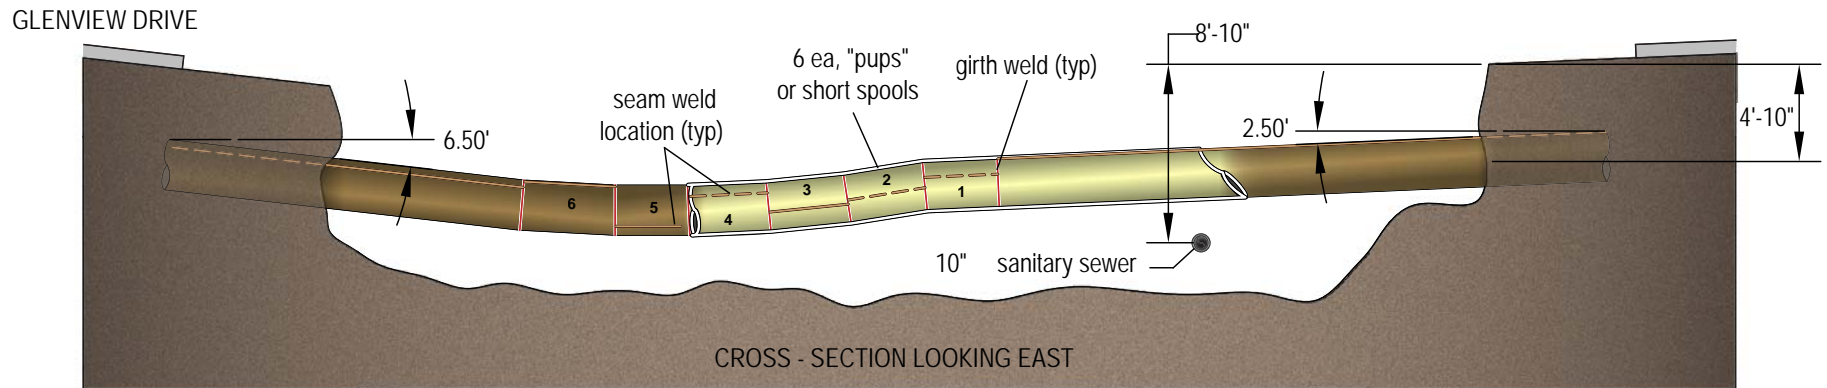
Field Sketch Of Pipe And Trench

This poster is an illustration based on a CADD drawing of the rupture location. It displays both the plan view and the elevation view of the pipe.

Locations are from the City of San Bruno survey, NTSB field measurements and photos.
 *2.5 deg measured from PC&E surveying drawing (NTSB_031-001).
 Pup length taken from lab report; pup millers and install based on relative incline of 1132 at n & s ends of the trench.
 Long seam positions have been taken from the lab factual report.

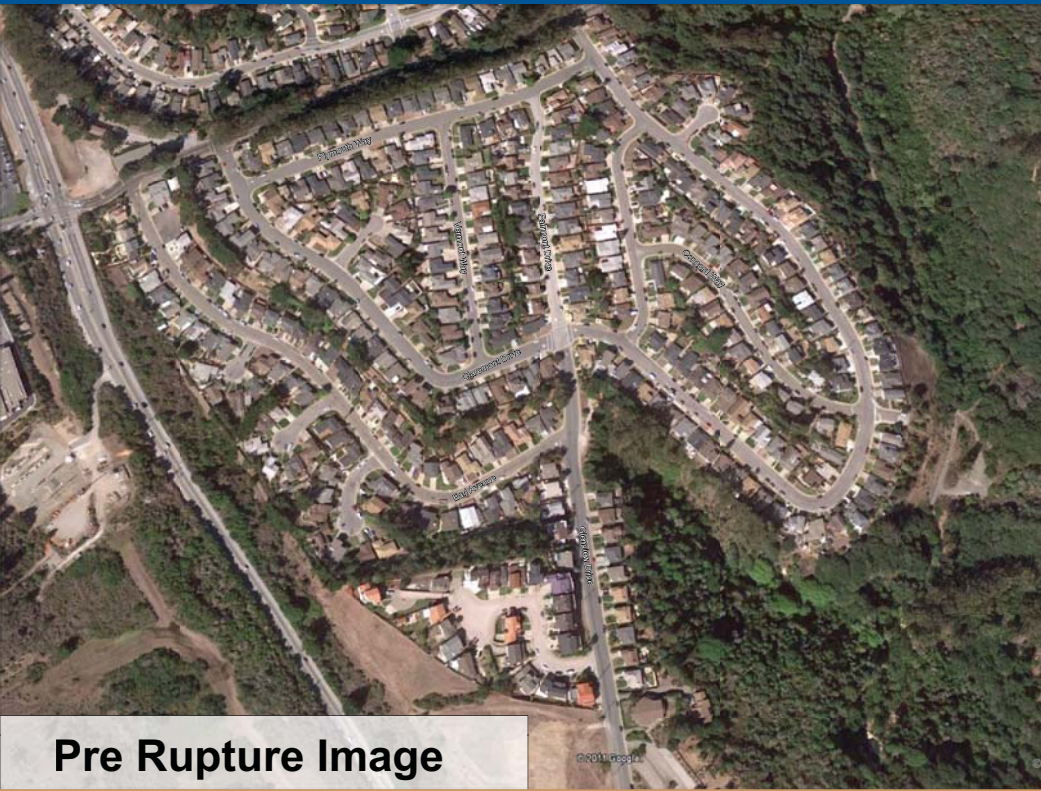
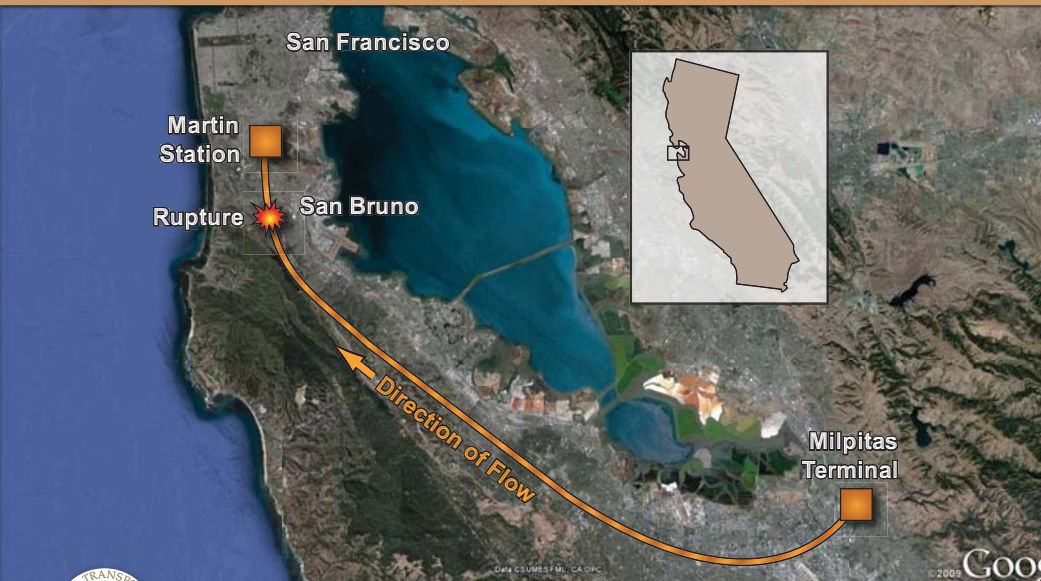
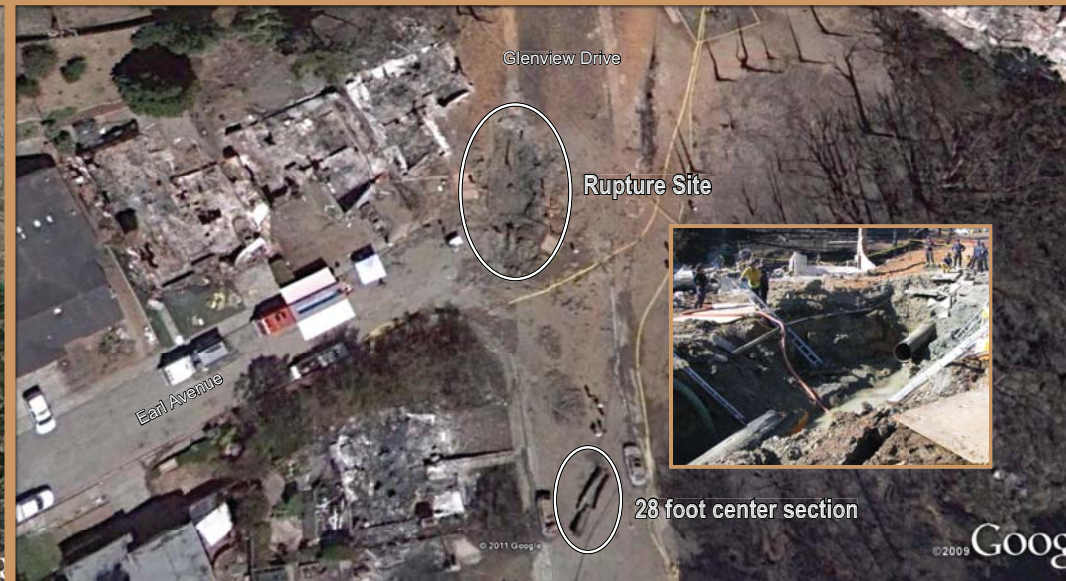
Rupture Location

This poster displays Google Earth images of the neighborhood affected by the rupture. It contains a map showing PG&E's Line 132; a pre rupture image of the neighborhood and a post rupture image of the neighborhood with the rupture site, destroyed properties and damaged properties annotated; and a close up view of the rupture site.

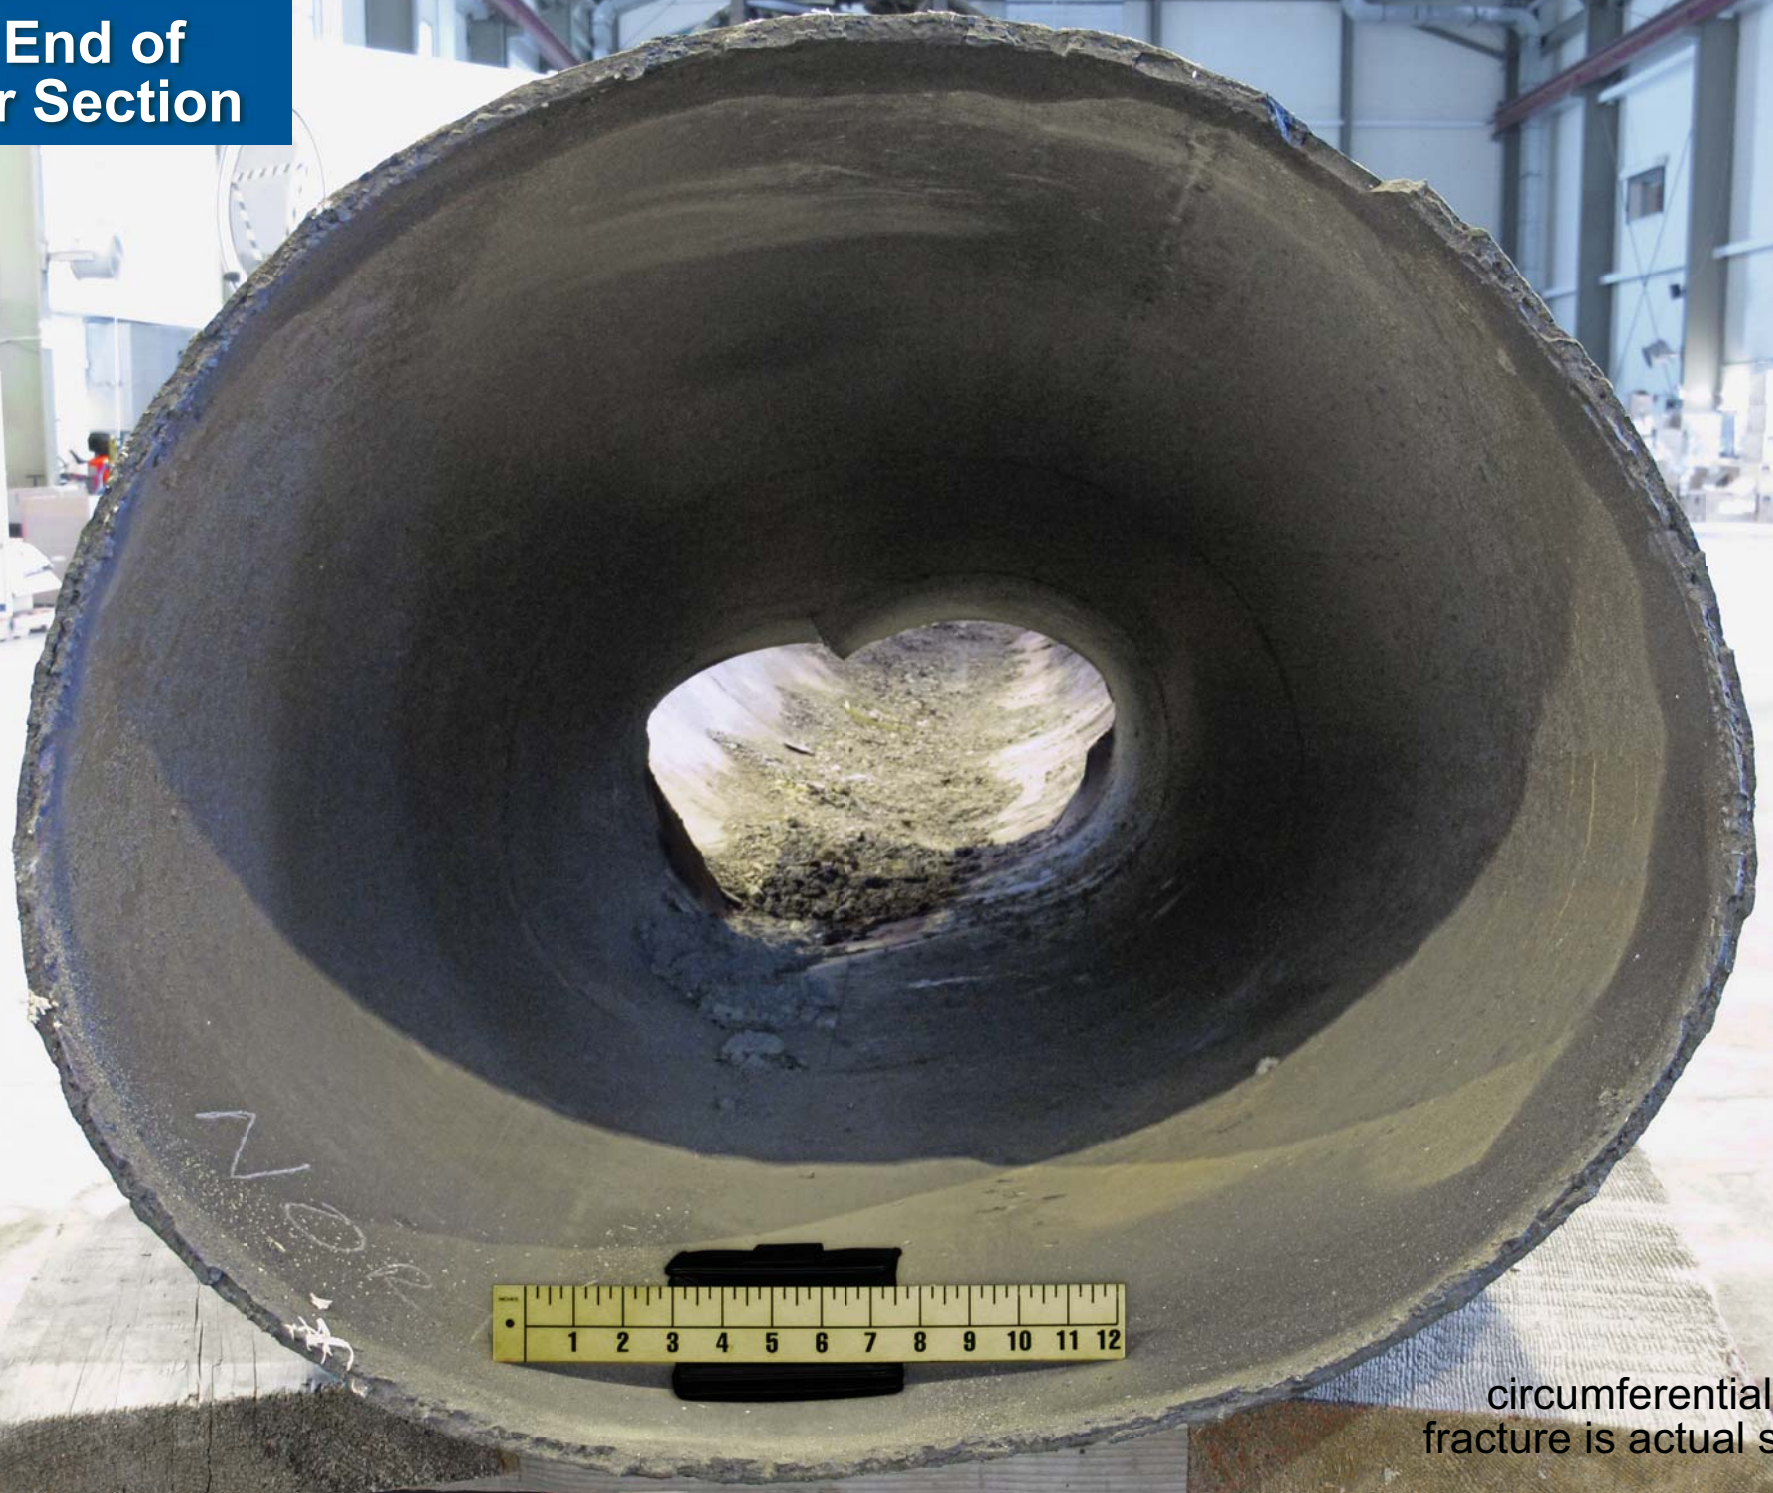
North End of Center Section

This poster displays a photo of the North end of the center section. The circumferential fracture is actual size.

circumferential
fracture is actual size

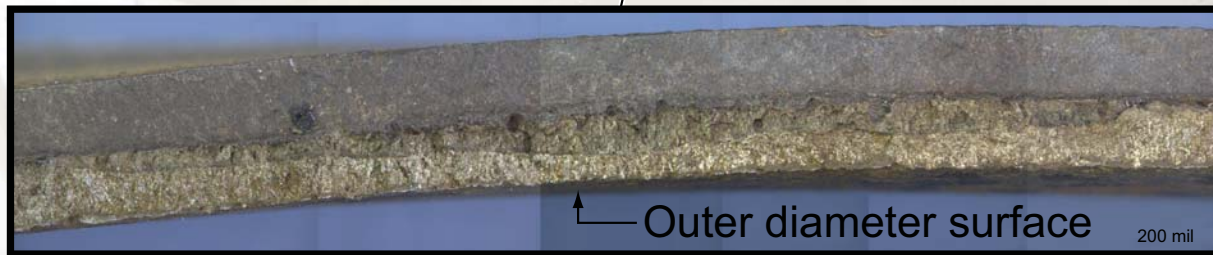
Initiation Site

Micrographs
