Figure 1 - Supplemental Power System Arrangement and Damage

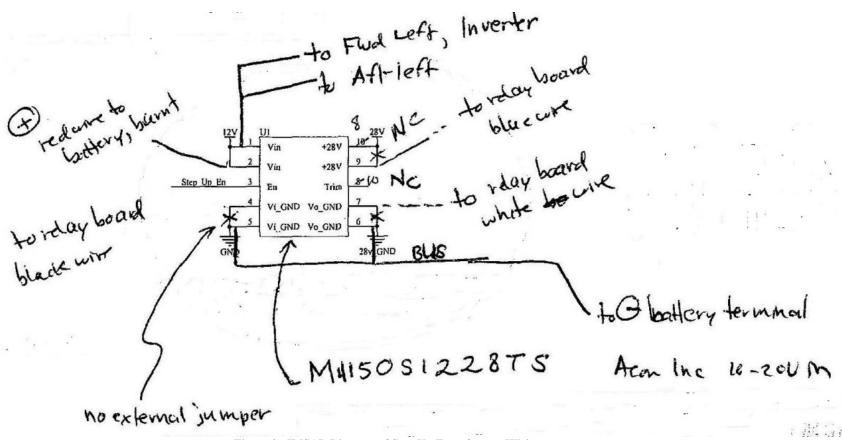
Figure 2 - IMSAR Diagram of Step Up Transformer Wiring

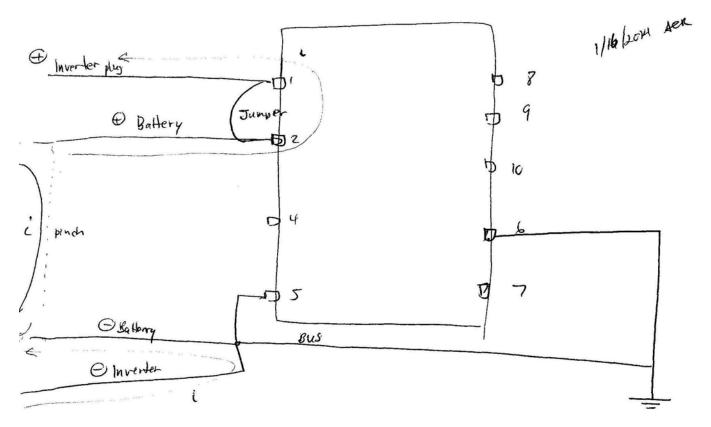
Figure 3 - IMSAR Drawing of Step Up Transformer Wiring

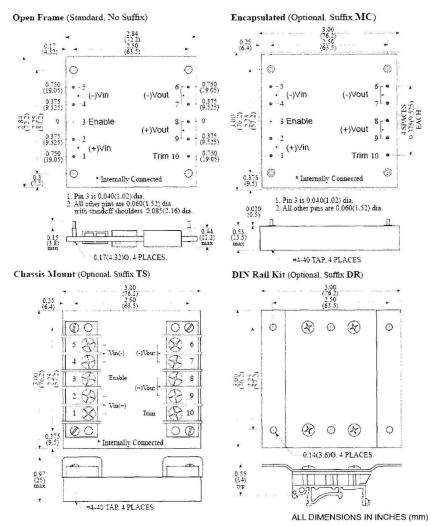
Figure 4 - Manufacturer's Drawing of Step Up Transformer

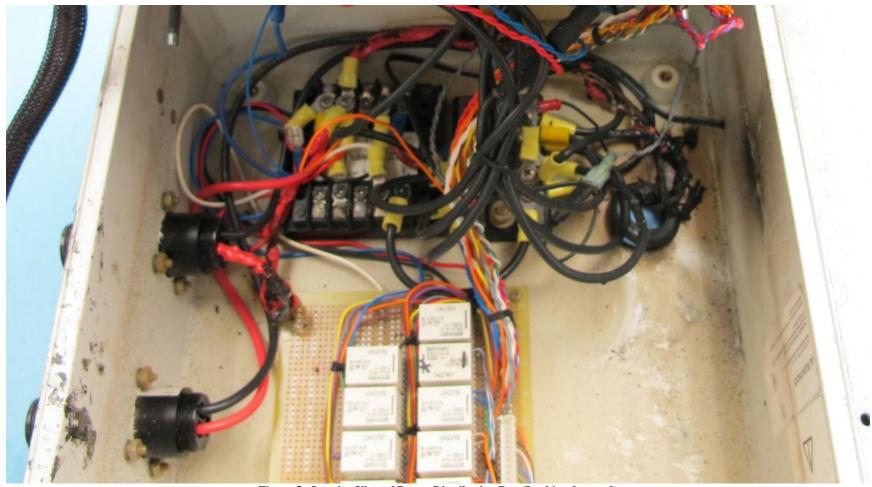
Figure 5 - Interior View of Power Distribution Box (Looking forward)

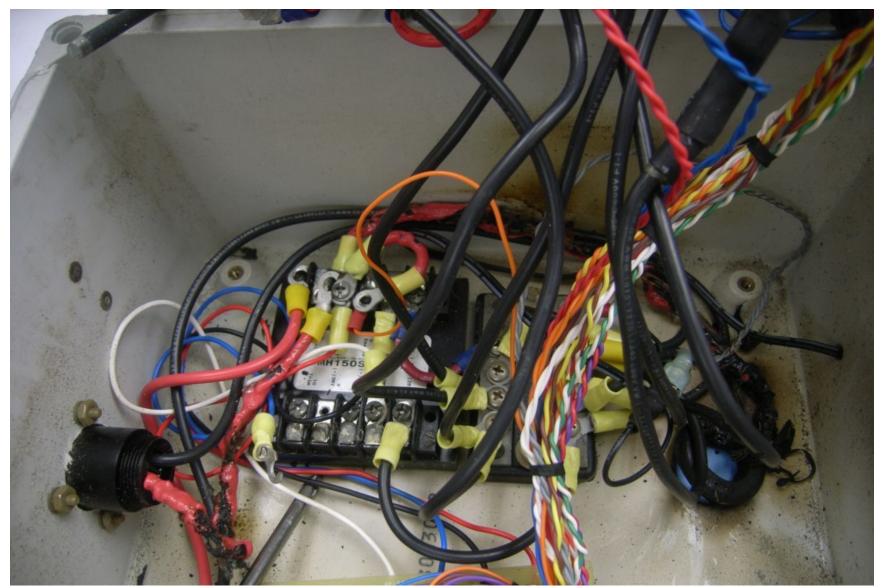
Figure 6 - Step Up Transformer, Bus Block, and Grommeted Hole

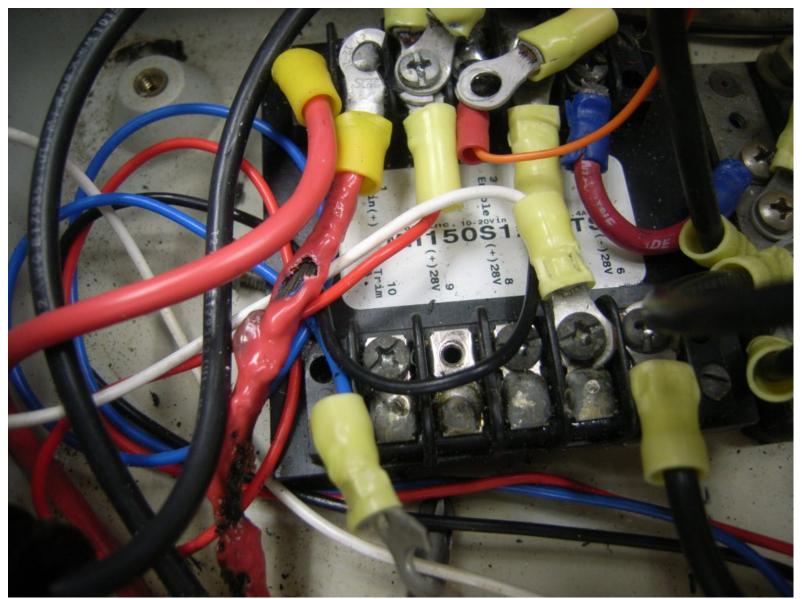
Figure 7 - Step Up Transformer

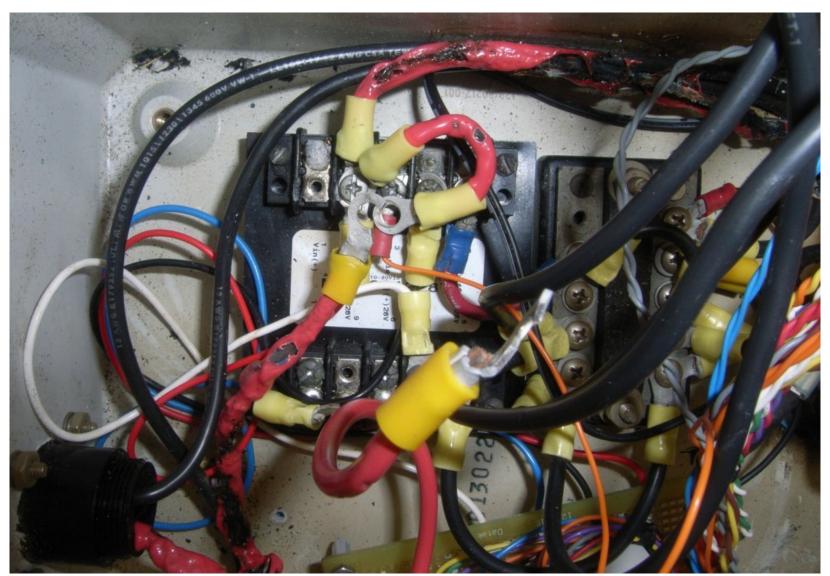
Figure 8 - Step Up Transformer and Bus Block

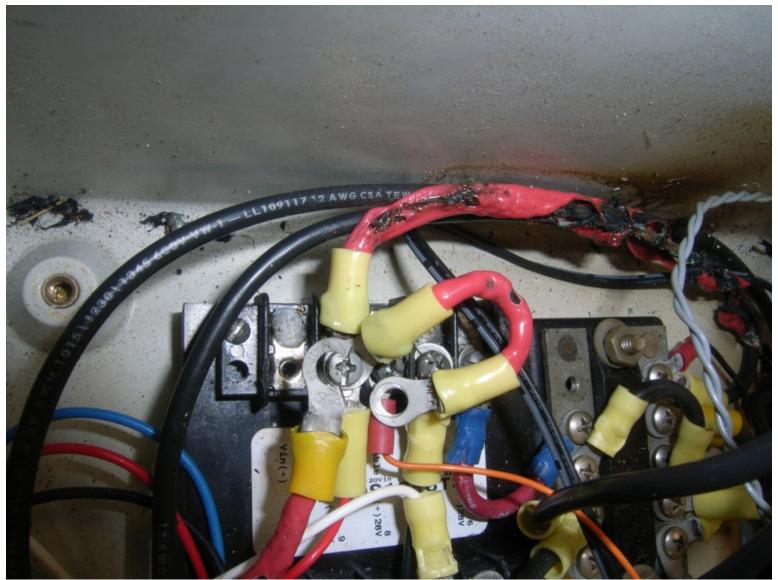
Figure 9 - Step Up Transformer and Bus Block

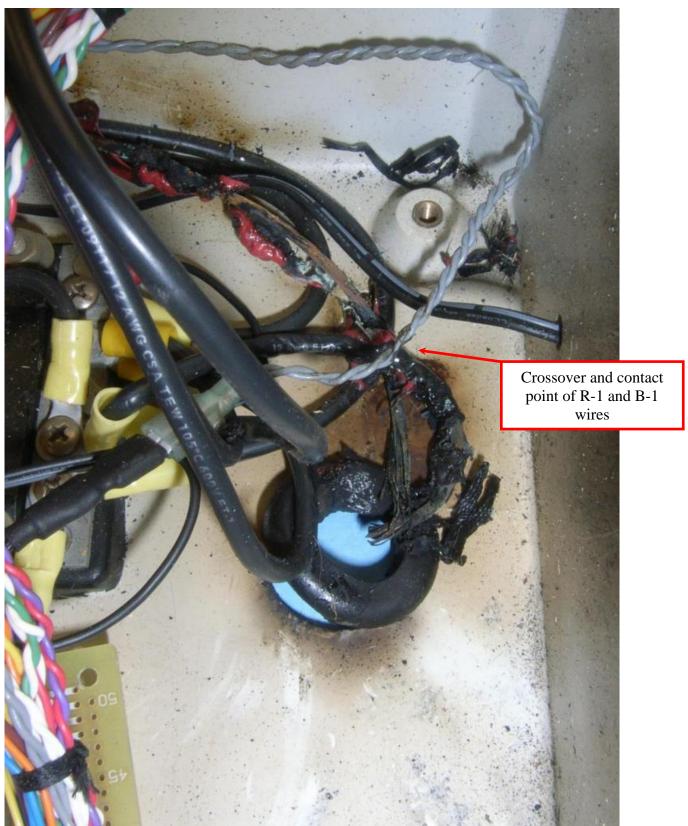
Figure 10 - Grommeted Hole and Damaged Wires

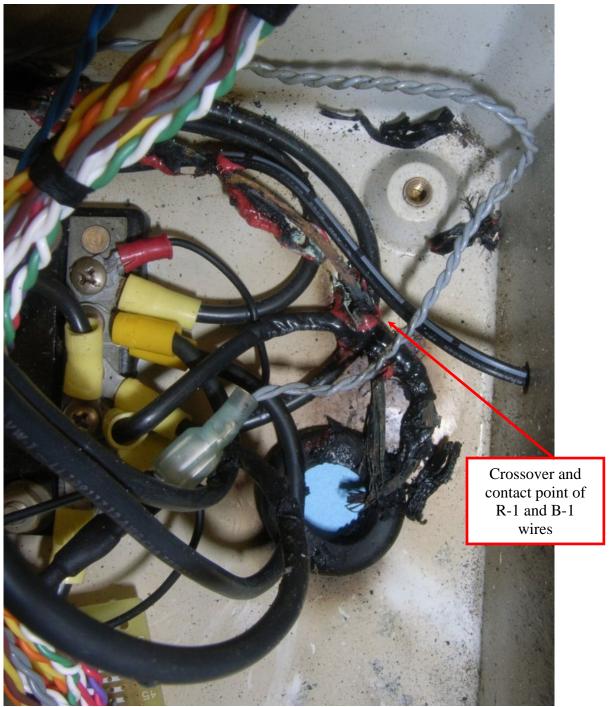
Figure 11 - Grommeted Hole and Damaged Wires

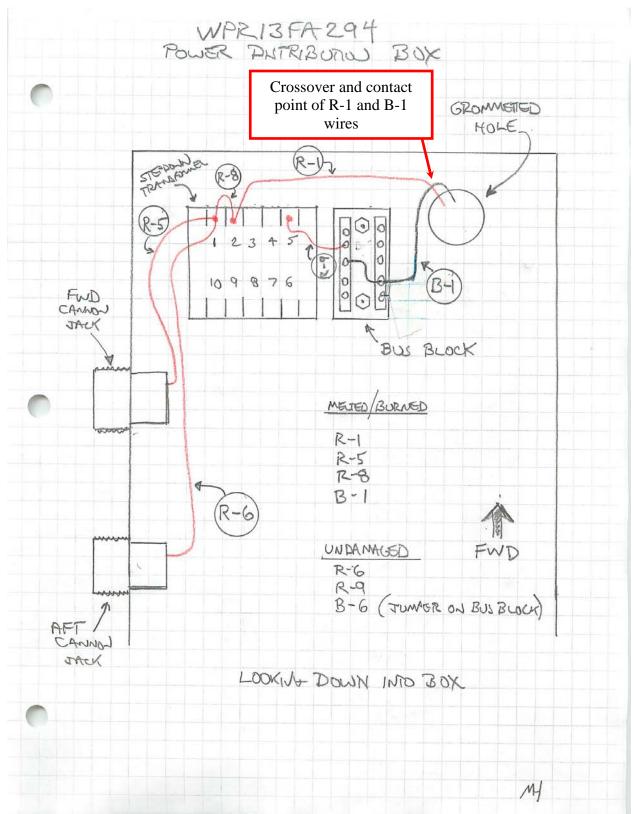
Figure 12 - Diagram of Distribution Box Wiring Damage
