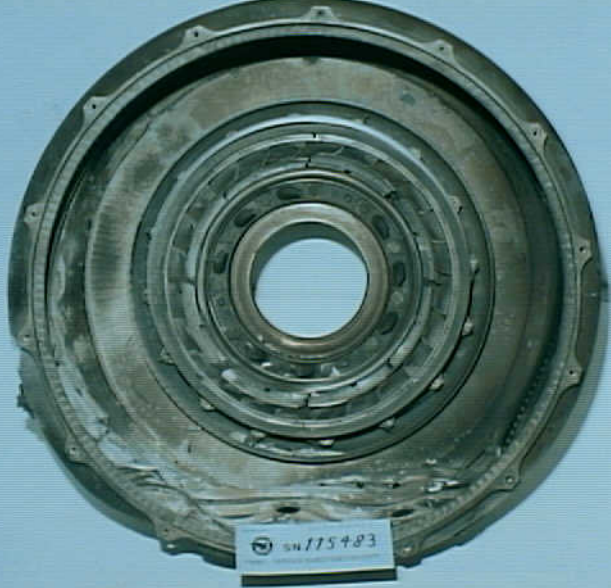
Powerplants 8 - Photo 37. Fractured low pressure and power turbine shafts from left engine
