**RECORDERS
FACTUAL REPORT**

HWY17MH007

NATIONAL TRANSPORTATION SAFETY BOARD

Specialist's Factual Report by Jane Foster

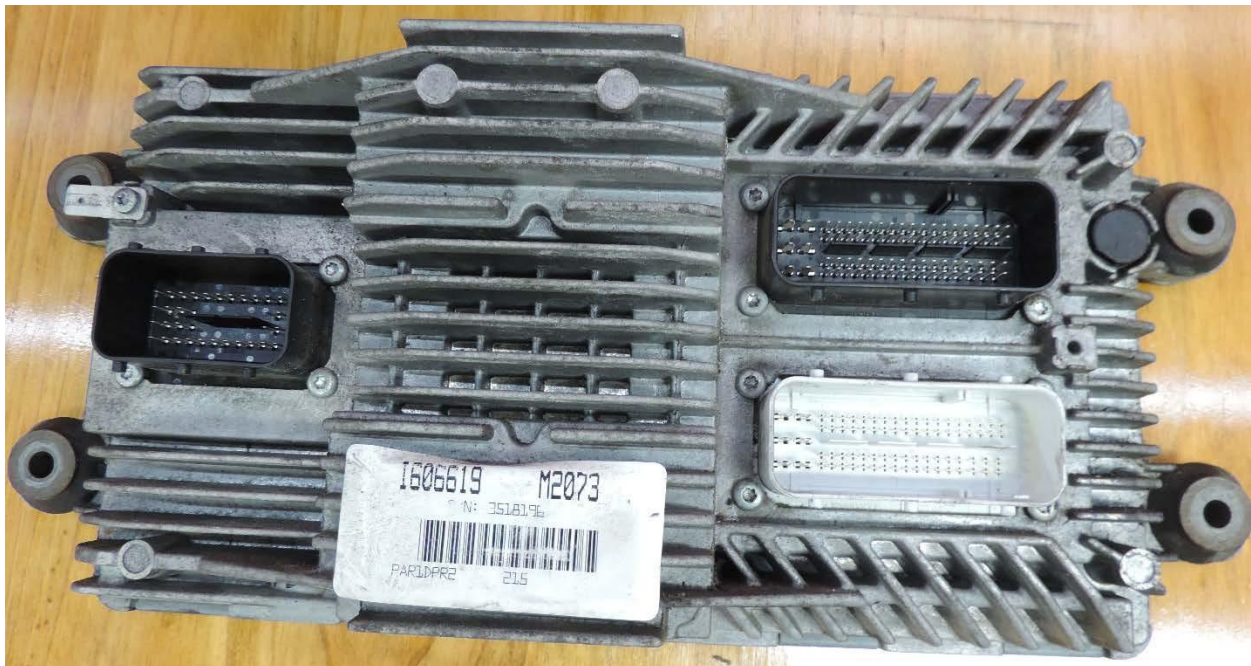
Figure 1. Front of International ECM removed from accident vehicle.

The electrical system of the school bus was compromised so the International ECM could not be imaged on the vehicle. The accident ECM was removed from the accident bus and placed in a surrogate bus. This prevents additional fault codes that appear on a bench top download. The International ECM that was removed from the accident bus is shown in **Figures 1 through 3**. Service Maxx Pro software application was used to image both the accident ECM and the surrogate ECM.

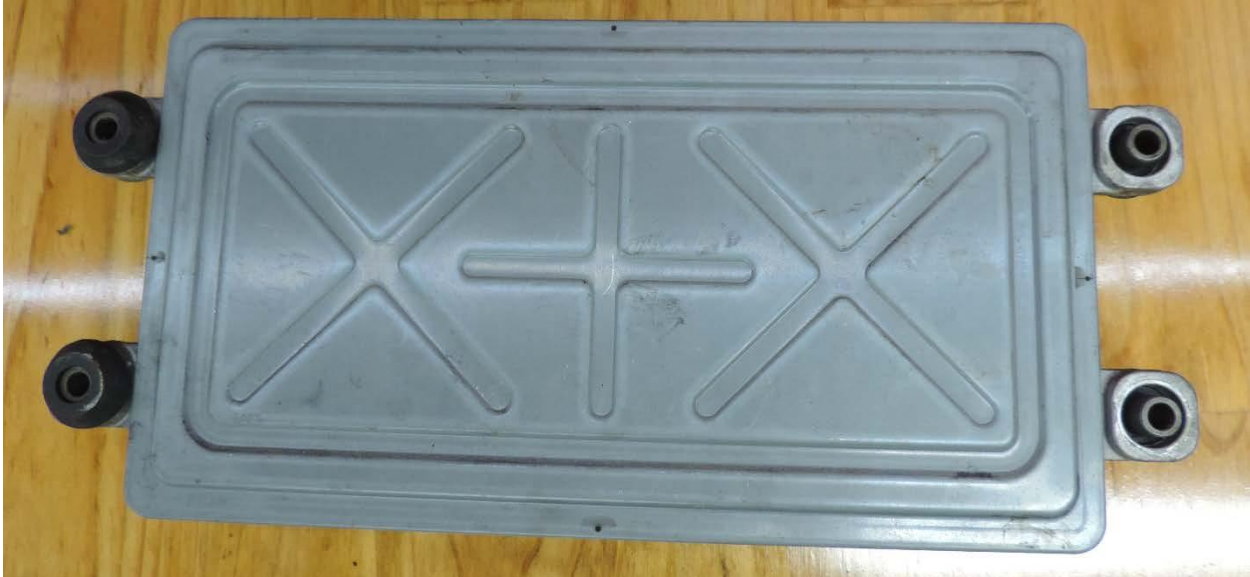
Figure 2. Back of International ECM removed from accident vehicle.

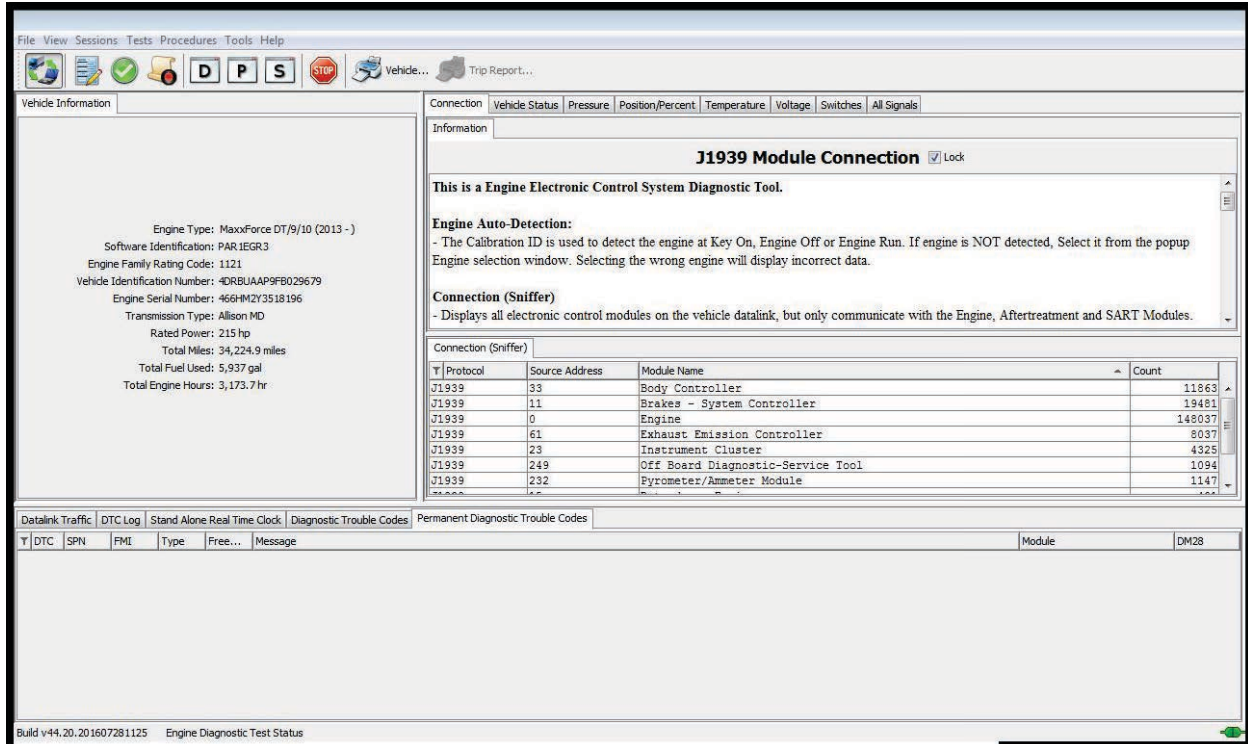
After determining that the surrogate engine would not produce new fault codes into the accident ECM, the accident ECM was installed in the surrogate vehicle. Three diagnostic trouble codes were found on the vehicle. Snapshots of the engine parameters known as freeze frames were taken at the time of the diagnostic trouble codes. None of the codes were accident pertinent. No permanent diagnostic trouble codes were present on the vehicle as shown in **Figure 5**.

Figure 5. Screenshot showing no permanent diagnostic trouble codes present on the accident ECM.

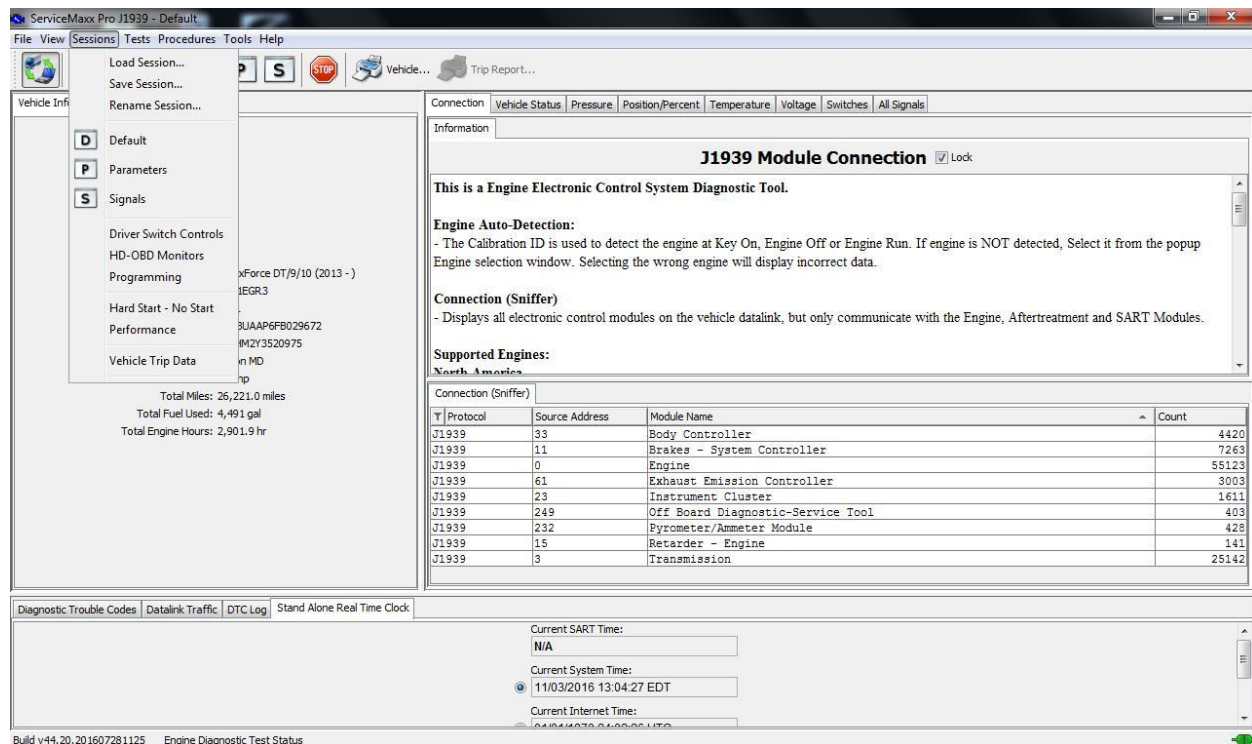
There was no Event Data Recorder or Vehicle Events recorded on the accident ECM. The menu where these options would normally reside is shown in **Figure 6** to confirm the lack of these options. This indicated that the recording features of the ECM were disabled. This ECM was not configured to record any last stop information or hard acceleration or deceleration data.

Figure 6. No Vehicle Events or Event Data Recorder available where they are normally found in the sessions menu for the accident ECM.

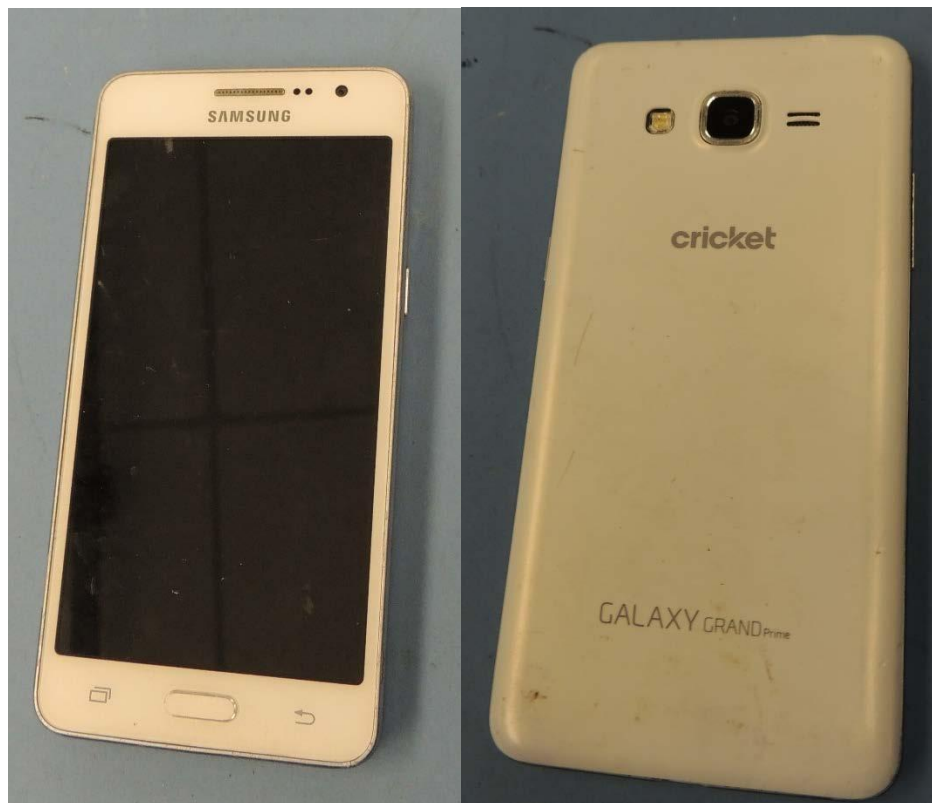
Upon arrival at the NTSB Vehicle Recorder Laboratory, an exterior examination revealed the unit had not sustained any damage. **Figure 9** shows the front and back of the Samsung Galaxy GRAND Prime as received. Information was extracted using forensic software.

Figure 9. Front and Back of Samsung Galaxy GRAND Prime as received.

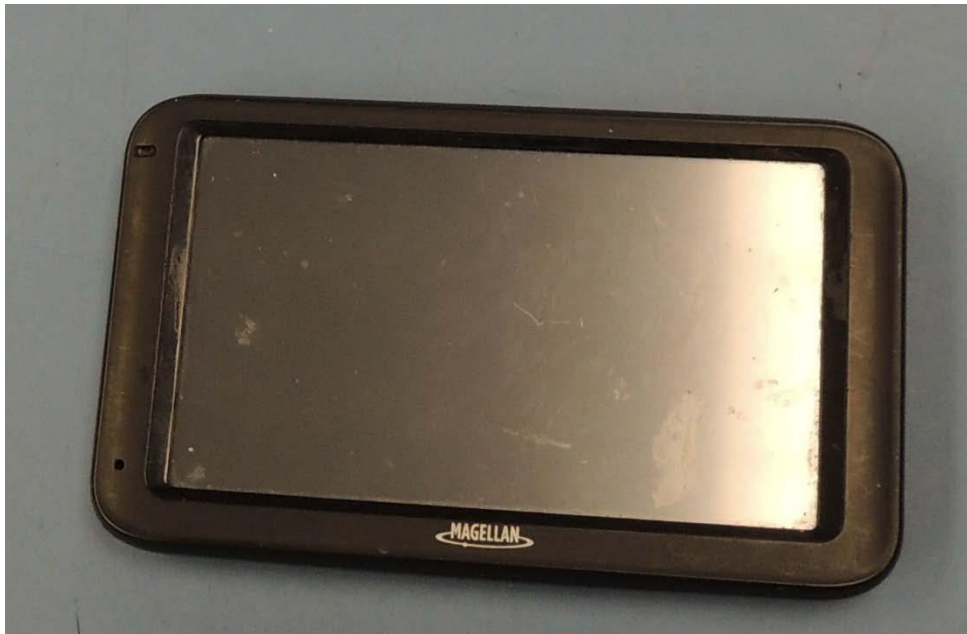
Upon arrival at the NTSB Vehicle Recorder Laboratory, an exterior examination revealed the unit had not sustained any damage and information was extracted using the manufacturer's software normally. **Figures 10 and 11** show the Magellan Roadmate GPS as received.

Figure 10. Front of Magellan Roadmate GPS as received.

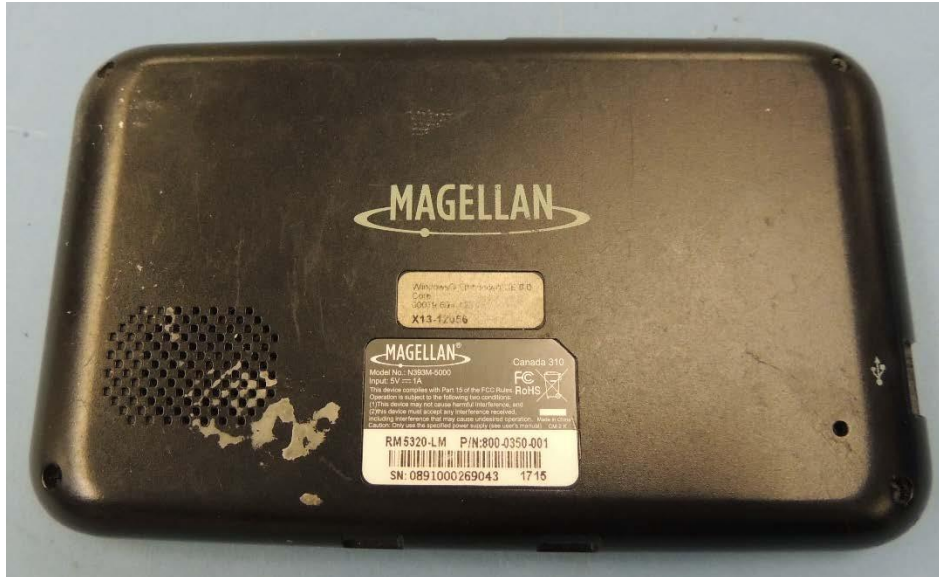
Figure 11. Back of Magellan Roadmate GPS as recieved.

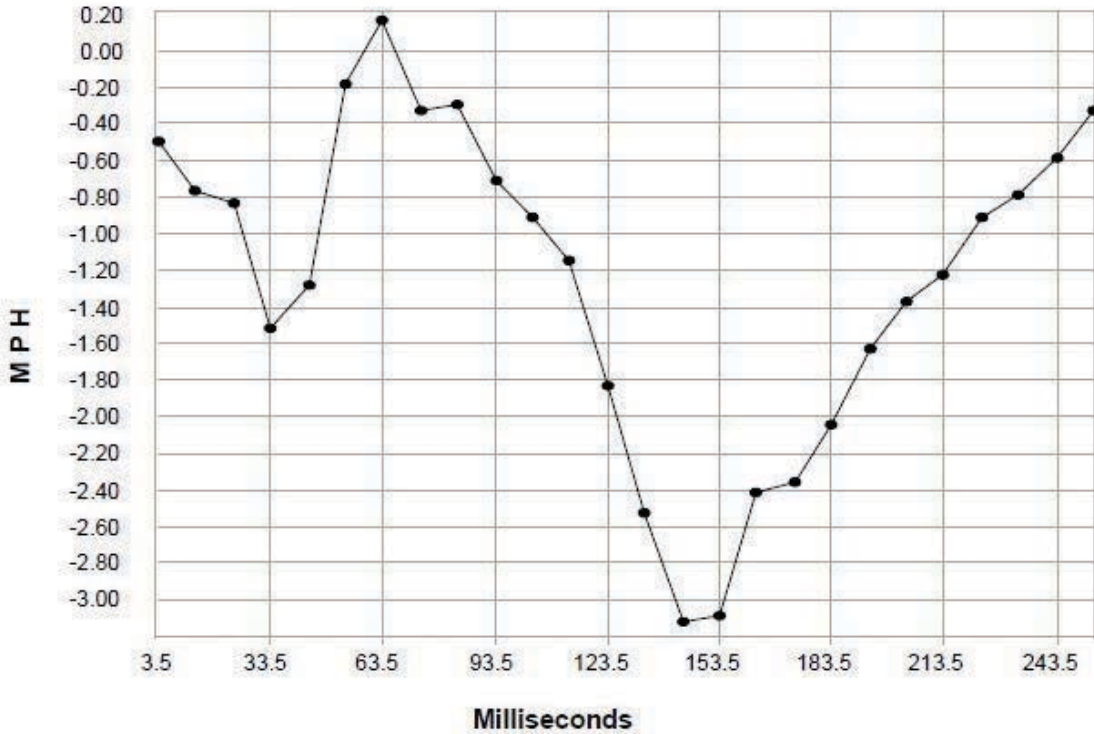
The first record occurred at a key-on time of 1620 seconds with a maximum longitudinal delta-V of 28.01 miles per hour (mph) and a maximum lateral delta-V of -3.20 mph. Maximum longitudinal delta-V is the maximum change of speed along the vehicle's longitudinal axis. Maximum lateral delta-V is the maximum change of speed along the vehicle's lateral axis. The driver was buckled. **Figure 12** shows the longitudinal crash pulse (first record) and **Figure 13** shows the lateral crash pulse (first record).

Figure 13. Plot of lateral crash pulse (first record).

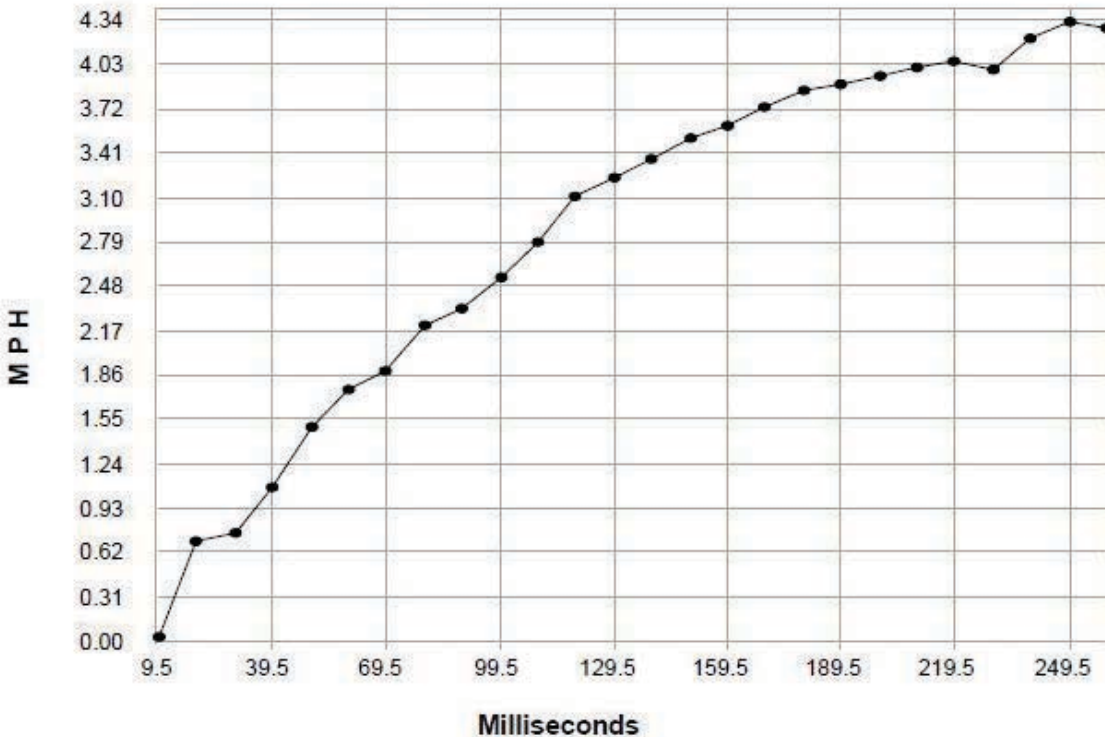
The second record occurred at a key-on time of 1620 seconds with a maximum longitudinal delta-V of 4.3 mph and a maximum lateral delta-V of 4.64 mph. The driver was buckled. **Figure 14** shows the longitudinal crash pulse (second record) and **Figure 15** shows the lateral crash pulse (second record).

Figure 15. Plot of lateral crash pulse (second record).

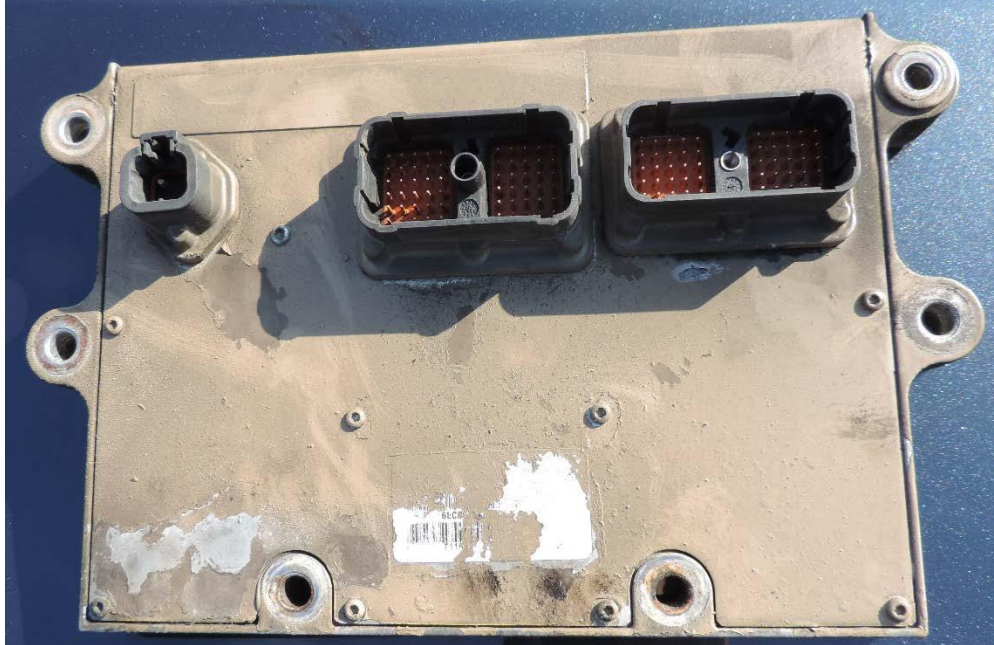
The electrical system of the transit bus was compromised so the Cummins ECM could not be imaged on the vehicle. The accident ECM was removed from the accident bus and placed in a surrogate bus. This prevents additional fault codes that appear on a bench top download. The accident ECM that was removed from the accident bus is shown in **Figures 16 and 17**.

Figure 16. Front of Cummins ECM after removal from vehicle.

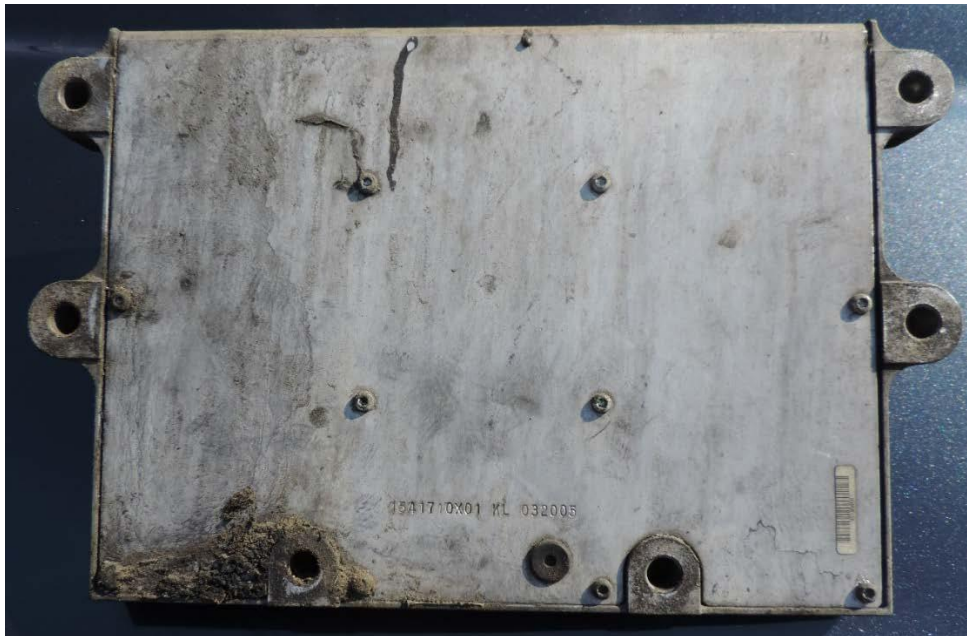
Figure 17. Back of Cummins ECM after removal from vehicle.
