**NATIONAL TRANSPORTATION SAFETY BOARD  
OFFICE OF HIGHWAY SAFETY  
WASHINGTON, D.C.**

**RECORDER SPECIALIST'S  
FACTUAL REPORT**

Location: Northbound US Highway 83 (US-83) near milepost 553.4 in Uvalde County, 6.5 miles north of Concan, Texas

NTSB #: **HWY17MH011**

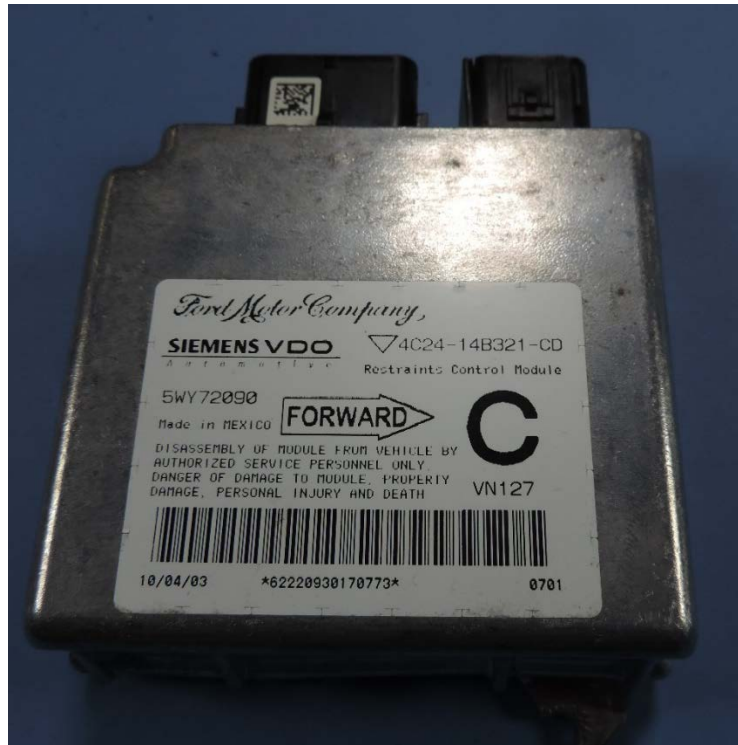
The electrical system of Vehicle #2 was compromised so the ACM could not be imaged normally. The ACM was removed from the vehicle and brought to the manufacturer for imaging. Figures 1 and 2 show the device as received.

Figure 1. Front of Airbag Control Module (Vehicle #2) as received.

The data extracted includes information about the x-sensor, the y-sensor, the EFS-sensor, the stored codes, and the algorithm decisions. The x-sensor records the longitudinal acceleration at the location of the module. There was approximately a 33.2 mile per hour change in longitudinal velocity for the recorded event. The y-sensor records latitudinal change in velocity at the location of the module. There was approximately a 12.1 mile per hour change in velocity for the recorded event. The EFS-sensor is the front crash sensor that records change in velocity at the front crash sensor location. There was approximately a 13.5 mile per hour change in velocity for the recorded event at the front crash sensor. The different changes in velocity occurred over different lengths of time. For more detail, see Recorders Attachment, Postcrash Data from the 2004 Ford E350 Airbag Control Module.

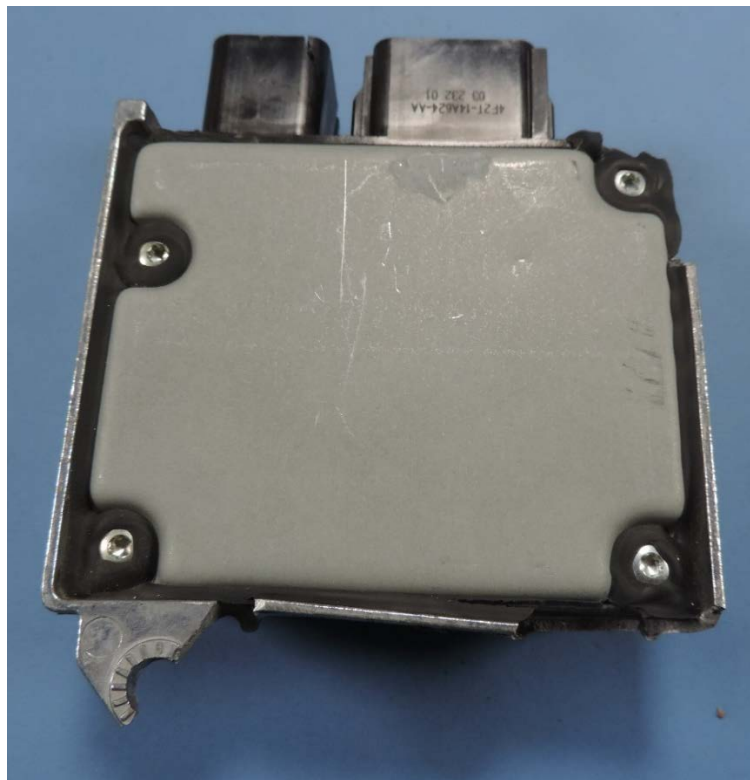
Figure 2. Back of Airbag Control Module (Vehicle #2) as received.

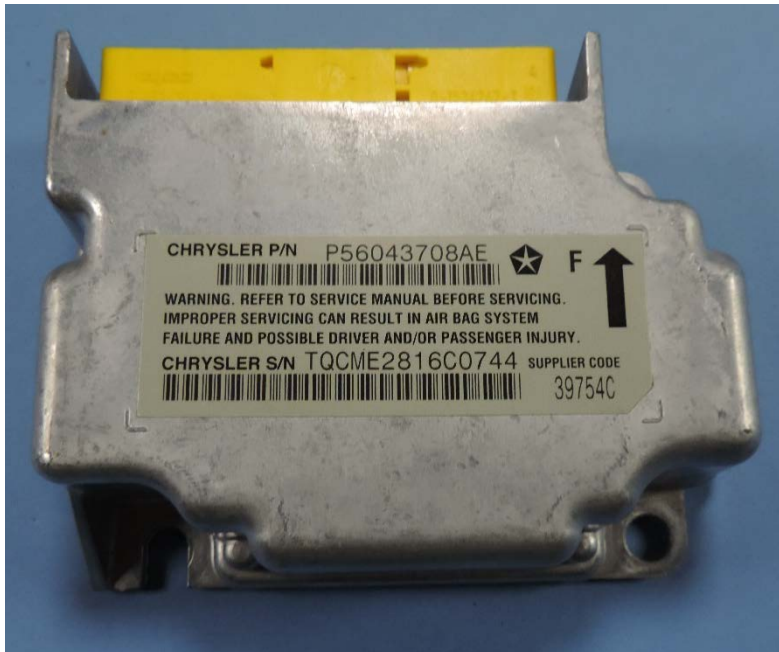
The ACM was imaged by the Texas Department of Public Safety. All post processing of the data was performed by the Crash Data Retrieval (CDR) software. The software organizes the imaged data in a \*.pdf report that contains the following sections: user information including date and time the device was imaged, user comments, data limitations, data source, tabular data and plot(s) from event(s), and raw hexadecimal data used in the report. The software does not correlate time to any standard such as eastern standard time (EST), and is recorded as seconds elapsed based on the start of the event referenced to an ignition cycle. Figures 3 and 4 show the device as received.

Figure 3. Front of Airbag Control Module (Vehicle #1) as received.

No accident data was available from the ACM in vehicle #1 due to sudden power loss. For more detail, see Recorders Attachment, Postcrash Data from the 2007 Dodge Ram Airbag Control Module.

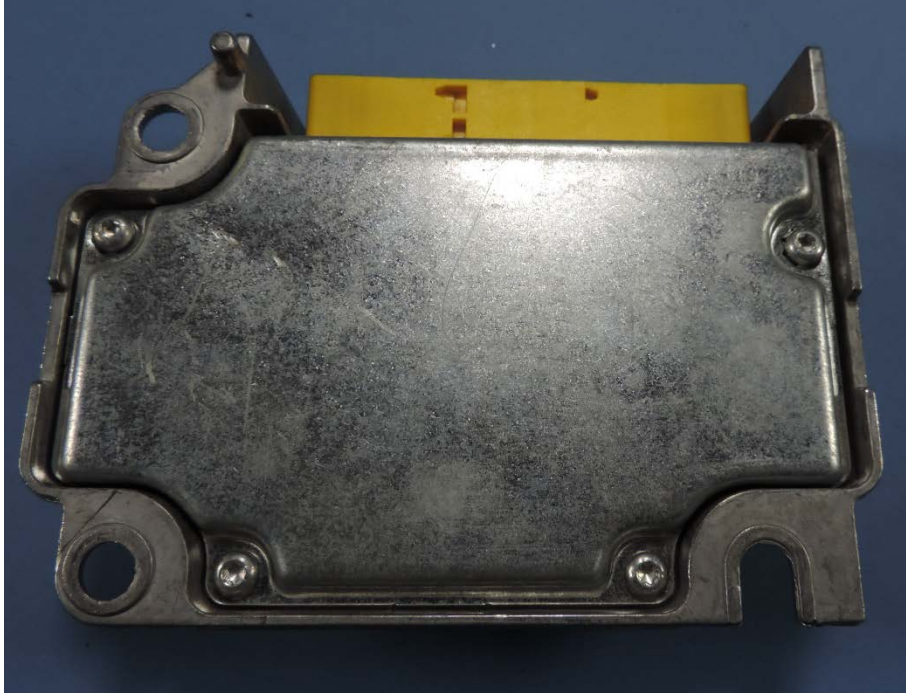
Figure 4. Back of Airbag Control Module (Vehicle #1) as received.

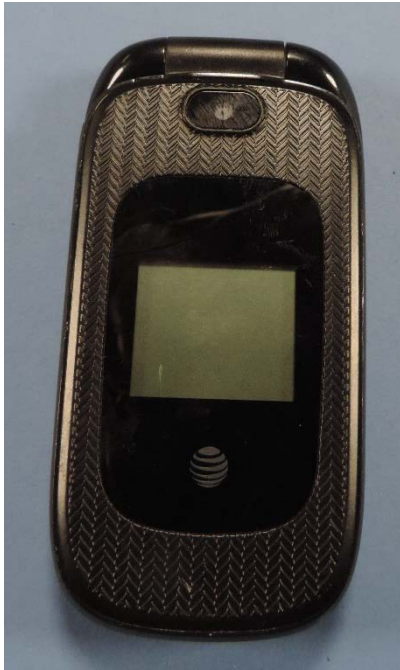
Upon arrival at the Vehicle Recorder Division, an exterior examination revealed the unit had not sustained any damage. Information was attempted to be extracted normally using the forensic software, however there was communication errors. The phone was manually analyzed for accident pertinent data. Figures 5 and 6 show the device as received.

Figure 5. Front of ZTE Z223 Cell Phone (Vehicle #1) as received.

No accident pertinent data was found on the phone.

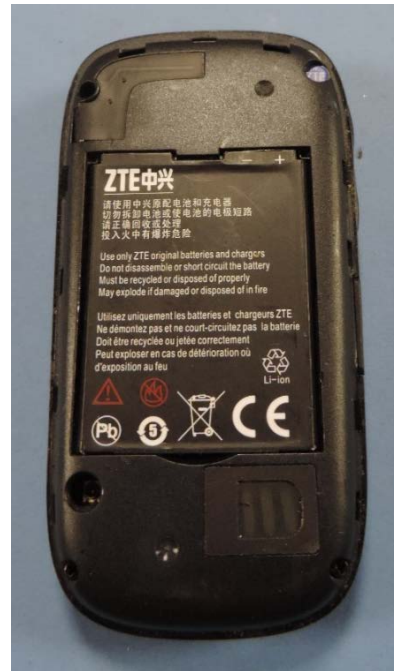
Figure 6. Back of ZTE Z223 Cell Phone (Vehicle #1) as received.

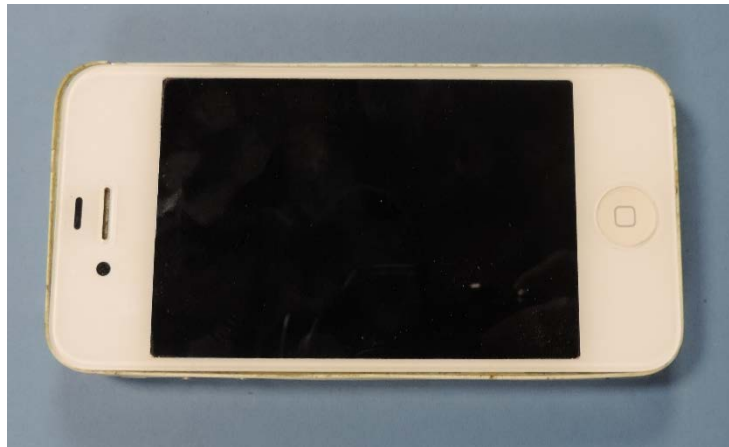
Upon arrival at the Vehicle Recorder Laboratory, an exterior examination revealed the unit had sustained considerable impact damage. The interior memory board was removed from the device and installed in a surrogate device. Figure 7 is a picture of the iPhone as received.

Figure 1. iPhone 4s (Vehicle #1) as received.

The extensive impact damage to the iPhone prevented any data retrieval from the device.
