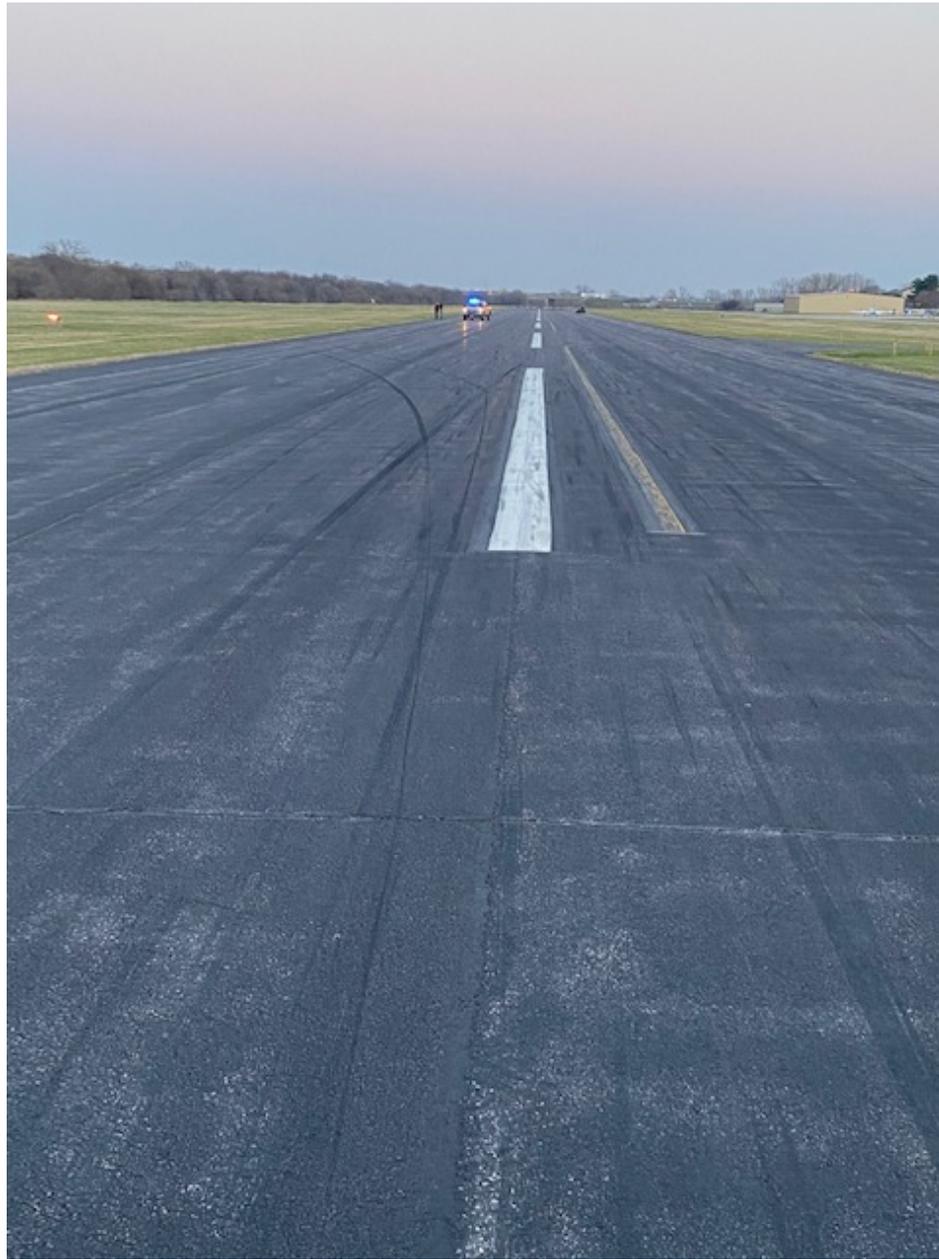
**Photo 1 – View to the southeast down runway 12. Note the skid mark angling off to the left (FAA photo)**

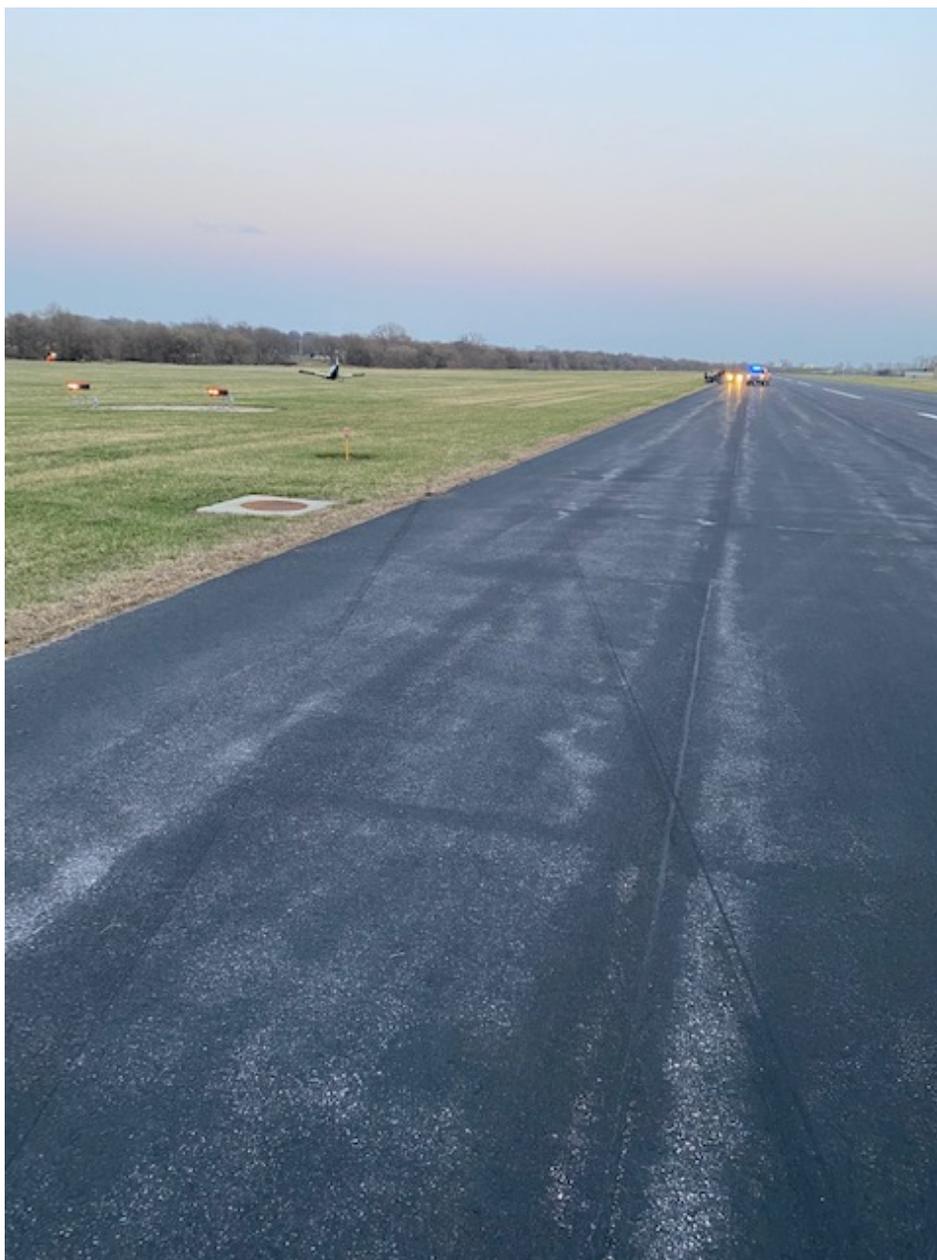
**Photo 2 – N9468W in the grass to the left of runway 12 (FAA photo)**

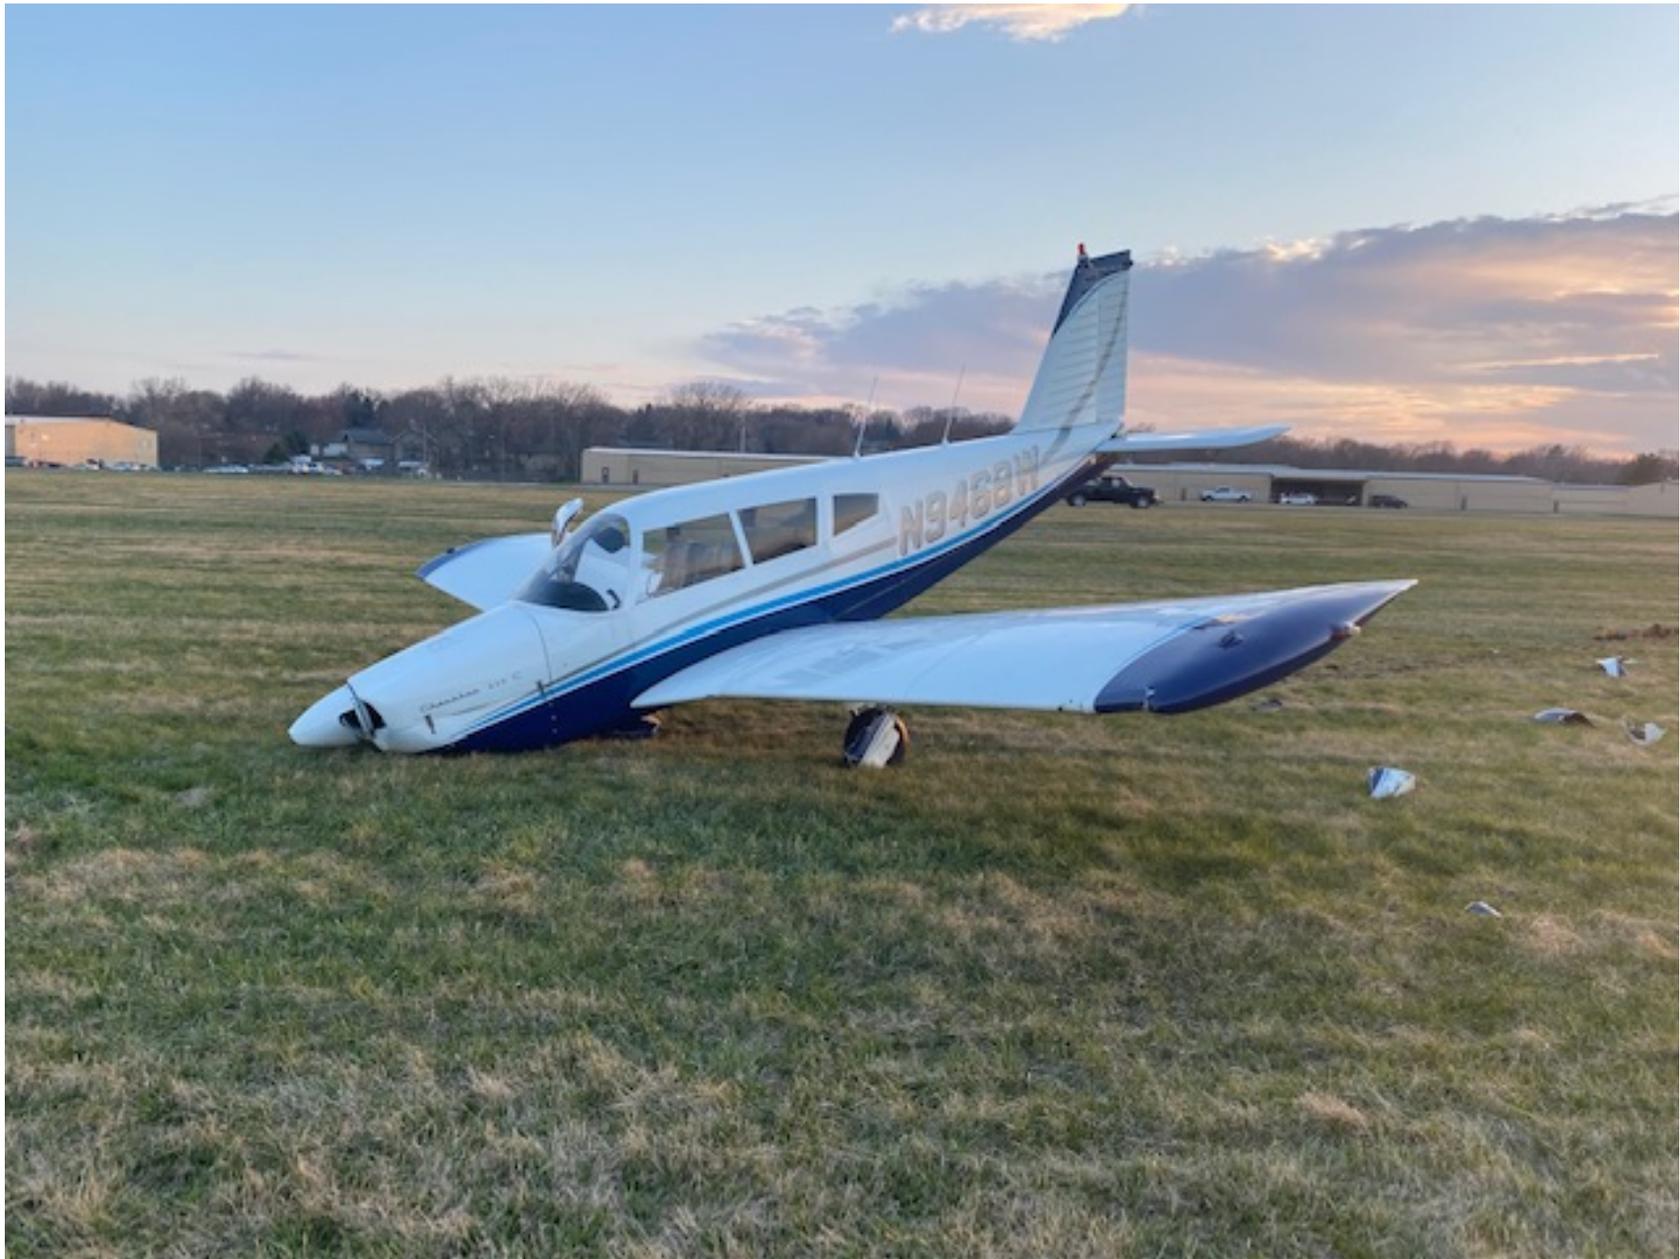
**Photo 3 – N9468W with collapsed nose landing gear (FAA photo)**

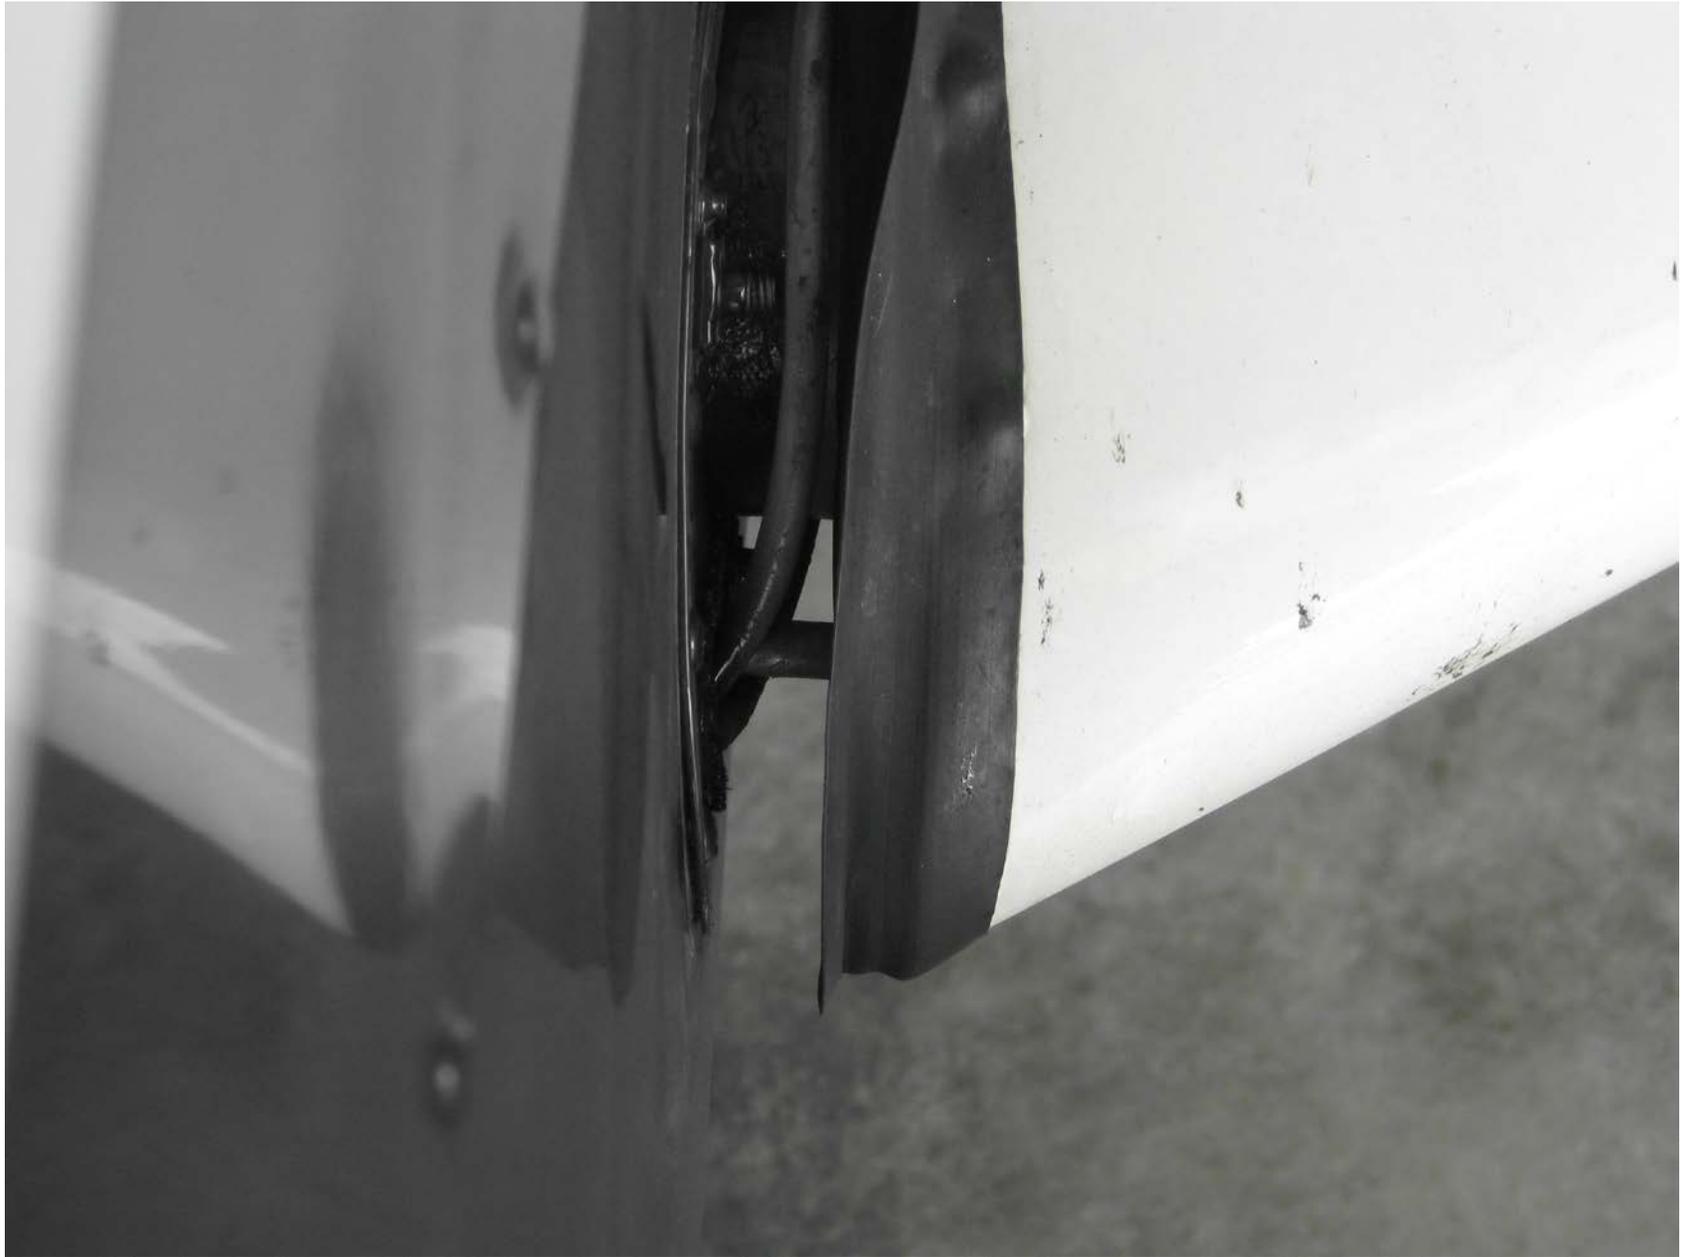
**Photo 4 – Left wing separation (FAA photo)**

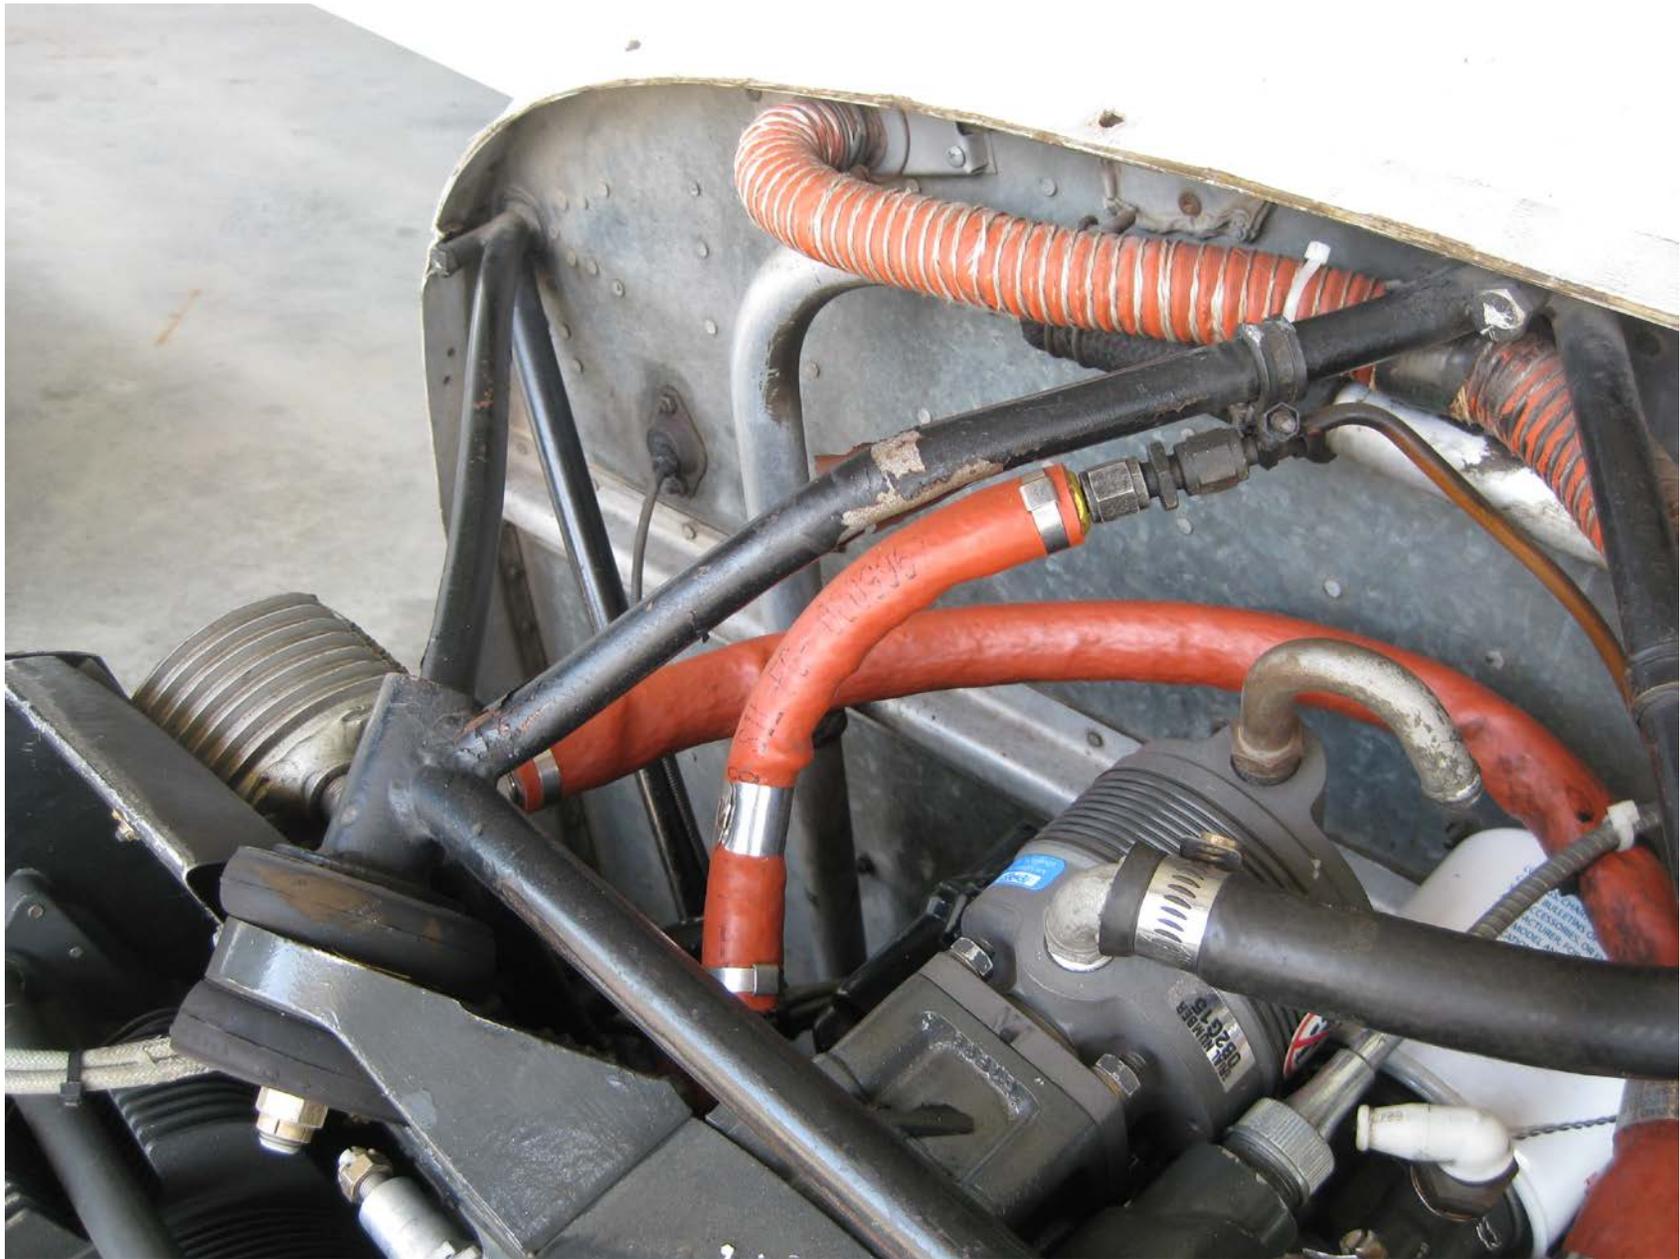
**Photo 5 – Bent engine mount and buckled firewall (FAA photo)**

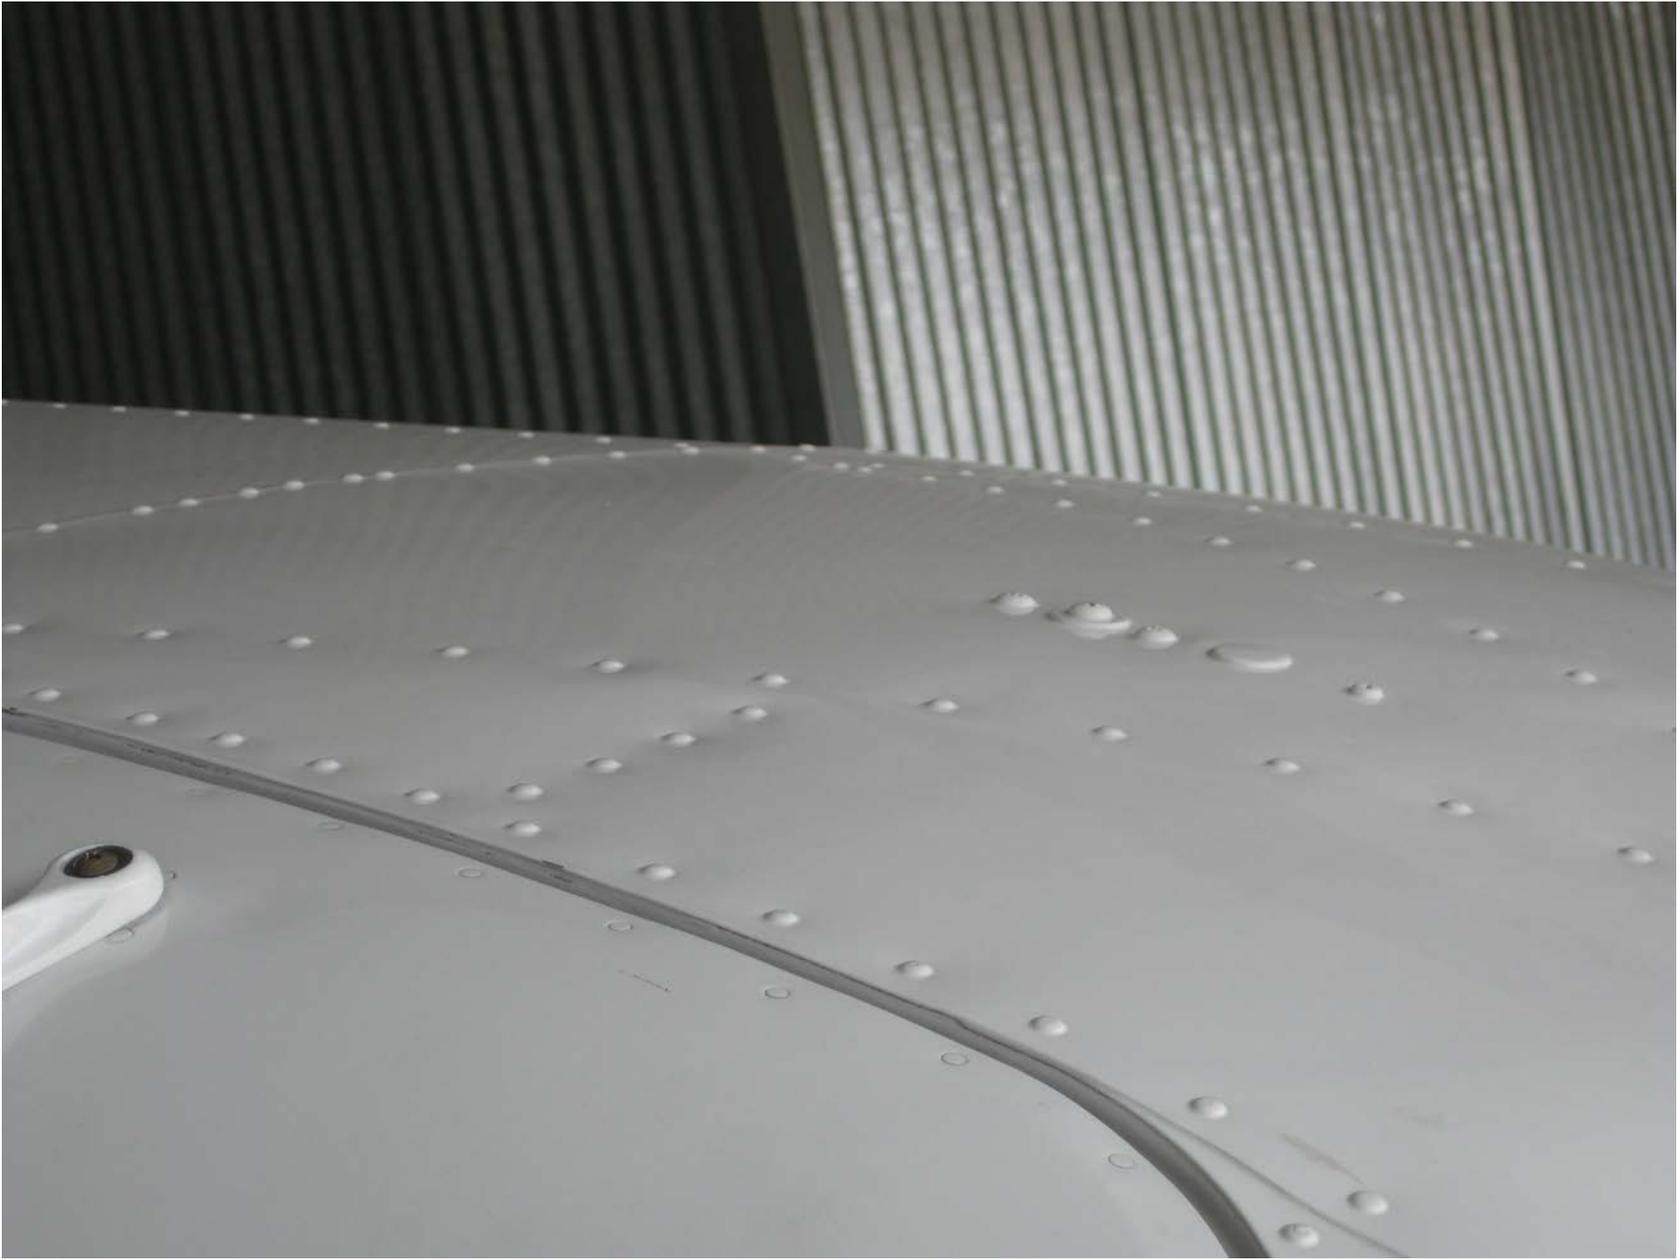
**Photo 6 – Wrinkle in roof next to cabin door handle (FAA photo)**

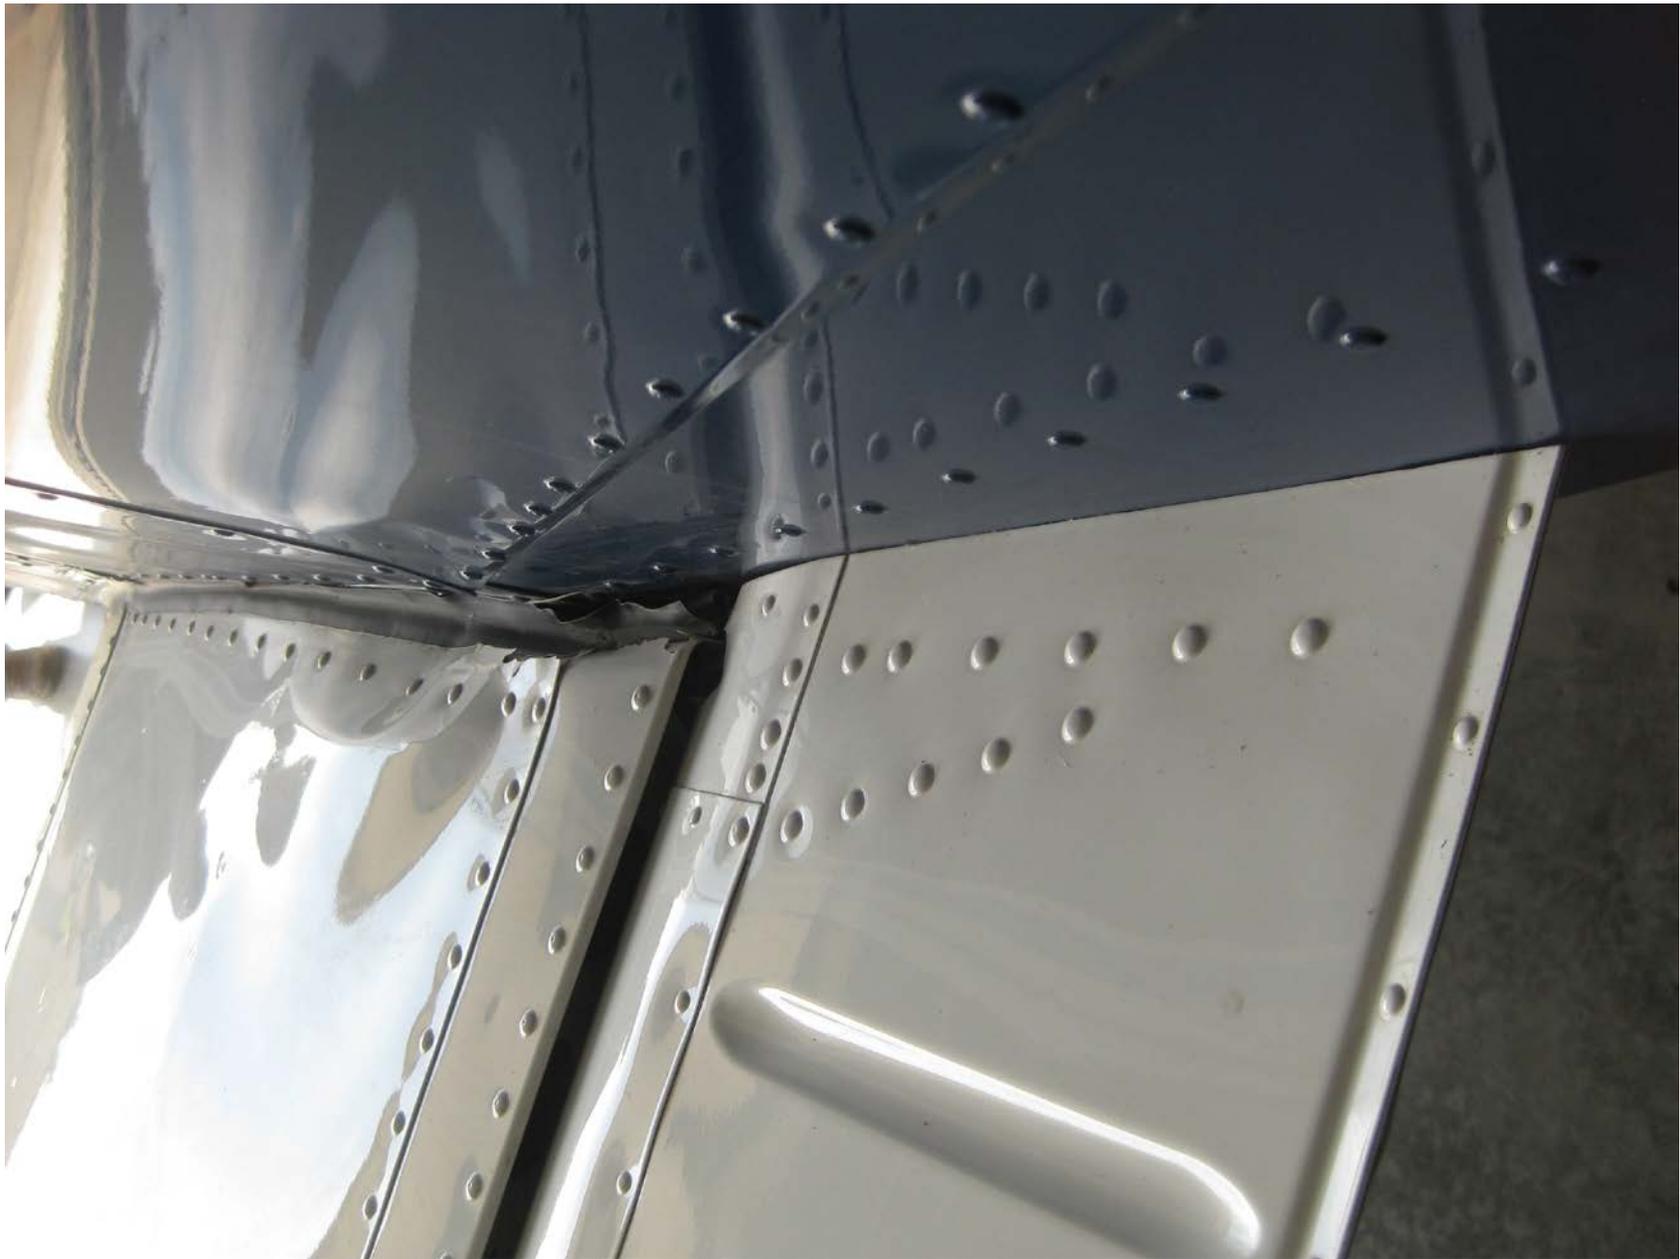
**Photo 7 – Torn skin on left wing and fuselage (FAA photo)**
