## **ENGINE FIELD INSPECTION REPORT**

ENGINE MODEL: 0-470

AIRCRAFT MODEL: Cessna 182P

REGISTRATION: N222CG

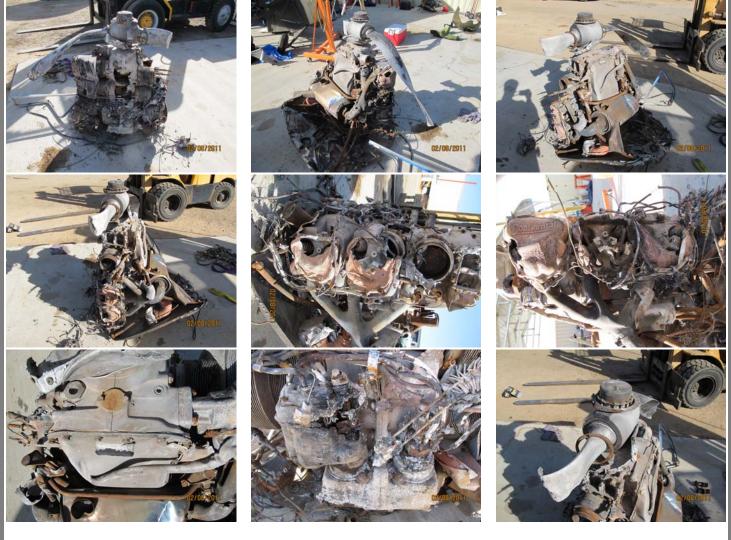
The engine inspection took place at Aircraft Recovery Services in Pearblossom, California on 09-08-2011. The engine separated from the main wreckage and remained attached to the firewall. The engine mount legs had impact damage and the engine mount assembly was cut away to facilitate the removal of the firewall. The propeller assembly had impact and thermal damage and remained attached to the engine. The engine had varying degrees of thermal damage. The top of the crankcase had thermal damaged and large openings revealed the crankcase interior components. The interior components were dry of oil and corroded. The cylinders had thermal damage to all cylinder heads. A small amount of the number 5 cylinder head remained attached to the cylinder barrel. The number 5 valve assemblies were found in the firewall area during the inspection. The number 3 and 5 pistons were visible through the thermally damaged heads. Several cylinder deck stud nuts and through-bolt nuts were missing or loose. The magnetos had thermal damage and the majority of the right magneto was missing. The exhaust assembly remained attached to the engine and had impact damage. The induction assembly from the risers to the carburetor was missing. The carburetor throttle valve and linkage remained intact to its control cable. The oil sump had thermal damage and large holes revealed the pickup tube mounting legs. The oil pickup screen was not visible. The oil pump cover could not be removed due to thermal deformation. The oil cap had thermal and impact damage and remained attached to the oil filler neck. The propeller governor remained attached to the engine and had thermal damage. The oil filter and adapter had thermal and impact damage and were not removed from the engine. The starter had impact and thermal damage. The starter adapter drive pulley had thermal damage and the alternator was missing. The inspection of the wreckage was under direct supervision of the NTSB investigator in charge.

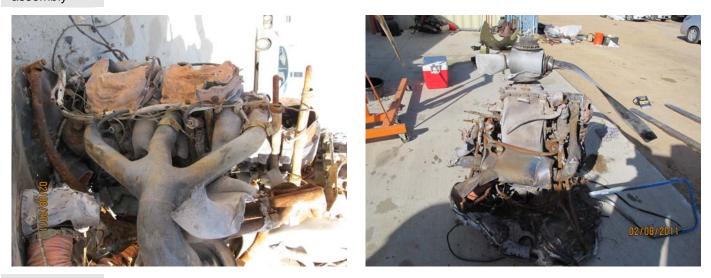
Exhaust assembly

Condition: The exhaust assembly remained attached to the engine and had impact damage.

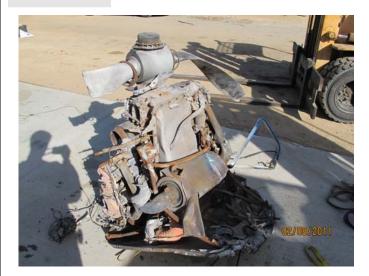
Induction assembly

Condition: The induction assembly had thermal damage and missing components. The carburetor throttle valve and linkage were found and remained attached to the control cable. The induction filter assembly was not found during the inspection.

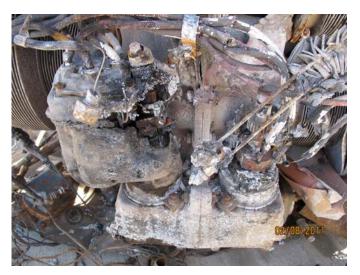
Condition: The magnetos remained attached to the engine and had extensive thermal damage. The magnetos were not removed during the inspection.

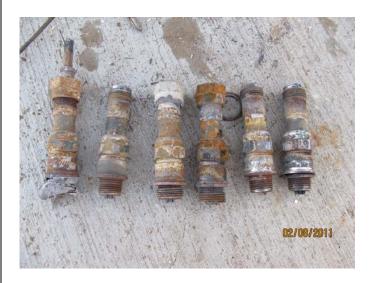
Spark Plugs Manufacturer: Champion Part No.: RHM-40E

Condition: The upper positioned spark plugs were removed from the engine prior to the inspection. The electrodes were undamaged and the electrode areas had melted aluminum and foreign deposits.

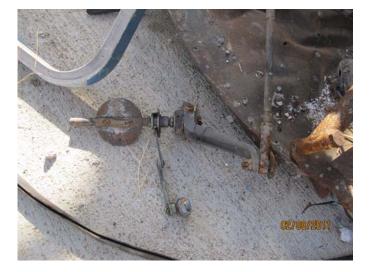
Condition: The carburetor throttle valve and linkage remained intact to its control cable. The carburetor was not found during the inspection.

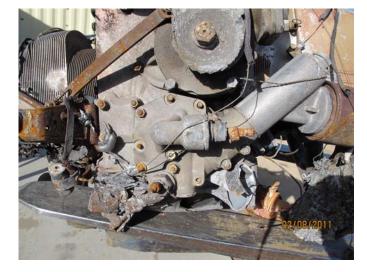
Oil Pump

The oil pump cover could not be removed from the engine.

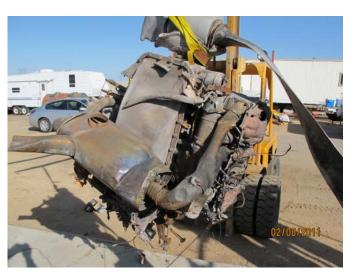
Oil Sump

Condition: The oil sump had thermal damage and large holes revealed the pickup tube mounting legs. The oil pickup screen was not visible.

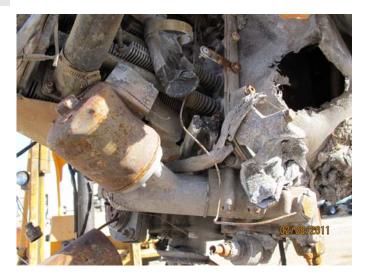
#### Oil Filter

The oil filter and adapter had thermal discoloration and impact damage. The oil filter was not removed during the inspection.

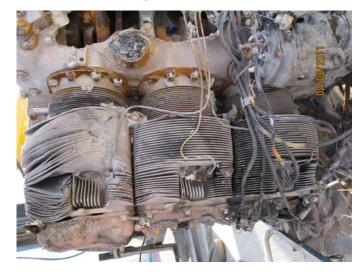
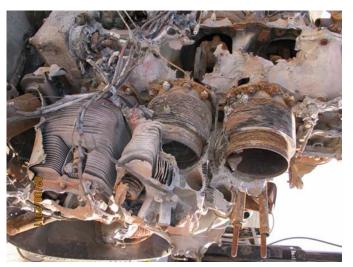
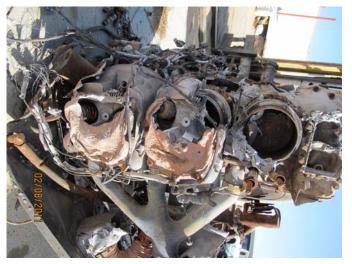
Condition: The cylinders had thermal damage to all cylinder heads. A small amount of the number 5 cylinder head remained attached to the cylinder barrel. The number 5 valve assemblies were found in the firewall area during the inspection. The number 3 and 5 pistons were visible through the thermally damaged heads. Several cylinder deck stud nuts and through-bolt nuts were missing or loose.

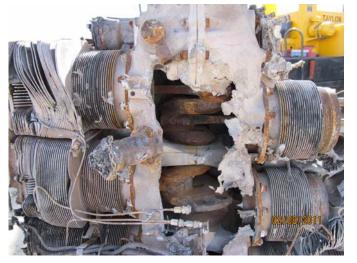
Condition: The top of the crankcase had thermal damaged and large openings revealed the crankcase interior components.

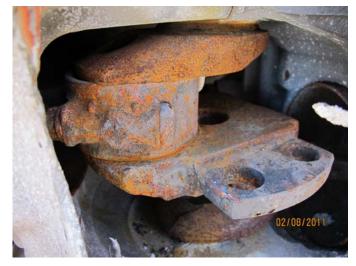
Condition: The crankshaft was visible through the crankcase damage. The crankshaft was dry of oil and had corrosion deposits covering its surface. No mechanical damage was noted.

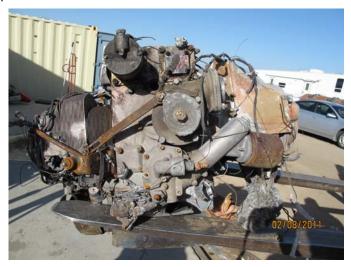
- Starter Manufacturer: Unknown
- Condition: The starter motor separated from the starter mounting flange. The mounting flange remained attached to the starter adapter.

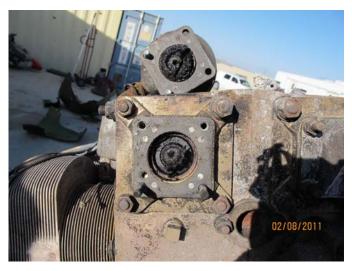
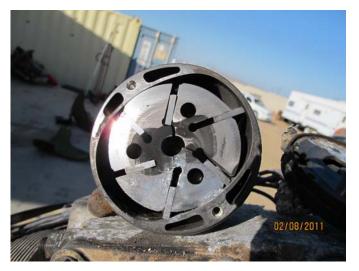
Condition: The vacuum pump was removed from the engine and the drive coupler had thermal damage. The vacuum pump was disassembled and the rotor was cracked in several sections.

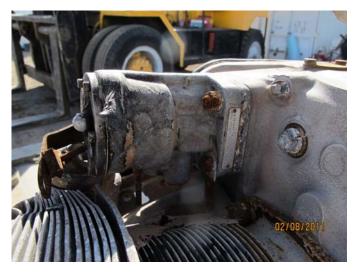
Condition: The propeller governor remained attached to the engine and had thermal damage.

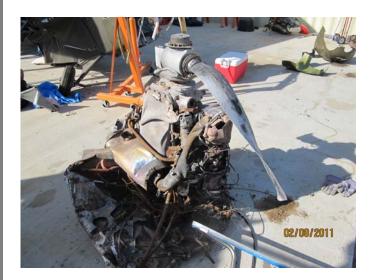
Condition: The propeller assembly remained attached to the engine. The propeller hub was undamaged and portions of the spinner remained attached to the aft side of the hub. Blade A was loose in the hub and had missing material from the mid-section to the tip. The remaining blade material had thermal deformation. Blade B was bent aft near the shank and had a decreased pitch twist from the mid-section to the tip. The cambered face had chord-wise scratches and gouging.
