Continental Motors

ENGINE RUN REPORT

ENGINE MODEL	TSIO550K1B
ENGINE SERIAL NUMBER	1010829
AIRCRAFT MAKE & MODEL	Cirrus SR22T
AIRCRAFT SERIAL NUMBER	0884
AIRCRAFT REGISTRATION	N227RR
FILE NUMBER	14-310

EXAMINATION		ACCIDENT DATA	
DATE	05/19/2015	NTSB ACCIDENT #	ERA15LA062
FACILITY	Continental Motors Inc.	NTSB INVESTIGATOR	Shawn Etcher
ADDRESS	[REDACTED] Mobile, AL [REDACTED]	FAA INVESTIGATOR	Not reported
		ACCIDENT DATE	November 28, 2014
		ACCIDENT LOCATION	Hampton, SC.

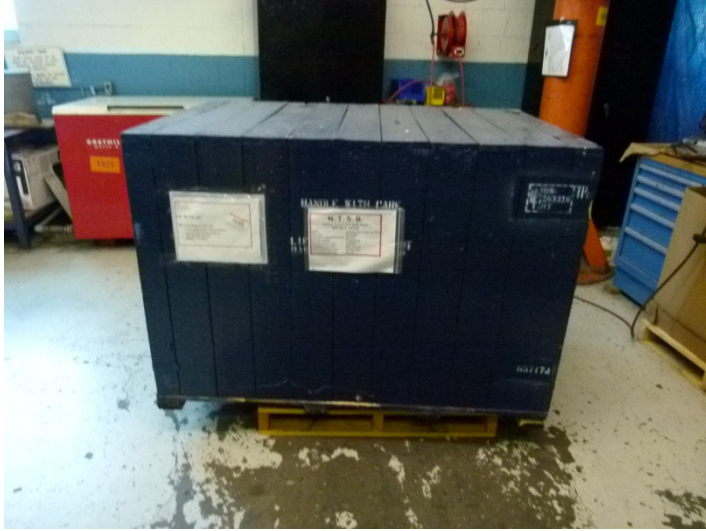
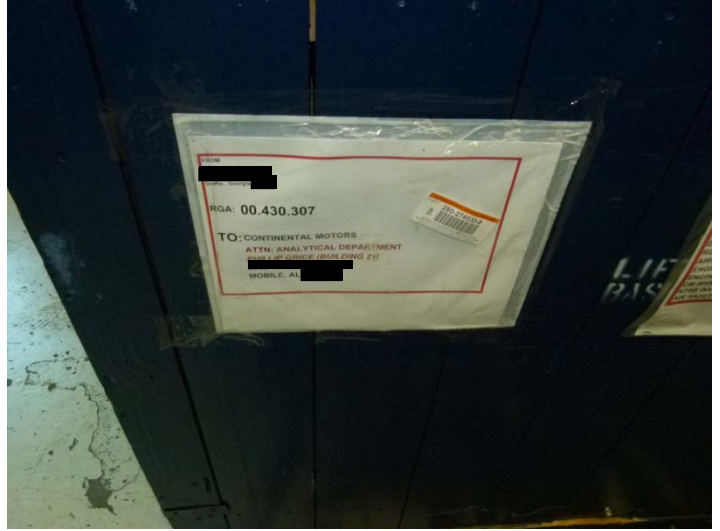
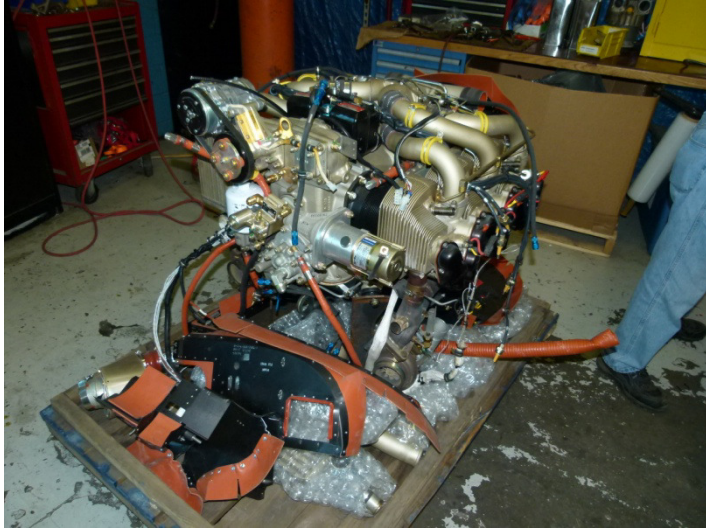
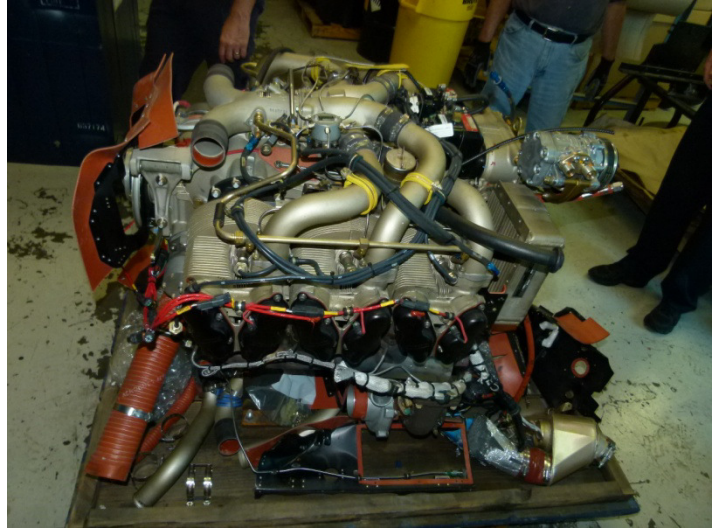
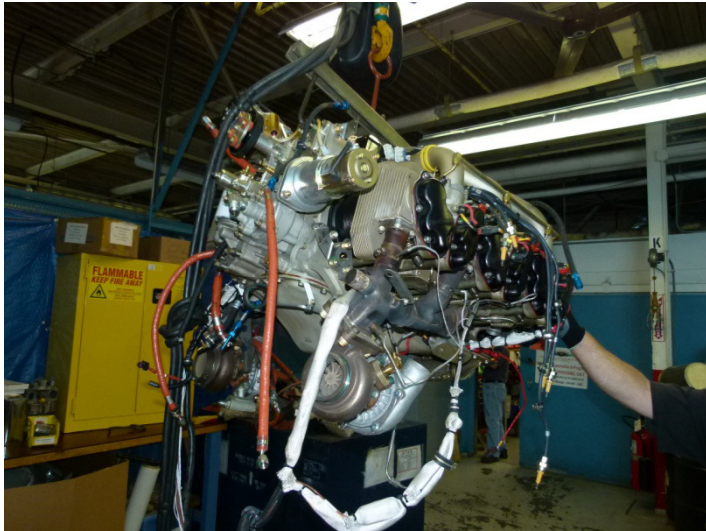
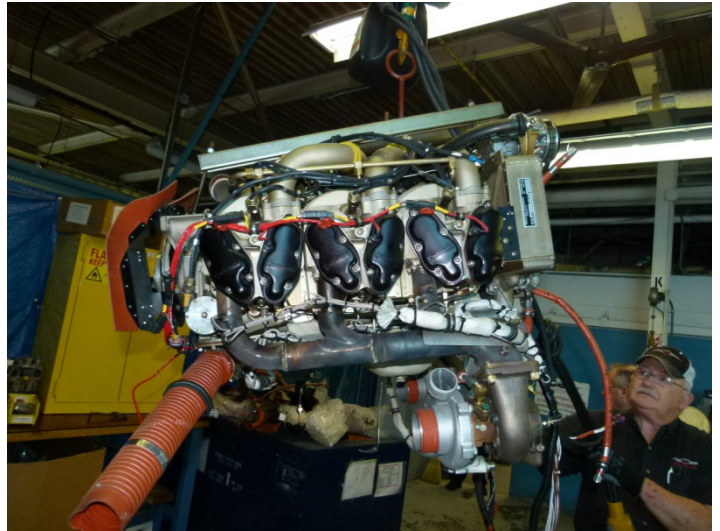
The engine arrived in a crate provided by Continental Motors; after unboxing the engine it was noted that several of the components were removed from the engine by the salvage yard employees. The right sides exhaust risers sustained damage consistent with impact damage to the #5 cylinder exhaust riser. The right intake tube going from the throttle body to the intercooler sustained damage consistent with impact damage. The fuel pump sustained damage consistent with impact damage; the aneroid adjustment screw was slightly bent. According to the investigator that examined the engine at the salvage yard the NTSB requested for the oil pump cover to be removed to examine the oil pump gears; it was determined that it would be necessary to remove the oil pump cover and restring the oil pump with silk thread. There were no anomalies noted with the external inspection of the engine.

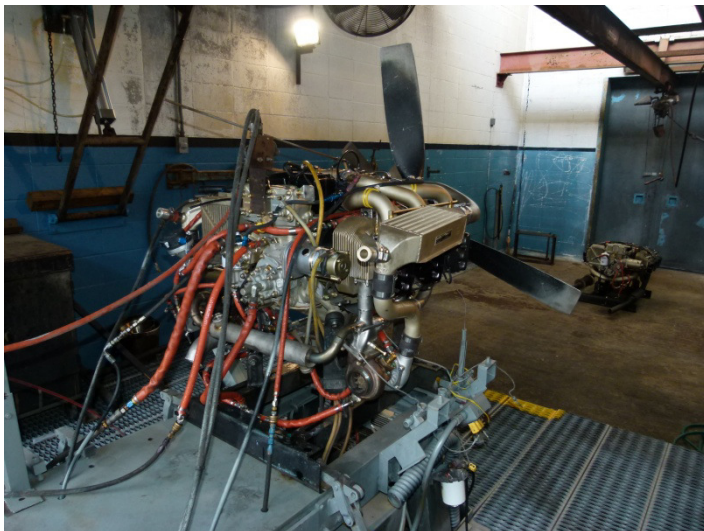
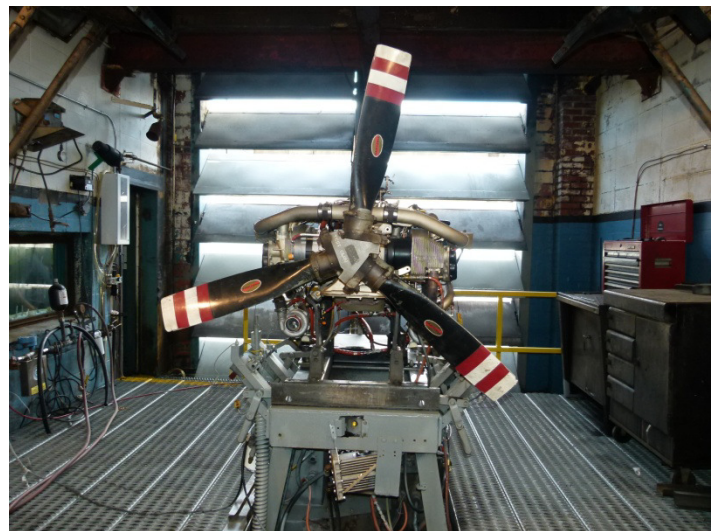
The engine was then prepared for operation by installing the appropriate thermocouples, pressure lines and test pads for monitoring purposes. The engine was then moved to CMI test cell number 43 and mounted for operation. The engine was fitted with a test club propeller for the TSIO-550-K engine model.

The engine started on the first attempt without hesitation. The engine RPM was brought to 1000 RPM to warm up the engine to normal operating temperatures; after engine start the oil pressure was noted to be within the normal operating range. The engine was run at 1200 for approximately five minutes to stabilize. The engine throttle was advanced to 1600 RPM and held for approximately five minutes to stabilize. The engine throttle was advanced to 2100 RPM and held for approximately five minutes to stabilize. The engine throttle was advanced to 2450 RPM and held for approximately five minutes to stabilize. The engine throttle was advanced to the full open position and held for approximately five minutes to stabilize. The engine throttle was brought down to idle for approximately five minutes to stabilize.

Throughout the test phase the engine operated normally and there were no anomalies noted that would have prevented normal operation or production of rated horsepower. After the engine oil was warmed to operating temperature the oil pressure stabilized and there were no abnormal changes in oil pressure during engine operation. There were no anomalies noted with the oil pressure during the engine run.
