Engine Analysis Report

Accident #:		ERA10FA404		Analytical Date:		April 27, 2011	
Accident Location:		Saltsburg, PA		RGA:		AS00.127.702	
Engine Model:		IO-550-C		Engine Serial #:		815289	
Engine:	<input checked="" type="checkbox"/>	Component:		New:		Rebuilt:	<input checked="" type="checkbox"/>
						Overhaul:	
Date:		09/15/1998					
Aircraft Make/Model:		Beech 58		Aircraft S/N:		TH-1328	
Reg. #:		N28MR					
Engine Position:		Single:		Left:		<input checked="" type="checkbox"/>	
				Right:			
Front:				Rear:			
Engine Build Date:		09/15/98		Date in Service:		N/R	
Date Removed:		N/R					
Date of Accident:		August 7, 2010		Engine/Component Hours:		N/R	
Inspection Performed By:		Terry L Horton		Search Code:		15-12-68

ENGINE EXAMINATION REPORT

AIRCRAFT MODEL: Beech 58 Baron

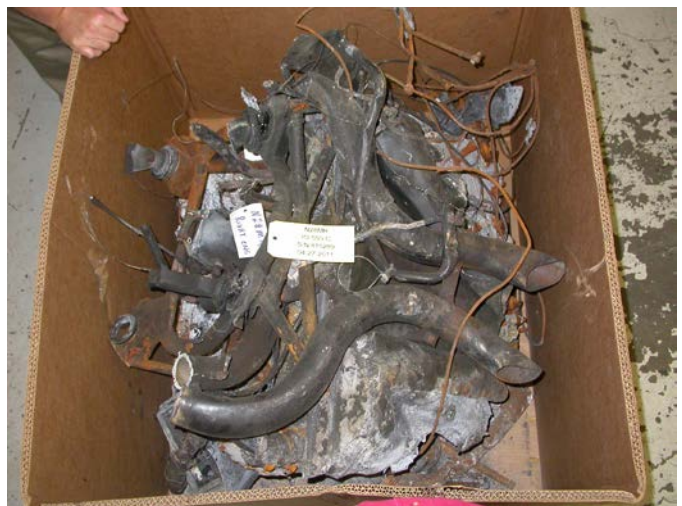
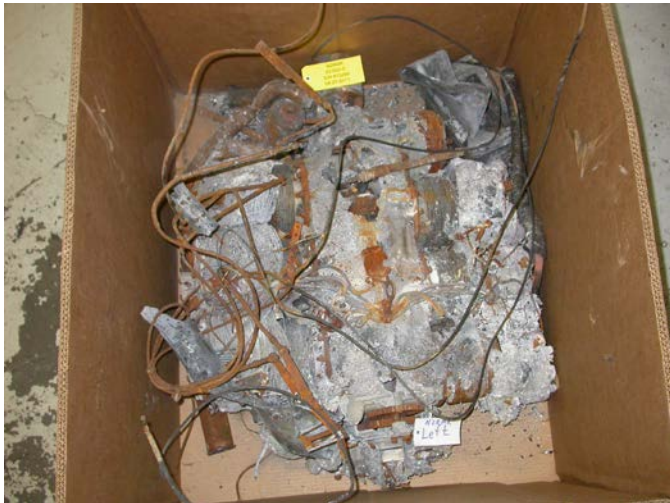
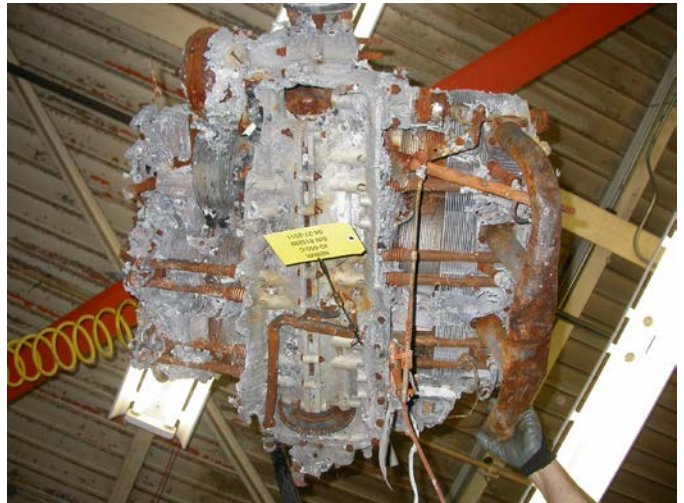
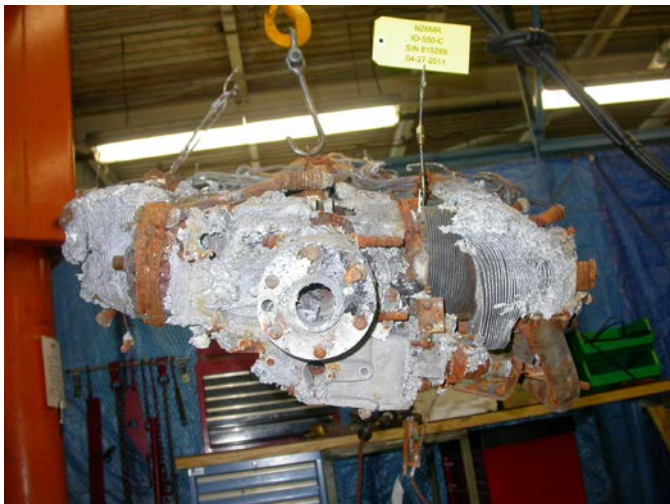
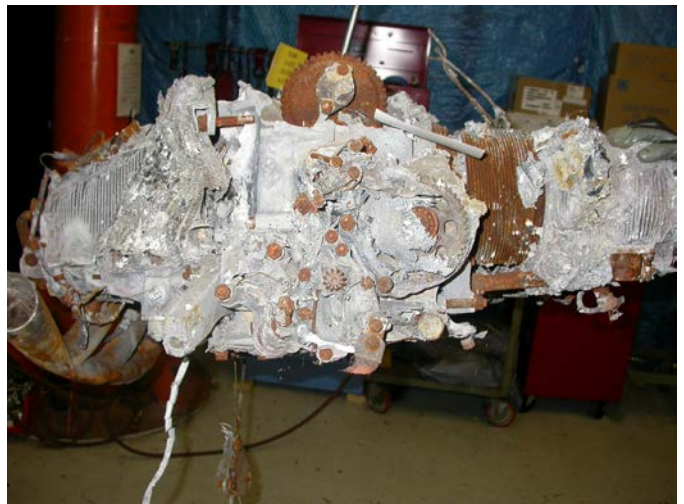
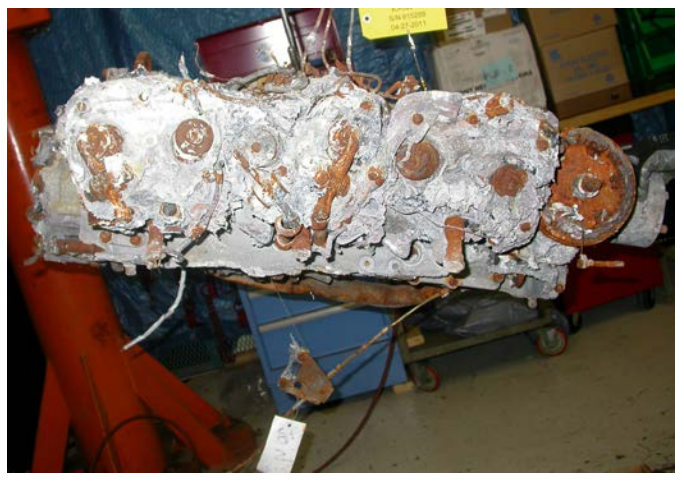
Analytical Report: The engine exhibited thermal deterioration and extensive corrosion, prohibiting separation of the assembly utilizing normal methods. Therefore, access to the internal components had to be gained by mechanical means to verify the continuity of the camshaft, pistons, crankshaft and their components. The camshaft, pistons, crankshaft and their components were intact and had exhibited no separation or fractures. The throttle and control assembly S/N 815290 (believed to be a component of the right-hand engine) was received with the engine.

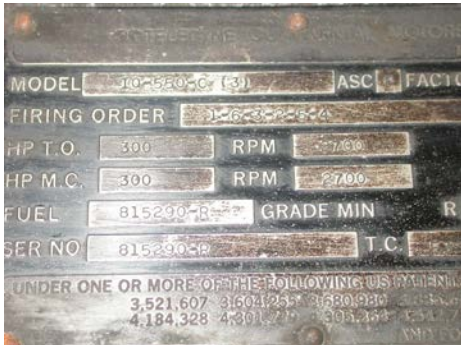
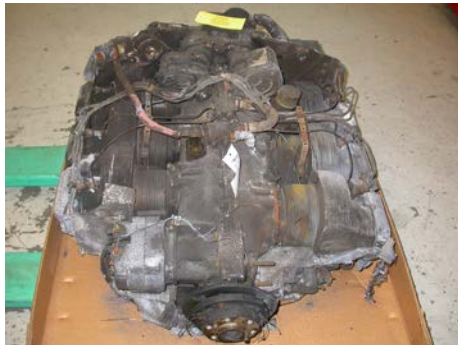
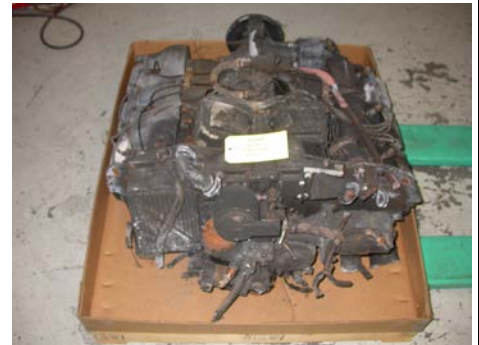
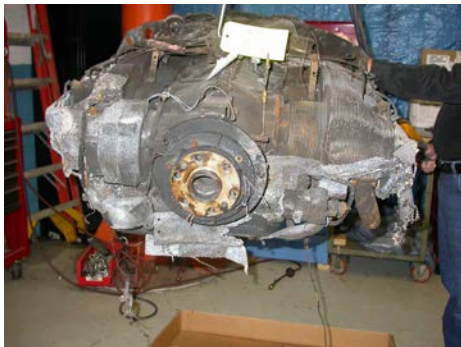
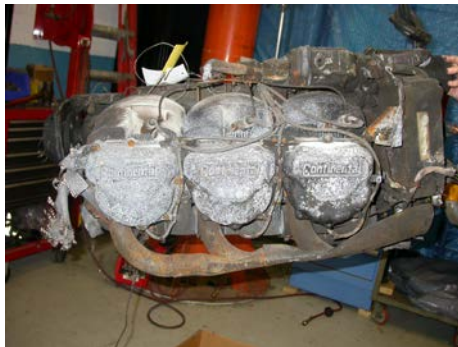
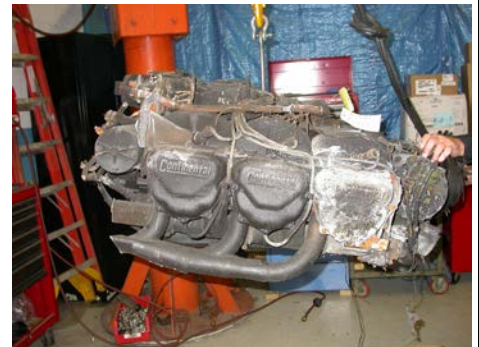
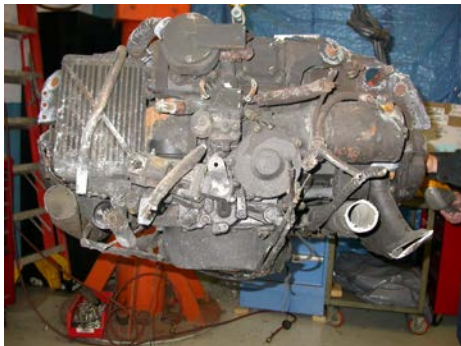
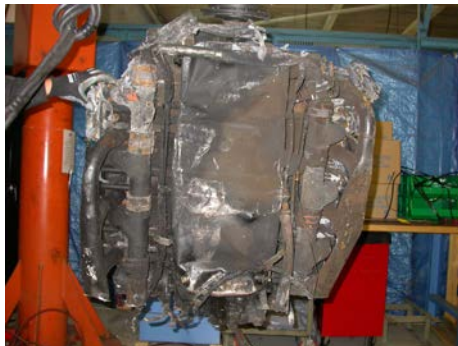
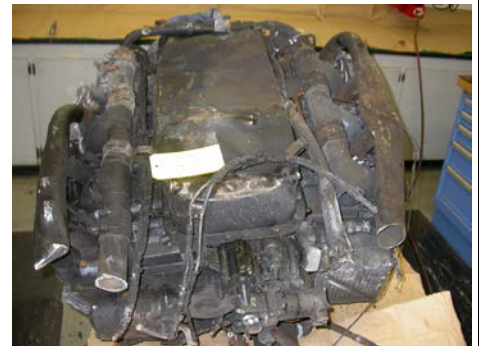
EXTERNAL INSPECTION OF ENGINE: The engine exhibited impact damage and extensive thermal discoloration and damage. Impact damage was concentrated at the bottom area of the engine assembly.

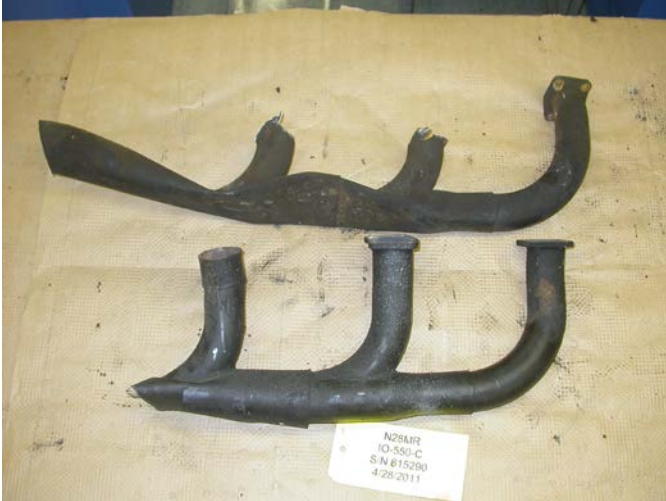
Exhaust System

Condition: The exhaust system components exhibited impact damage and had been cut to allow engine and system removal.

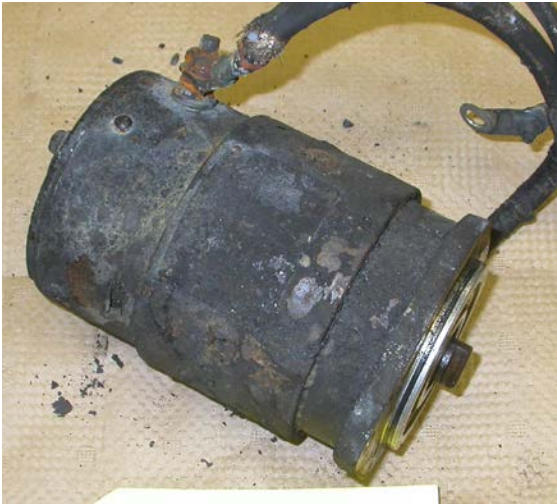
Starter

Condition: The starter could not be rotated by hand and exhibited thermal damage.

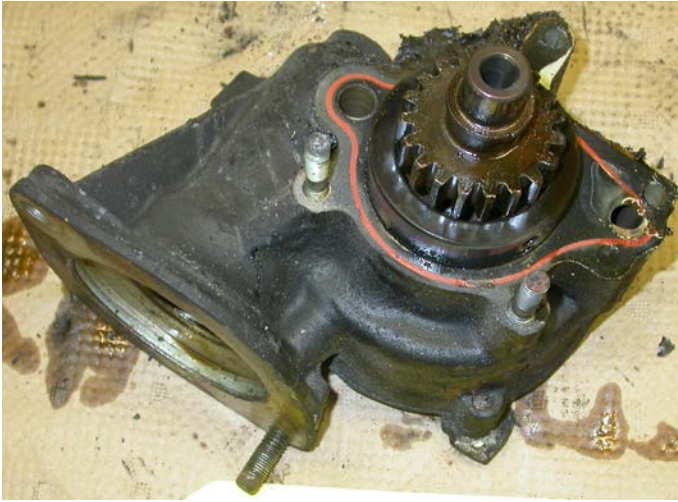
Starter Adapter Part Number: Illegible.

Condition: The starter rotated by hand and was intact and undamaged.

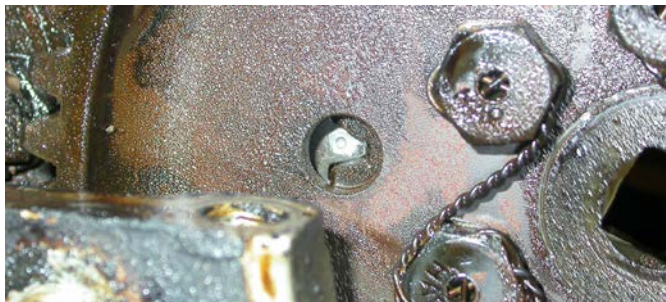
Crankshaft to Camshaft Timing

The crankshaft to camshaft timing was verified by the alignment of the gear's timing marks.

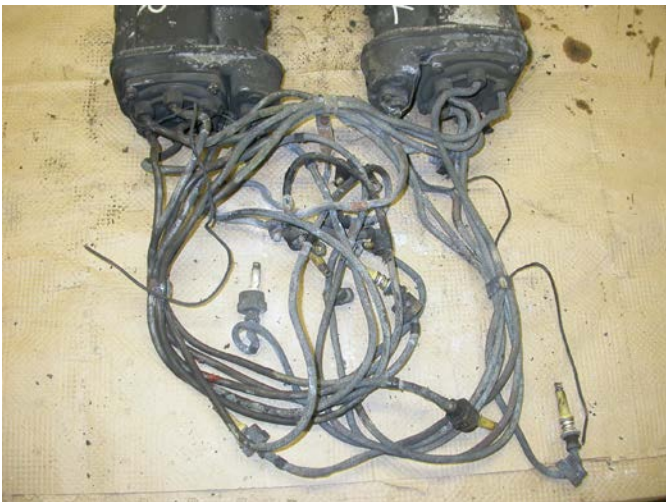
Ignition Harness Manufacturer: TCM

Condition: All leads exhibited thermal damage.

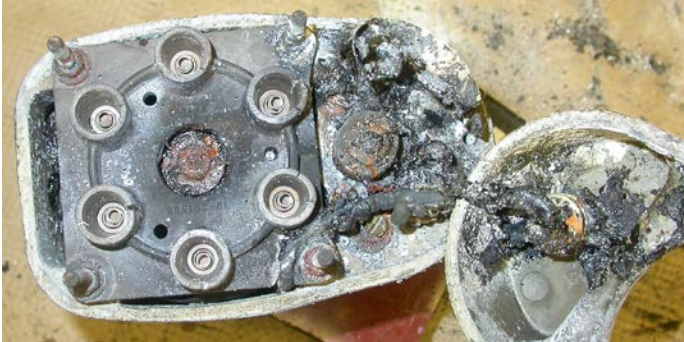
L/H Magneto

Condition: The left-hand magneto could not be turned freely by hand. The impulse coupling was intact. The magneto was disassembled and found to exhibit significant thermal damage.

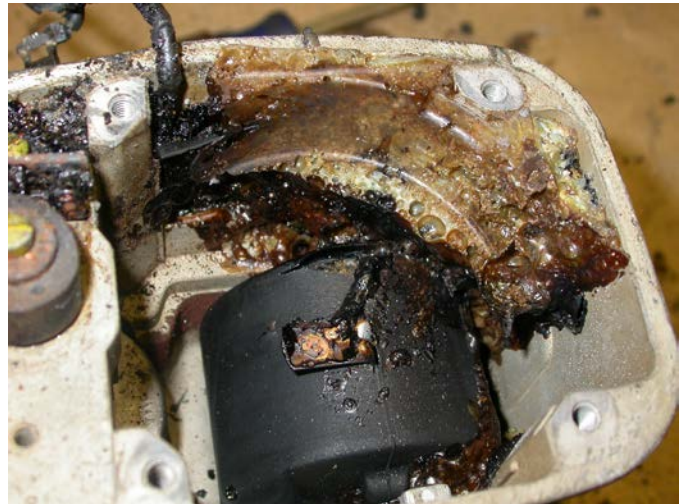
R/H Magneto

Condition: The right-hand magneto turned freely with impulse coupling engagement. The impulse coupling was intact. The magneto was disassembled and found to exhibit significant thermal damage.

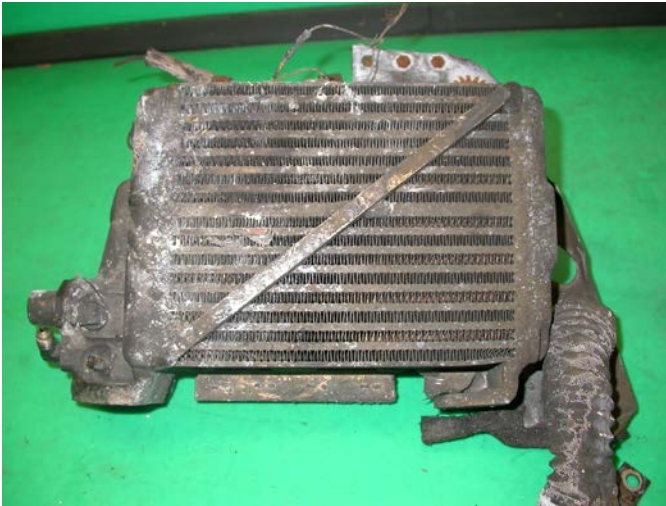
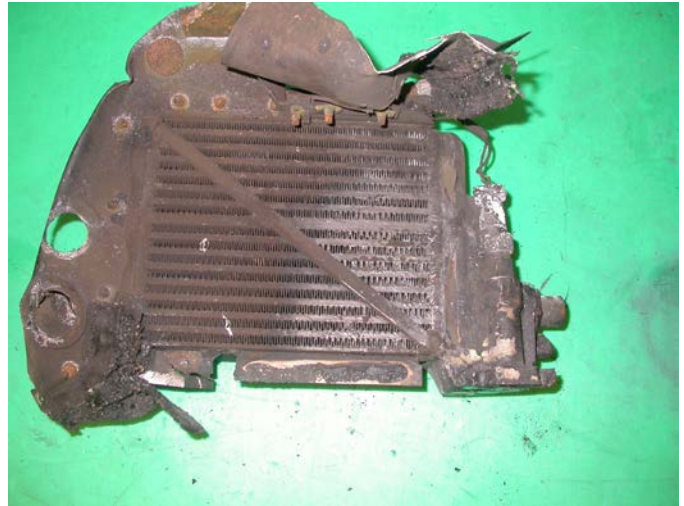
Oil Cooler

Condition: The oil cooler thermal discoloration and impact damage.

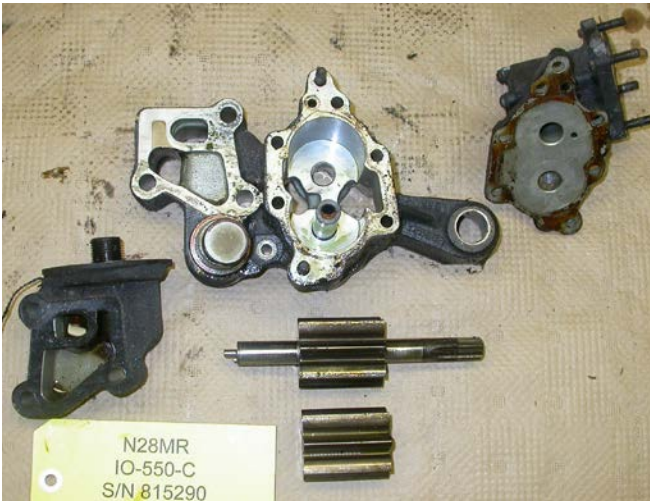
Oil Pump

Condition: The oil pump drive was intact and the exterior exhibited thermal discoloration. The oil pump cavity contained light scratches and exhibited normal operating signatures. The oil pump gear teeth exhibited normal operating signatures. The oil pressure relief valve and seat contained no obstructions and exhibited signatures of proper seating.

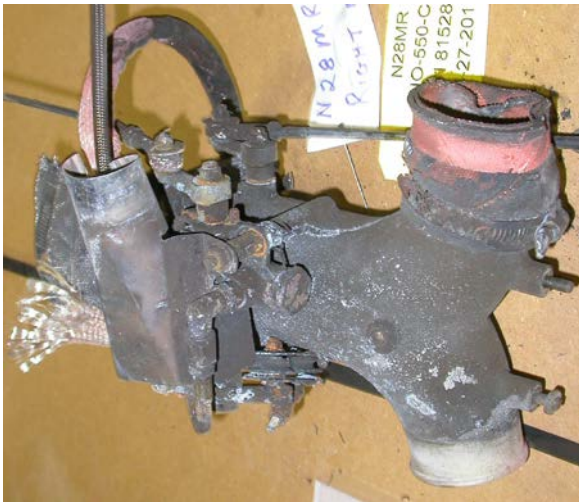
Condition: The throttle and control assembly was not returned with the engine. TCM engine build records indicate that the throttle and metering assembly (S/N H319809AR) received with the left-hand engine shipment (S/N 815289) was originally supplied with this engine. The following photographs were taken from the file created during the examination of the left-hand engine. The throttle and metering assembly (S/N H319809AR) exhibited thermal discoloration and damage. The linkage was intact and secure. The finger screen was intact and unrestricted.

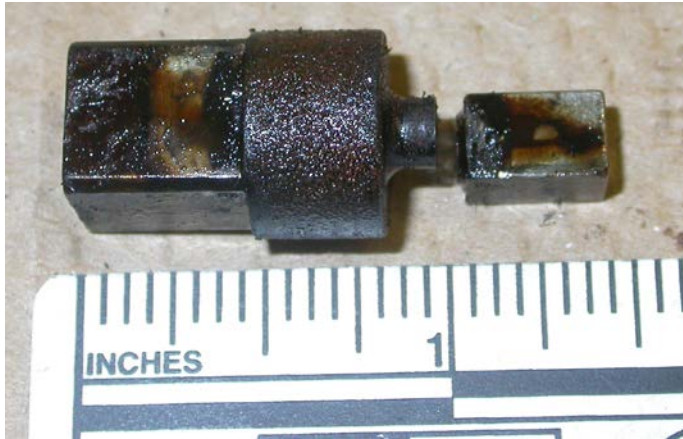
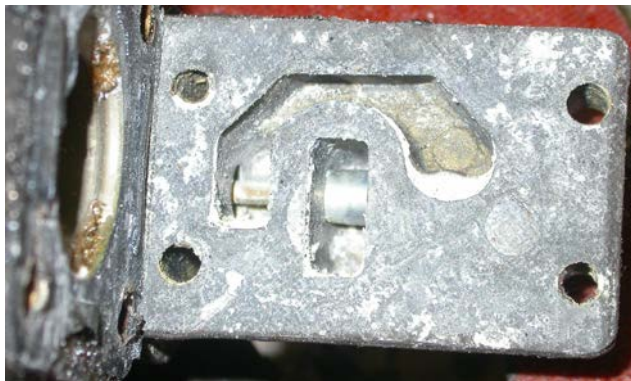
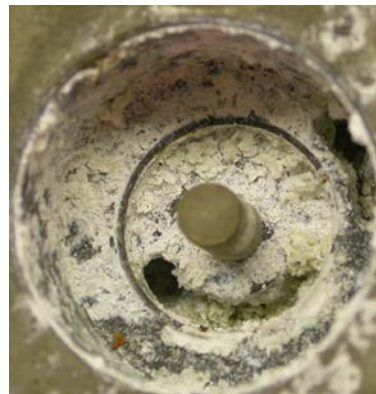
Fuel Pump

Condition: The fuel pump could not be turned freely and exhibited thermal damage. The fuel pump drive was fracture in two pieces. The fuel pump was disassembled and exhibited extensive thermal damage and corrosion. The fuel pump and drive coupling were shipped to the NTSB Laboratory for further examination.

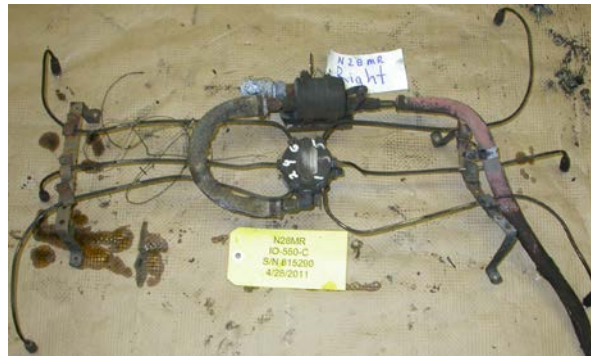
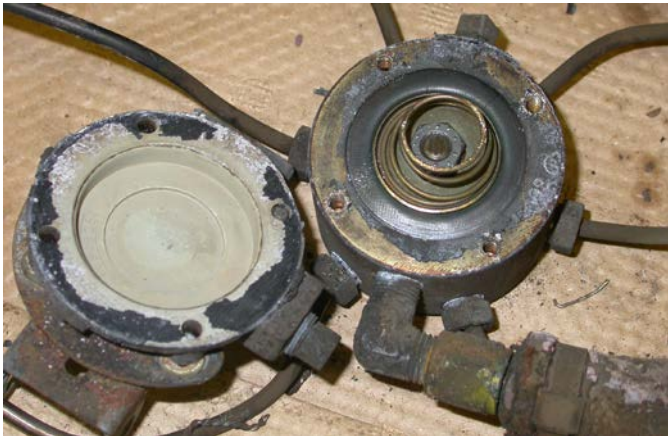
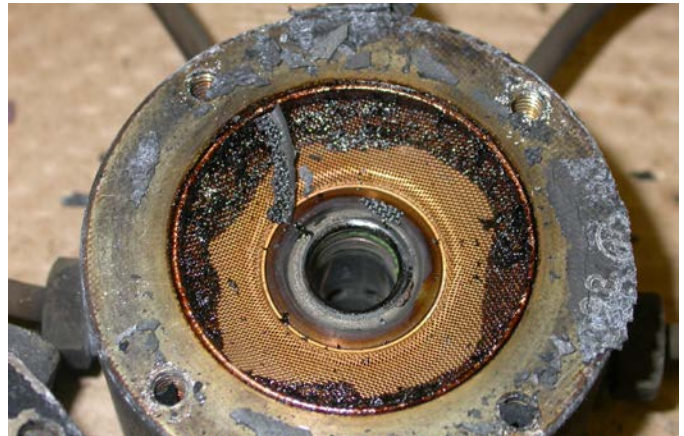
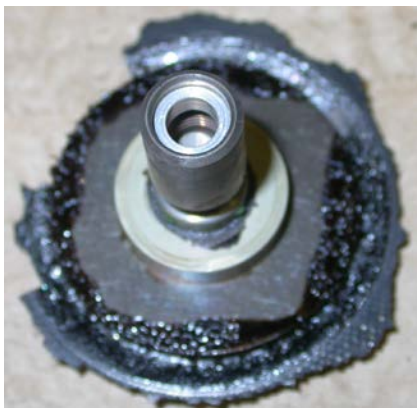
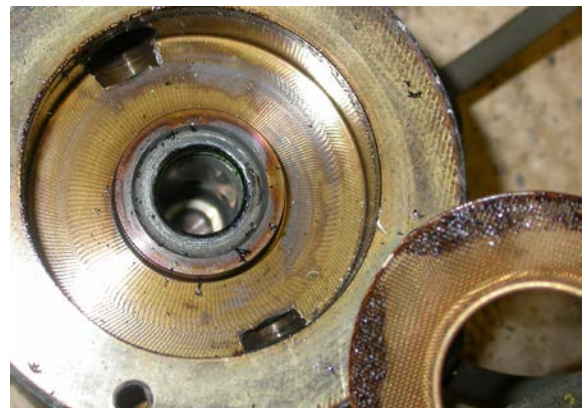
Condition: The fuel manifold valve exhibited thermal discoloration and damage. The manifold valve was disassembled to examine the internal components. The diaphragm was thermally destroyed. The manifold valve plunger assembly was intact and secure. There were no signatures of fuel stains or leakage in the vent chamber side of the diaphragm.

Condition: The fuel nozzles were unrestricted and exhibited thermal discoloration. The fuel lines were intact and exhibited thermal discoloration.

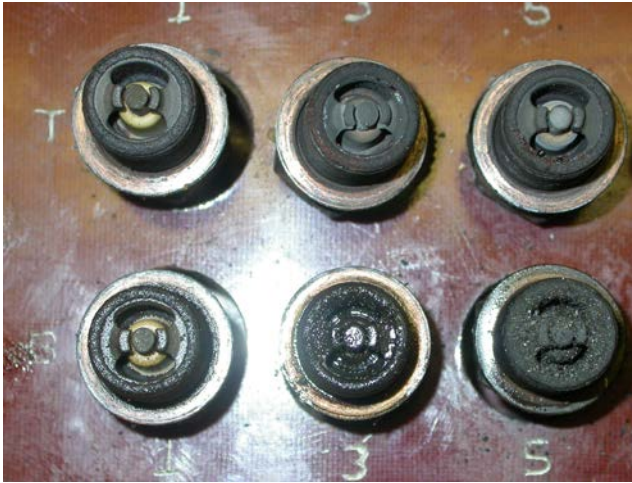
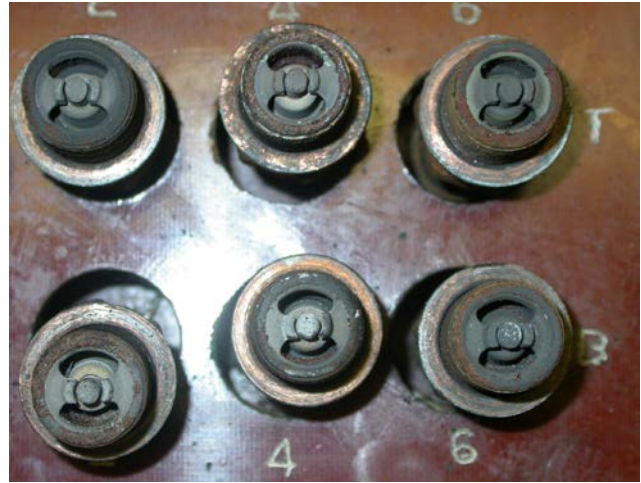
Spark Plugs

Condition: The top and bottom sparkplugs had normal wear signatures in accordance with the Champion Aviation check-a-plug comparison chart.

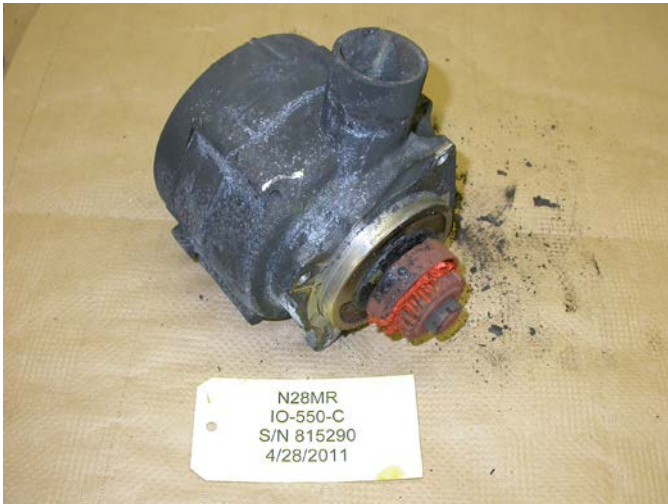
Alternator

Condition: The alternator would not turn through freely and exhibited thermal damage. The drive coupling was intact and corroded. The elastomer was displaced and deteriorated.

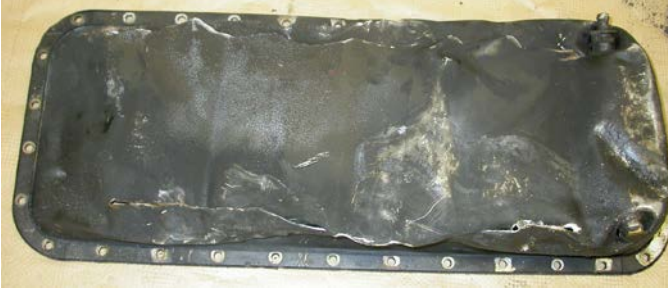
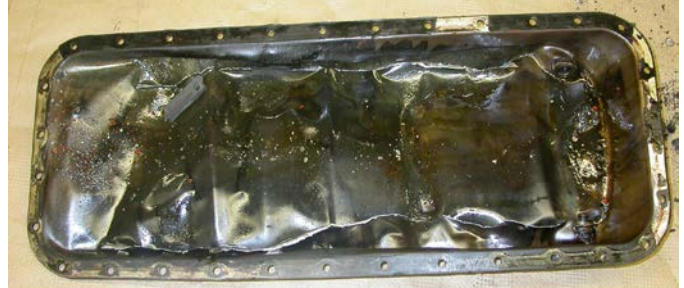
Oil Sump

Condition: The oil sump drain plugs were safetied. The oil sump was crushed and had to be mechanically deformed to allow access to the attaching hardware for removal. The oil sump contained only residual oil. Fragments of the alternator drive coupling elastomer were located in the sump and internal areas of the engine.

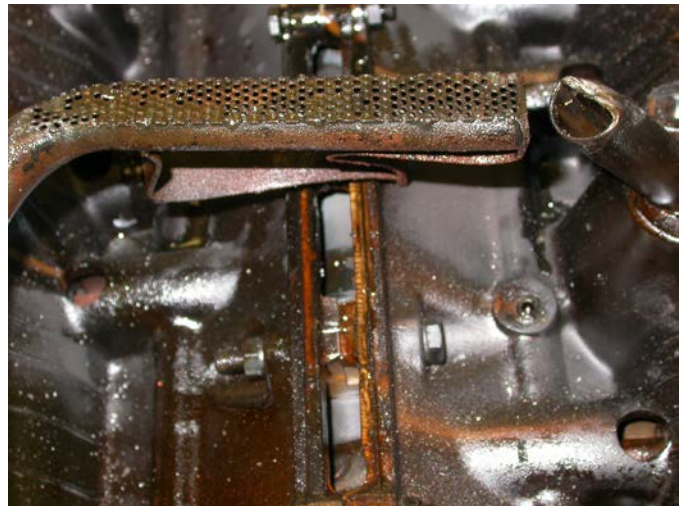
Oil Pick-up Tube & Screen

Condition: The oil pick-up tube was deformed from impact damage to the oil sump. The oil suction screen was unrestricted.

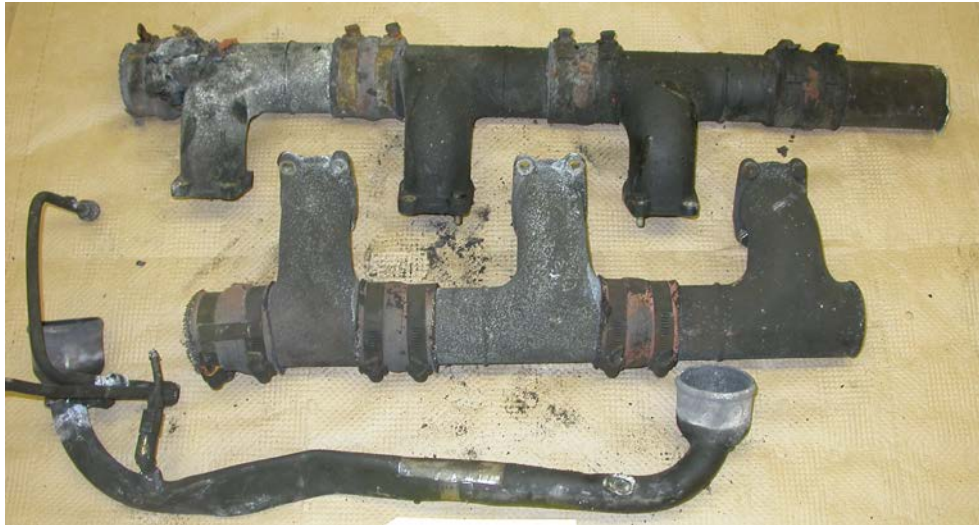
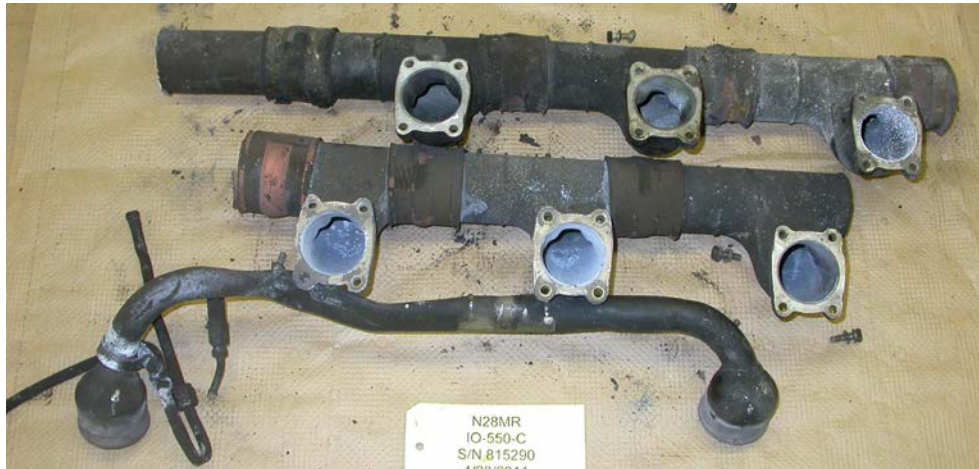
Induction System

Condition: The induction risers and balance tube were intact and exhibited thermal and impact damage.

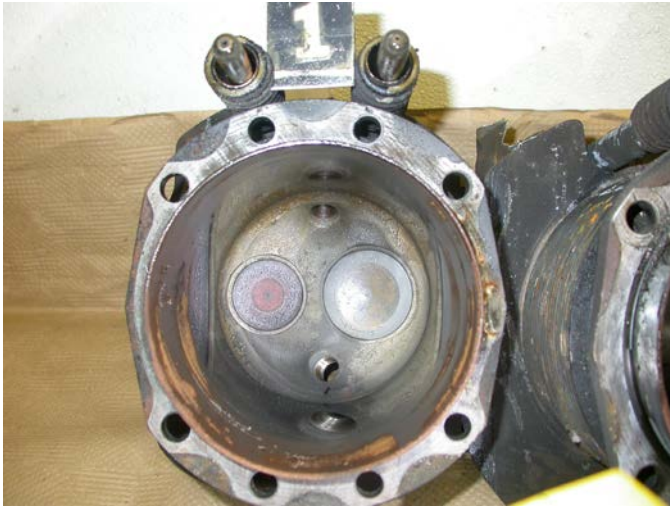
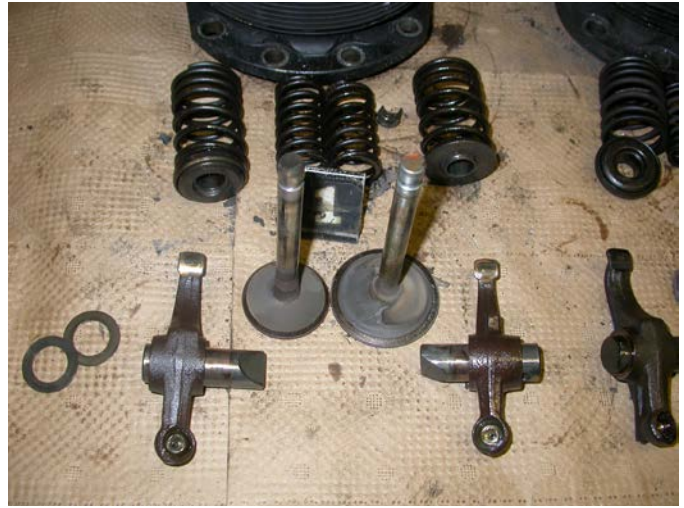
Cylinder #1 Part Number: 654961 Head Date: 9-98 Barrel Surface: Steel

Condition: The spot putty was not evident on the cylinder hold-down nuts. The cylinder combustion chamber had a normal amount of combustion deposits and the bore condition was free of scoring and corroded. The cylinder skirt was intact and undamaged and there were no hone marks visible in the cylinder bore ring travel area. The intake and exhaust valve heads exhibited normal deposits and operating signatures. The rocker box area had oil residue in the overhead. The cylinder overhead components (valves, rocker arms, guides, springs, retainers and shafts) were lubricated and undamaged.

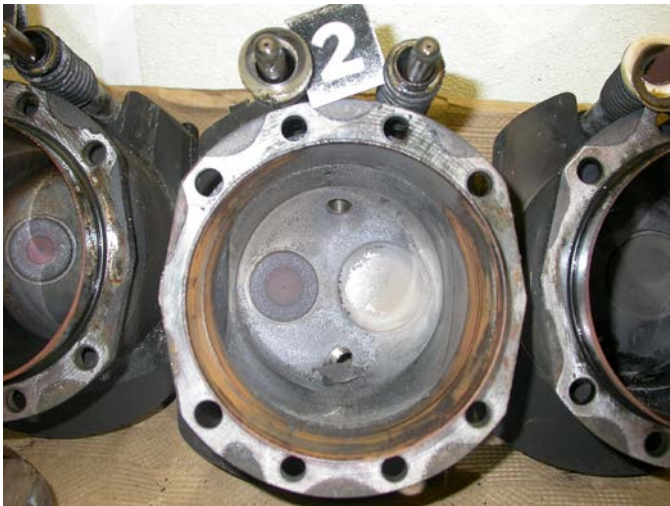
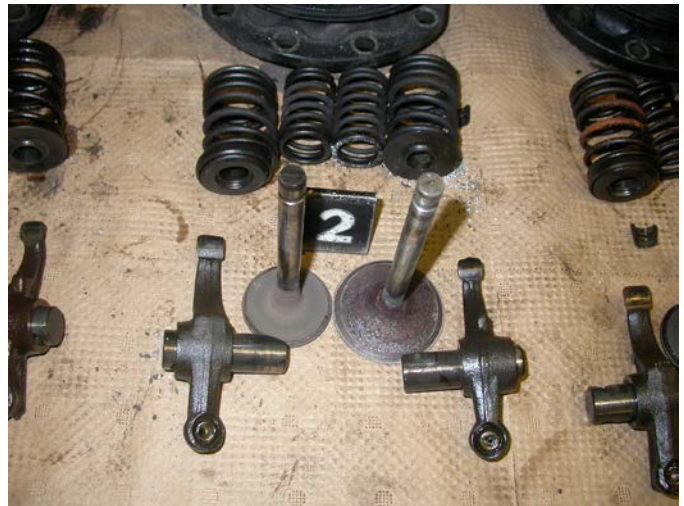
Cylinder #2 Part Number: 654961 Head Date: 9-98 Barrel Surface: Steel

Condition: The spot putty was not evident on the cylinder hold-down nuts. The cylinder combustion chamber had a normal amount of combustion deposits and the bore condition was free of scoring and corroded. The cylinder skirt was intact and undamaged and there were no hone marks visible in the cylinder bore ring travel area. The intake and exhaust valve heads exhibited normal deposits and operating signatures. The rocker box area had oil residue in the overhead. The cylinder overhead components (valves, rocker arms, guides, springs, retainers and shafts) were lubricated and undamaged.

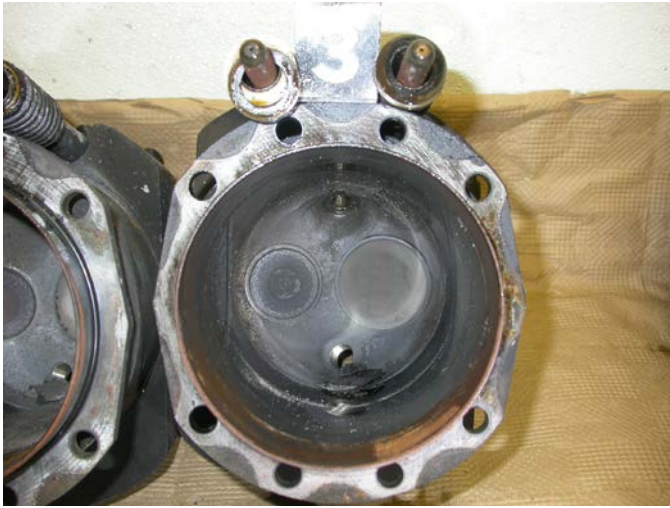
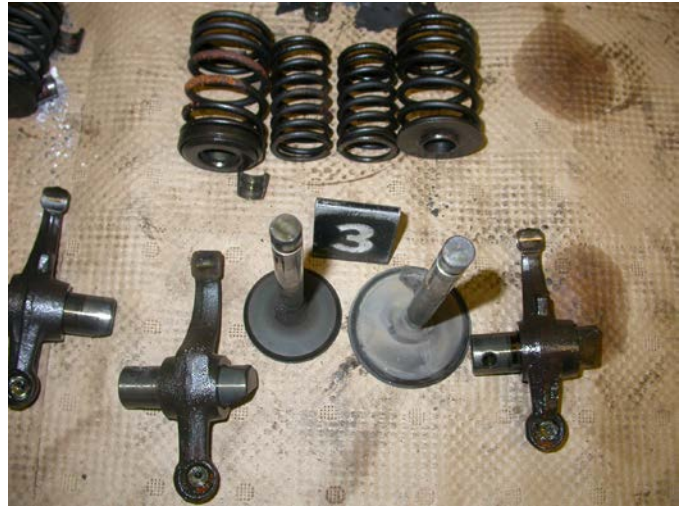
Cylinder #3 Part Number: 654961 Head Date: 9-98 Barrel Surface: Steel

Condition: The spot putty was not evident on the cylinder hold-down nuts. The cylinder combustion chamber had a normal amount of combustion deposits and the bore condition was free of scoring and corroded. The cylinder skirt was intact and undamaged and there were no hone marks visible in the cylinder bore ring travel area. The intake and exhaust valve heads exhibited normal deposits and operating signatures. The rocker box area had oil residue in the overhead. The cylinder overhead components (valves, rocker arms, guides, springs, retainers and shafts) were lubricated and undamaged.

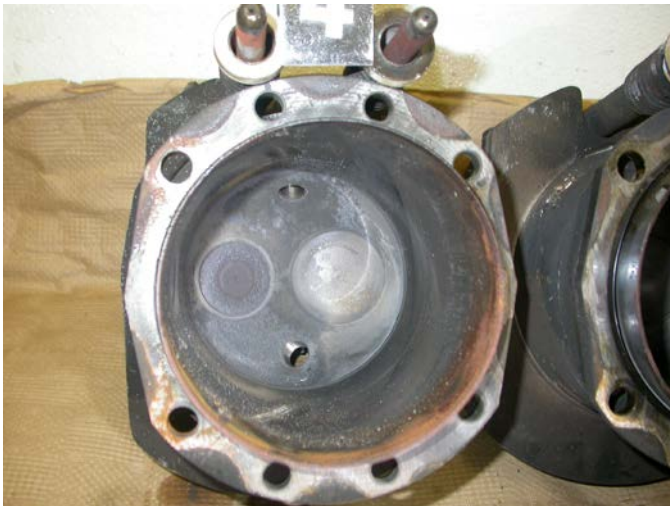
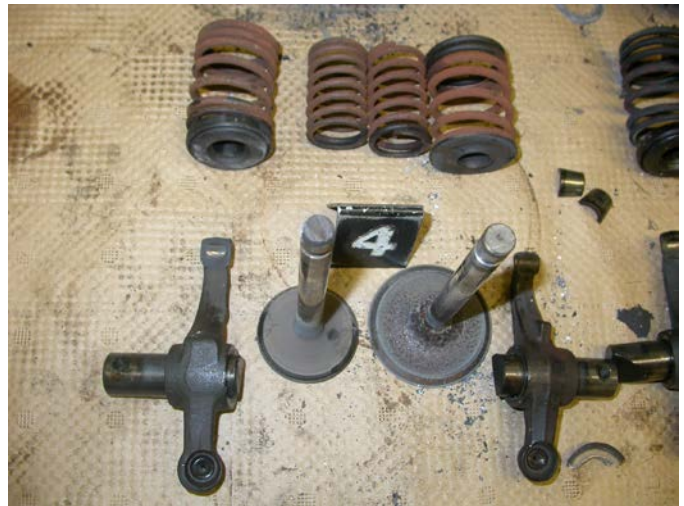
Cylinder #4 Part Number: 654961 Head Date: 9-98 Barrel Surface: Steel

Condition: The spot putty was not evident on the cylinder hold-down nuts. The cylinder combustion chamber had a normal amount of combustion deposits and the bore condition was free of scoring and corroded. The cylinder skirt was intact and undamaged and there were no hone marks visible in the cylinder bore ring travel area. The intake and exhaust valve heads exhibited normal deposits and operating signatures. The rocker box area had minimal oil residue. The cylinder overhead components (valves, rocker arms, guides, springs, retainers and shafts) were intact.

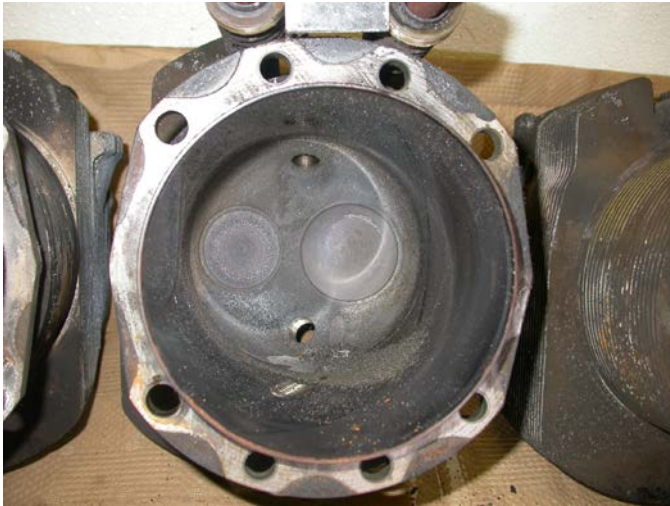
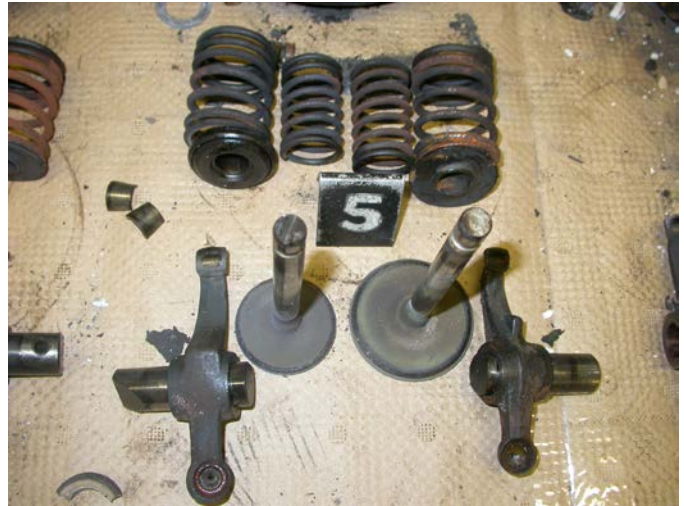
Cylinder #5 Part Number: 654961 Head Date: 9-98 Barrel Surface: Steel

Condition: The spot putty was not evident on the cylinder hold-down nuts. The cylinder combustion chamber had a normal amount of combustion deposits and the bore condition was free of scoring and undamaged. The cylinder skirt was intact and undamaged and there were no hone marks visible in the cylinder bore ring travel area. The intake and exhaust valve heads exhibited normal deposits and operating signatures. The rocker box area had minimal oil residue. The cylinder overhead components (valves, rocker arms, guides, springs, retainers and shafts) were intact.

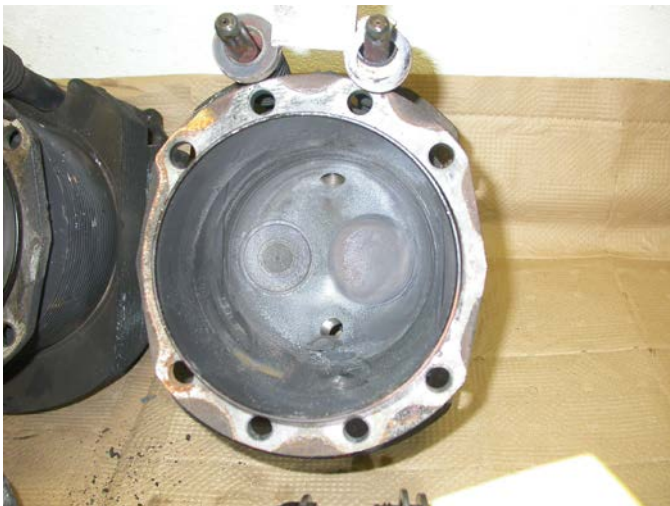
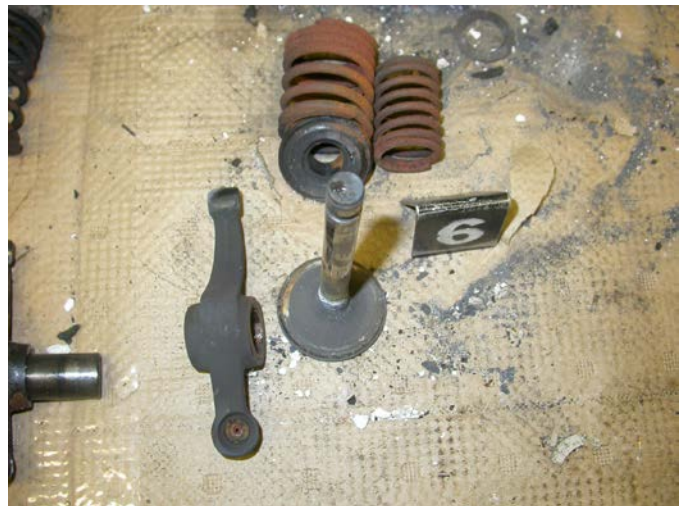
Cylinder #6 Part Number: 654961 Head Date: 9-98 Barrel Surface: Steel

Condition: The spot putty was not evident on the cylinder hold-down nuts. The cylinder combustion chamber had a normal amount of combustion deposits and the bore condition was free of scoring and undamaged. The cylinder skirt was intact and undamaged and there were no hone marks visible in the cylinder bore ring travel area. The intake and exhaust valve heads exhibited normal deposits and operating signatures. The rocker box area had no oil residue. The cylinder overhead components (valves, rocker arms, guides, springs, retainers and shafts) were intact. The intake valve was not removed due to the thermal damage and corrosion.

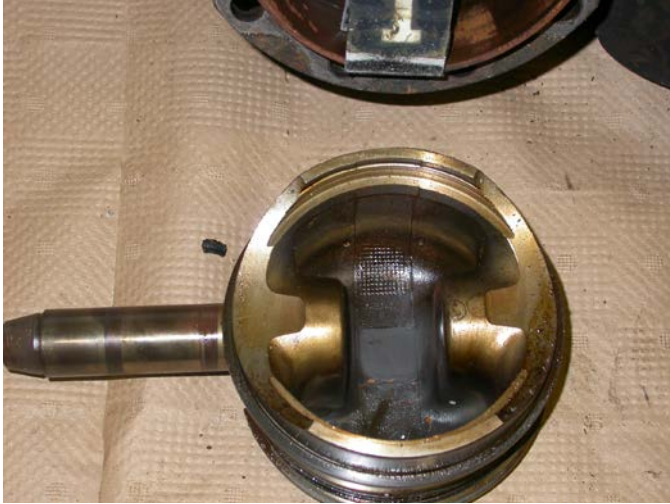
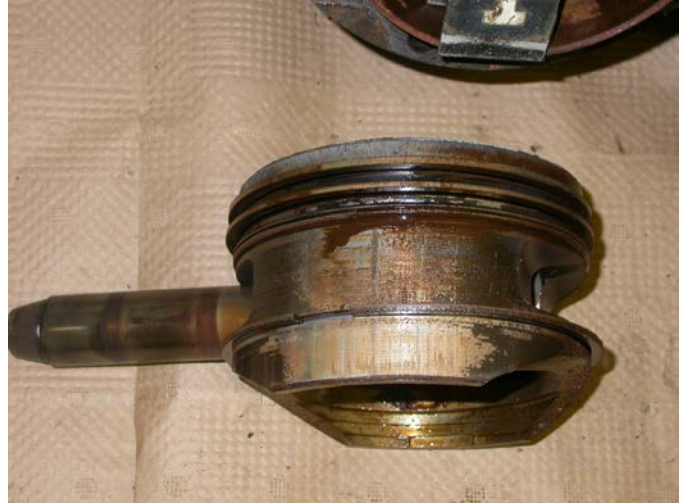
#1 Piston, Rings and Pin Piston Part Number: 648046

Condition: The piston head exhibited a minimal amount of combustion deposits and the piston skirt was free of scoring and damage. The piston rings were intact, free in their grooves, exhibited normal wear and operating signatures. The piston pin and plug assembly was intact and undamaged.

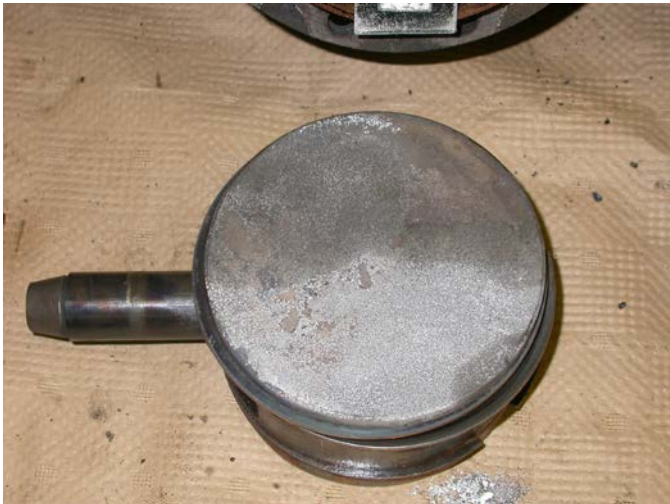
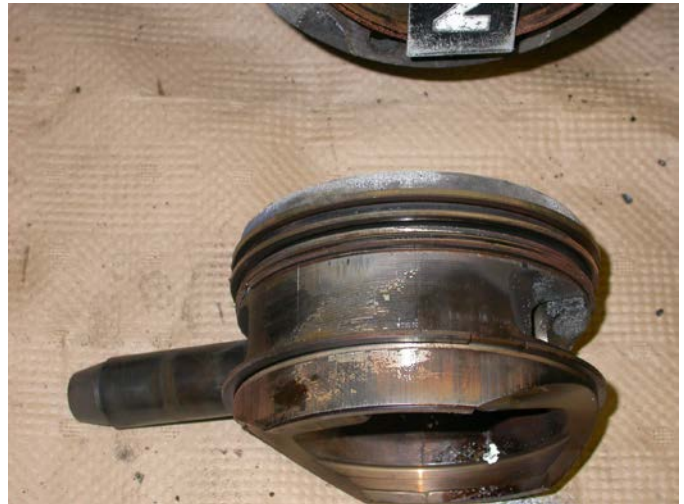
#2 Piston, Rings and Pin Piston Part Number: 648046

Condition: The piston head exhibited a minimal amount of combustion deposits and the piston skirt was free of scoring and damage. The piston rings were intact, free in their grooves, exhibited normal wear and operating signatures. The piston pin and plug assembly was intact and undamaged.

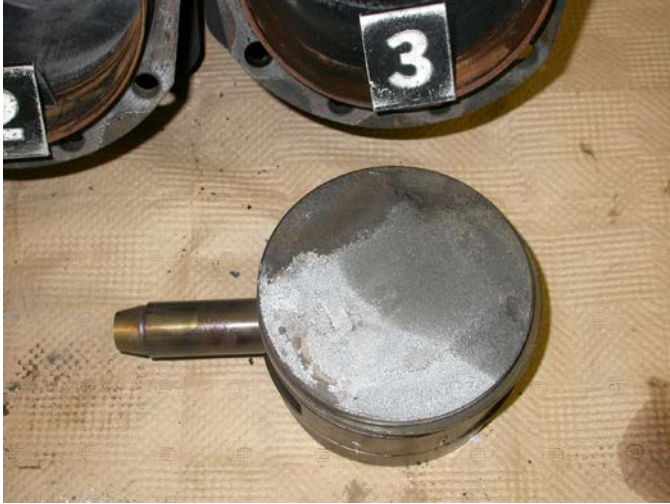
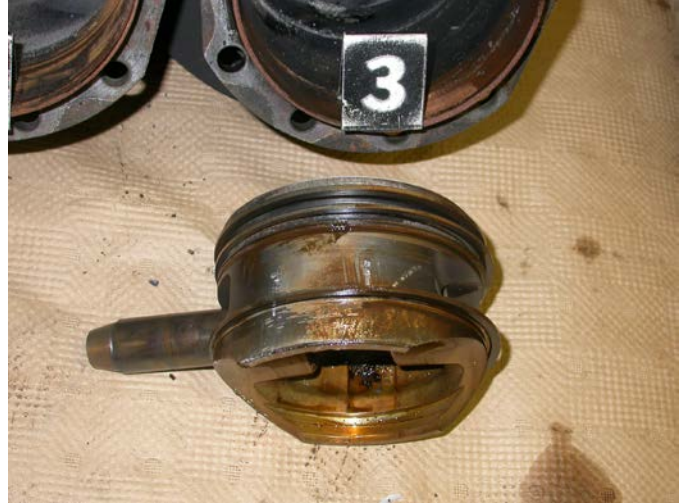
#3 Piston, Rings and Pin Piston Part Number: 648046

Condition: The piston head exhibited a minimal amount of combustion deposits and the piston skirt was free of scoring and damage. The piston rings were intact, free in their grooves, exhibited normal wear and operating signatures. The piston pin and plug assembly was intact and undamaged.

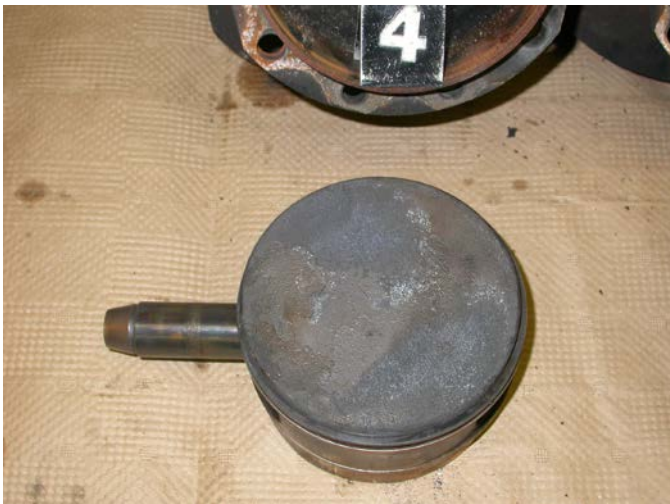
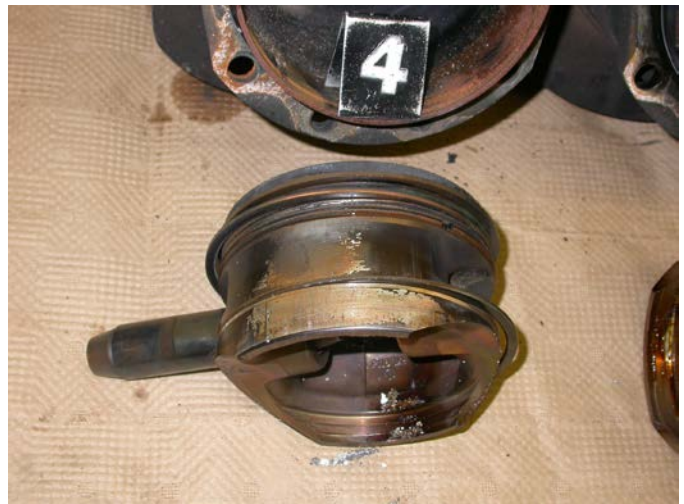
#4 Piston, Rings and Pin Piston Part Number: 648046

Condition: The piston head exhibited a normal amount of combustion deposits and the piston skirt was free of scoring and damage. The piston rings were intact, free in their grooves, exhibited normal wear and operating signatures. The piston pin and plug assembly was intact and undamaged.

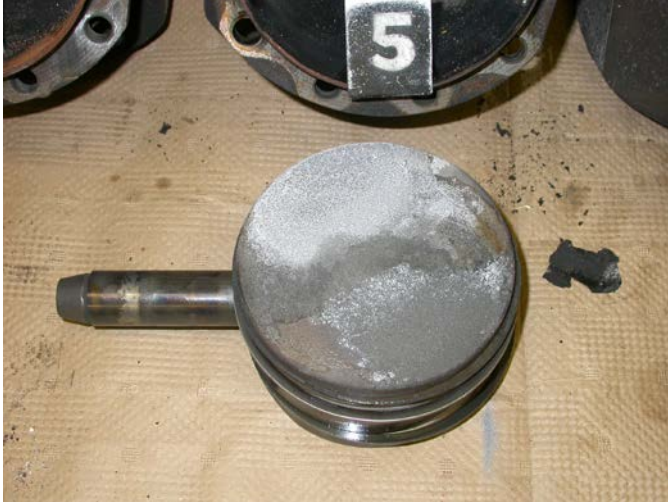
#5 Piston, Rings and Pin Piston Part Number: 648046

Condition: The piston head exhibited a minimal amount of combustion deposits and the piston skirt was free of scoring and damage. The piston rings were intact, free in their grooves, exhibited normal wear and operating signatures. The piston pin and plug assembly was intact and undamaged.

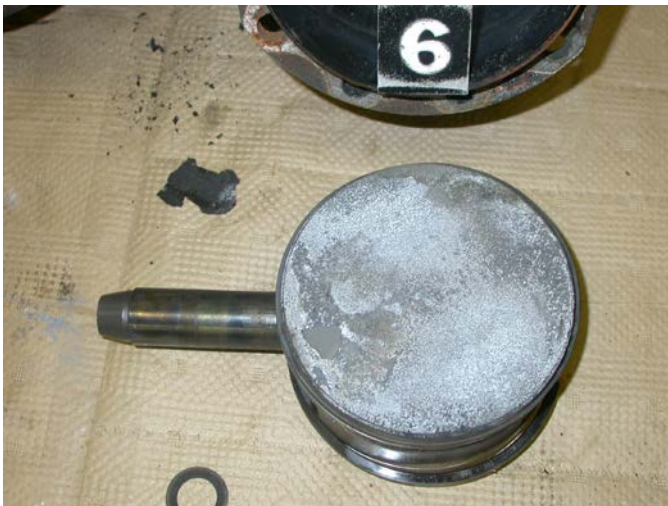
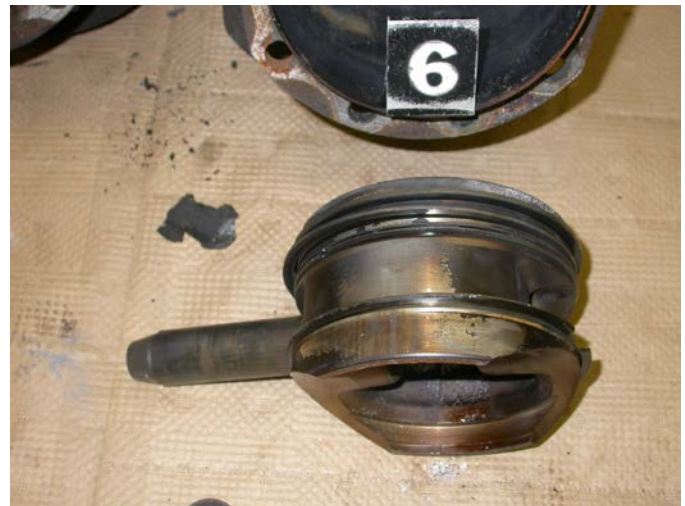
#6 Piston, Rings and Pin Piston Part Number: 648046

Condition: The piston head exhibited a normal amount of combustion deposits and the piston skirt was free of scoring and damage. The piston rings were intact, free in their grooves, exhibited normal wear and operating signatures. The piston pin and plug assembly was intact and undamaged.

Condition: The number 2 and number 6 exhaust lifters exhibited fragments missing from the face circumference. The remaining lifter faces exhibited normal operating signatures. The lifter bodies were intact and exhibited normal operating signatures.
