Engine Analysis Report

Accident #:		ERA10FA404		Analytical Date:		April 27, 2011	
Accident Location:		Saltsburg, PA		RGA:		AS00.127.702	
Engine Model:		IO-550-C		Engine Serial #:		815289	
Engine:	<input checked="" type="checkbox"/>	Component:		New:		Rebuilt:	<input checked="" type="checkbox"/>
						Overhaul:	
Date:		09/15/1998					
Aircraft Make/Model:		Beech 58		Aircraft S/N:		TH-1328	
Reg. #:		N28MR					
Engine Position:		Single:		Left:		<input checked="" type="checkbox"/>	
				Right:			
Front:				Rear:			
Engine Build Date:		09/15/98		Date in Service:		N/R	
Date Removed:		N/R					
Date of Accident:		August 7, 2010		Engine/Component Hours:		N/R	
Inspection Performed By:		Terry L Horton		Search Code:		15-12-68

ENGINE EXAMINATION REPORT

AIRCRAFT MODEL: Beech 58 Baron

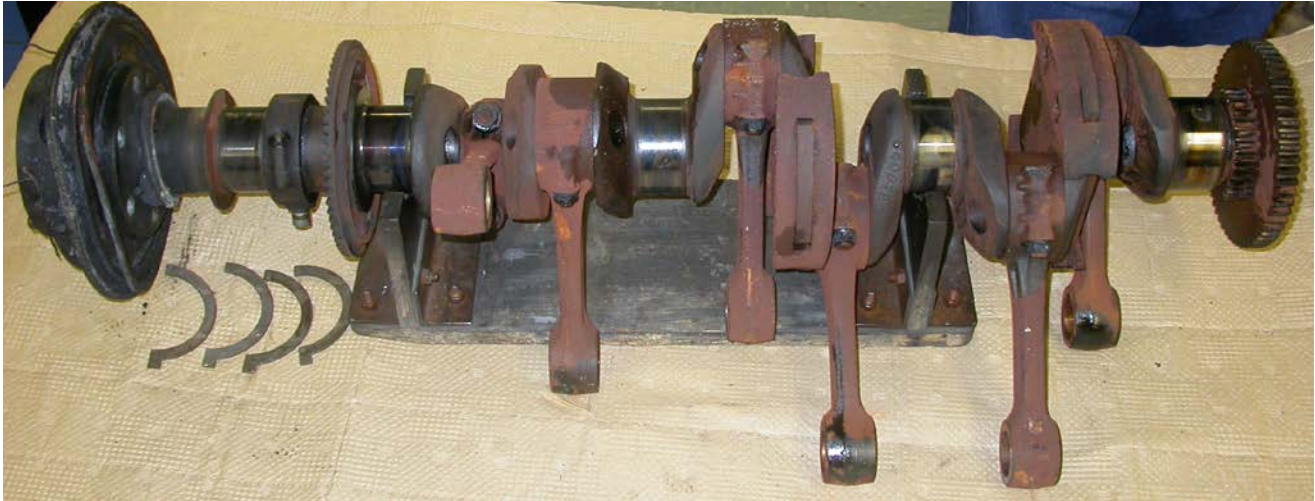
Crankshaft Forging number: 649878 Serial number: G139806N Heat code: Illegible - ?KO

Condition: The crankshaft and counterweight assembly exhibited thermal discoloration and corrosion, but was otherwise undamaged and exhibited normal operating signatures. The connecting rod journals, main journals and thrust surfaces were undamaged and showed no signs of abnormal wear or lubrication distress. The crankshaft counterweight pins, plates and snap-rings were intact. The counterweights were undamaged and had free and unrestricted movement on the hanger blades. The gear bolts were tight and safetied and the gear teeth were undamaged. The oil transfer passages were open and unrestricted. Alternator drive face gear teeth were intact and undamaged. The oil transfer collar was intact and undamaged. The oil transfer plug was tight and in position.

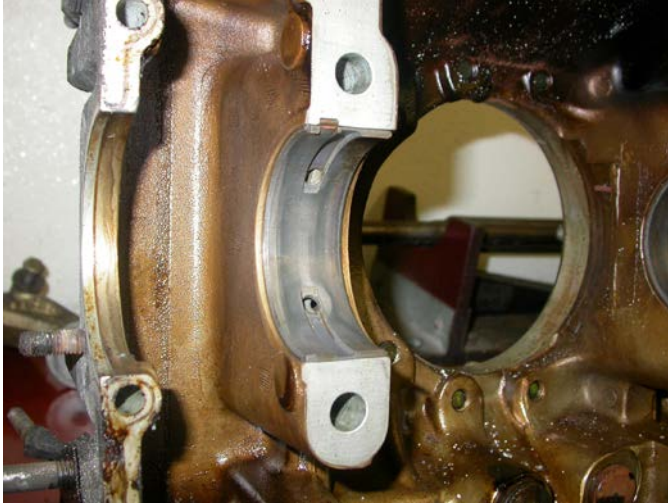
Condition The #1 (rear) crankshaft main bearings exhibited normal operating and lubrication signatures. The bearings were intact and exhibited an insignificant amount of contamination and hard particle passage. There were no signs of lubrication distress.

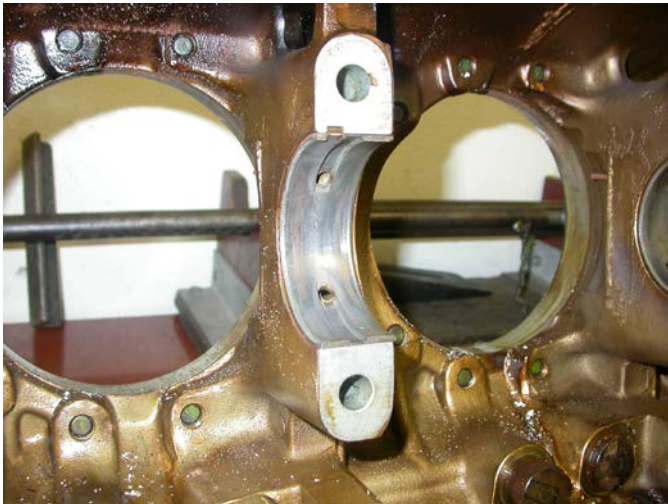
#2 Main Bearings Part #: 654503

Condition The #2 (intermediate) crankshaft main bearings exhibited normal operating and lubrication signatures. The bearings were intact and exhibited an insignificant amount of contamination and hard particle passage. There were no signs of lubrication distress.

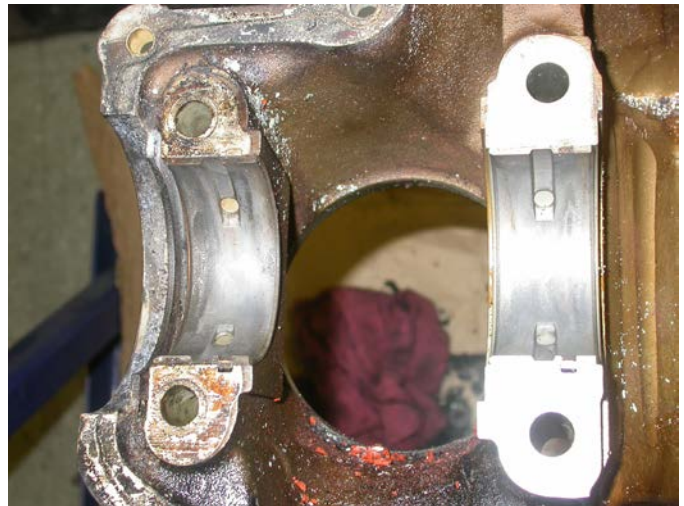
#5 Main Bearings Part #: 653547

The #5 (front) crankshaft main bearings exhibited normal operating and lubrication signatures. Condition The bearings were intact and exhibited an insignificant amount of contamination and hard particle passage. There were no signs of lubrication distress.

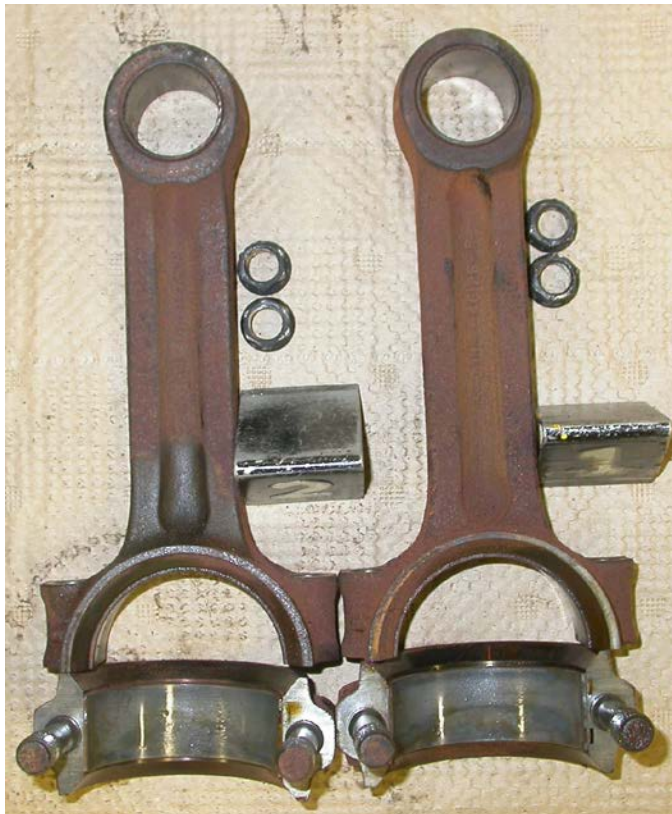
Condition: The connecting rod exhibited corrosion, but was otherwise intact and undamaged. The connecting rod nuts and bolts were intact and secure. The connecting rod bushing exhibited normal operating and lubrication signatures.

Condition: The connecting rod bearing exhibited normal operating and lubrication signatures. The connecting rod bearings were intact and exhibited an insignificant amount of contamination and hard particle passage. There were no signs of lubrication distress.

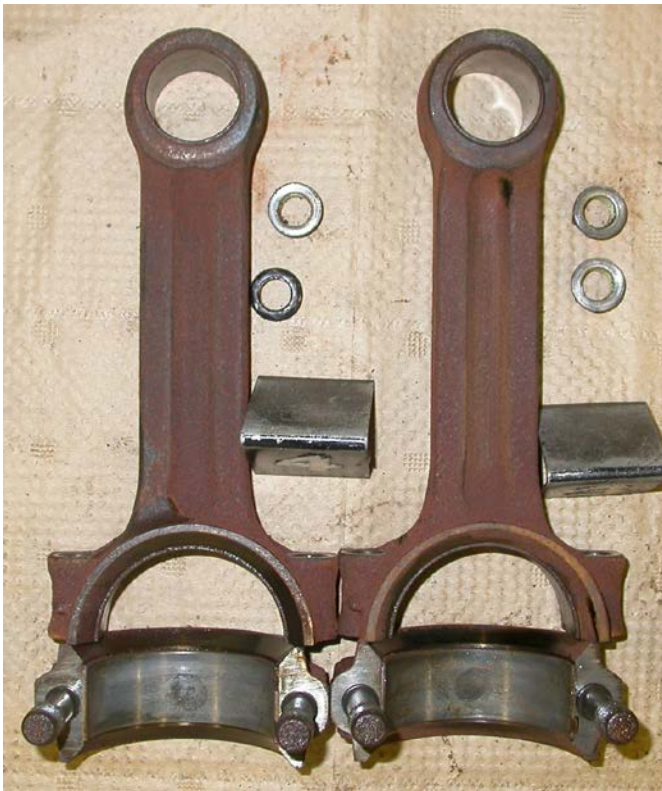
Condition: The connecting rod exhibited corrosion, but was otherwise intact and undamaged. The connecting rod nuts and bolts were intact and secure. The connecting rod bushing exhibited normal operating and lubrication signatures.

Condition: The connecting rod bearing exhibited normal operating and lubrication signatures. The connecting rod bearings were intact and exhibited an insignificant amount of contamination and hard particle passage. There were no signs of lubrication distress.

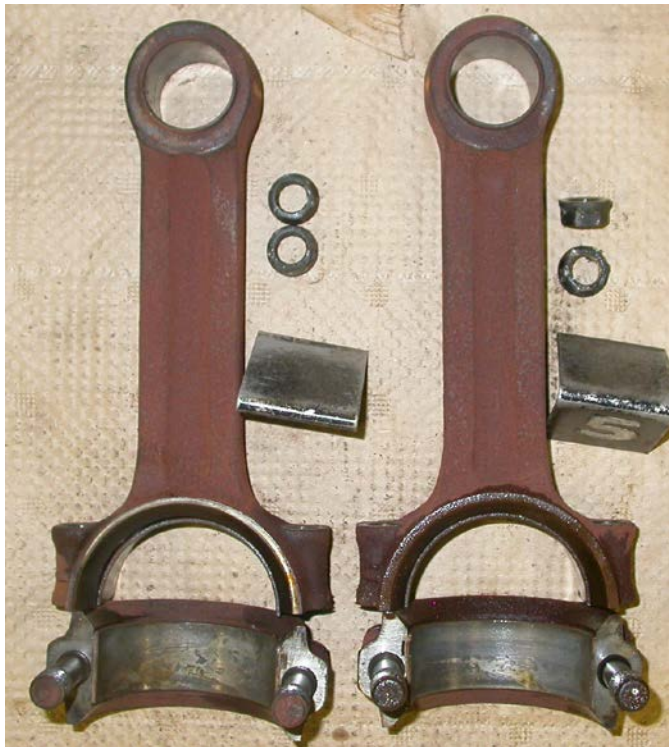
Condition: The connecting rod exhibited corrosion, but was otherwise intact and undamaged. The connecting rod nuts and bolts were intact and secure. The connecting rod bushing exhibited normal operating and lubrication signatures.

Condition: The connecting rod bearing exhibited normal operating and lubrication signatures. The connecting rod bearings were intact and exhibited an insignificant amount of contamination and hard particle passage. There were no signs of lubrication distress.

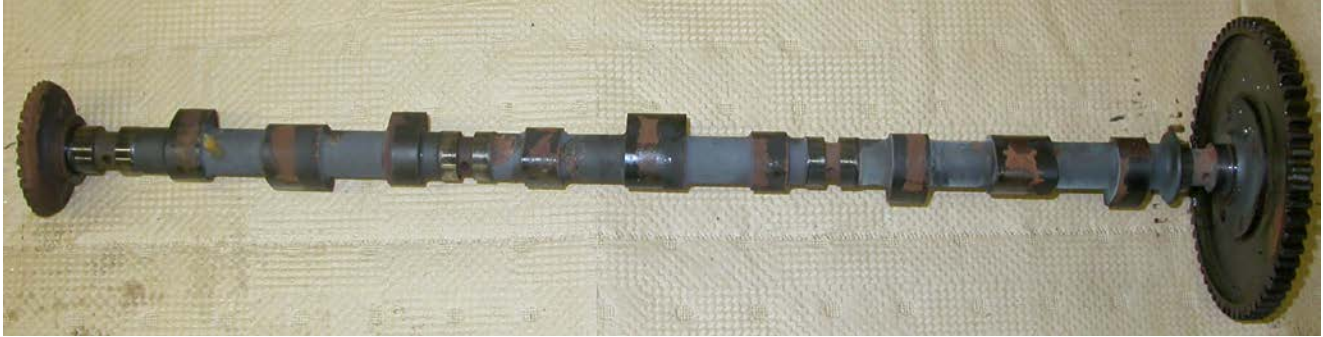
Camshaft Part number: 654837

Condition: The camshaft and gear assembly exhibited corrosion. The camshaft lobes exhibited normal operating signatures. The camshaft cluster gear was intact and exhibited normal operating signatures. The gear bolts were tight and saftied and the gear teeth were undamaged.

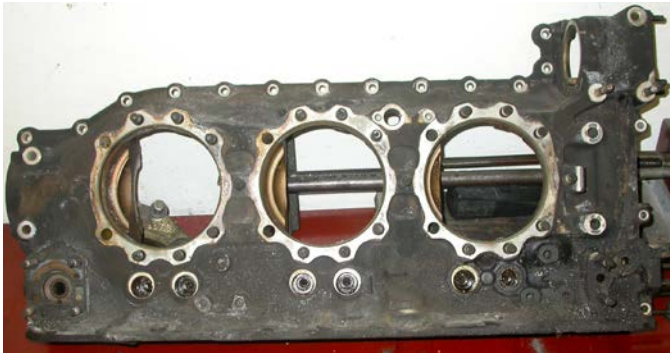
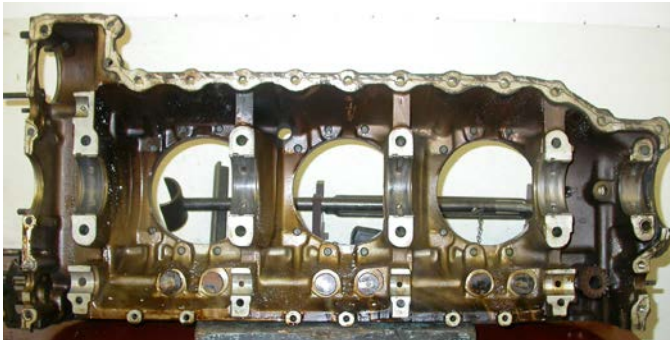
Condition: The crankcase assembly exhibited thermal discoloration. The cylinder bays were intact and undamaged. The main bearing support mating surfaces were intact and exhibited no signs of fretting or bearing tang lock-slot elongation. The main bearing support diameters were intact and exhibited no signs of bearing movement or rotation. The oil galleys and passages in the left and right crankcase halves were intact, clear and unrestricted.

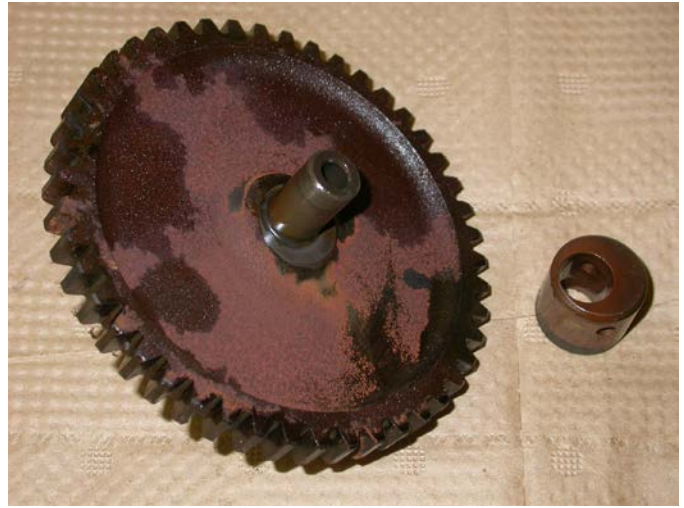
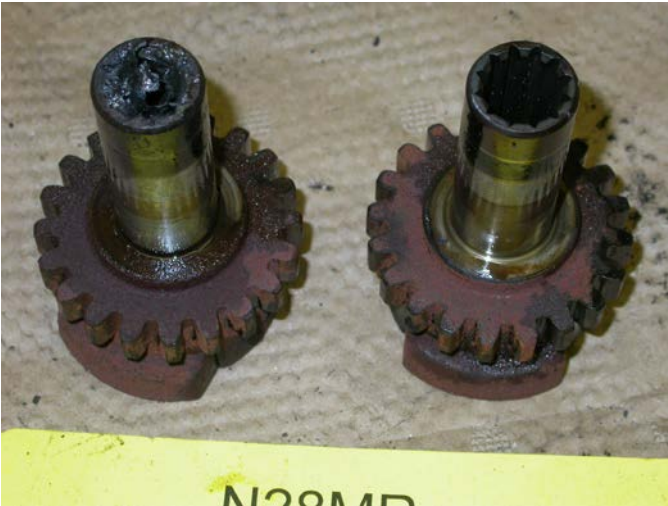
Accessory Gears

Condition: The accessory gears had continuity. The teeth were undamaged and exhibited corrosion.

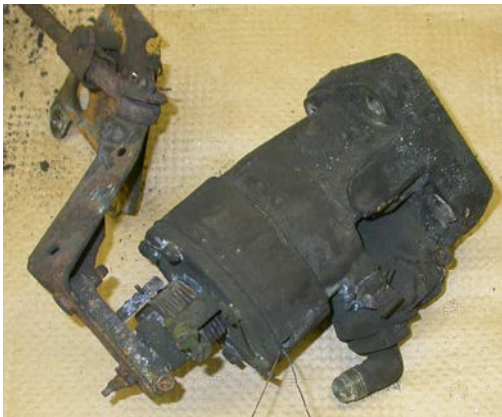
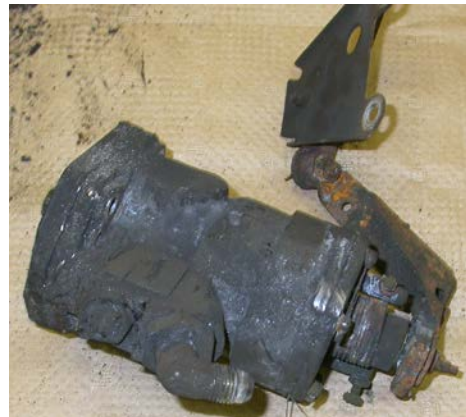
Propeller Governor

Condition: The propeller governor could not be rotated by hand and exhibited thermal discoloration.

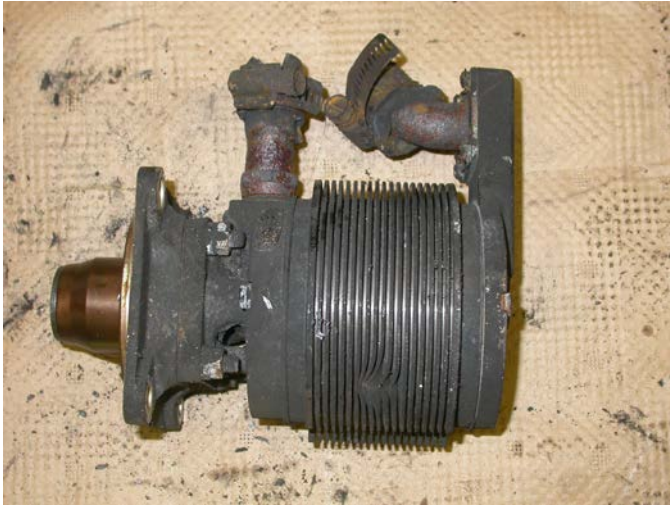
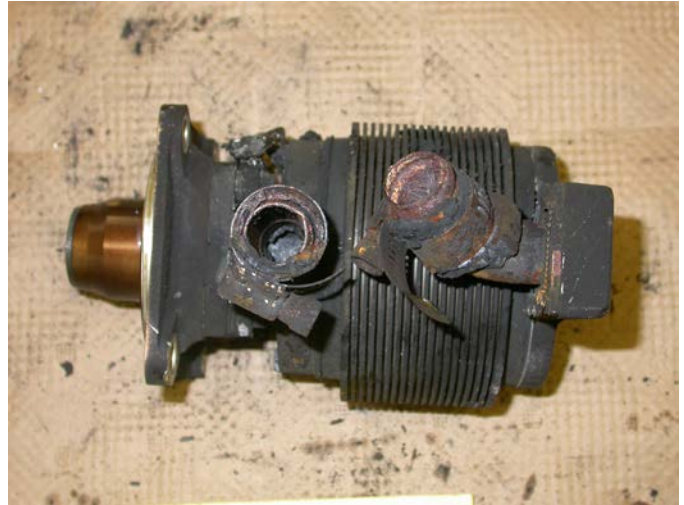
Vacuum Pump

Condition: The vacuum pump could not be rotated by hand. The vacuum pump exhibited thermal damage.
