September 29, 2013

Santa Monica Municipal Airport, Santa Monica, California

Cessna 525A Citation, N194SJ

WPR13FA430

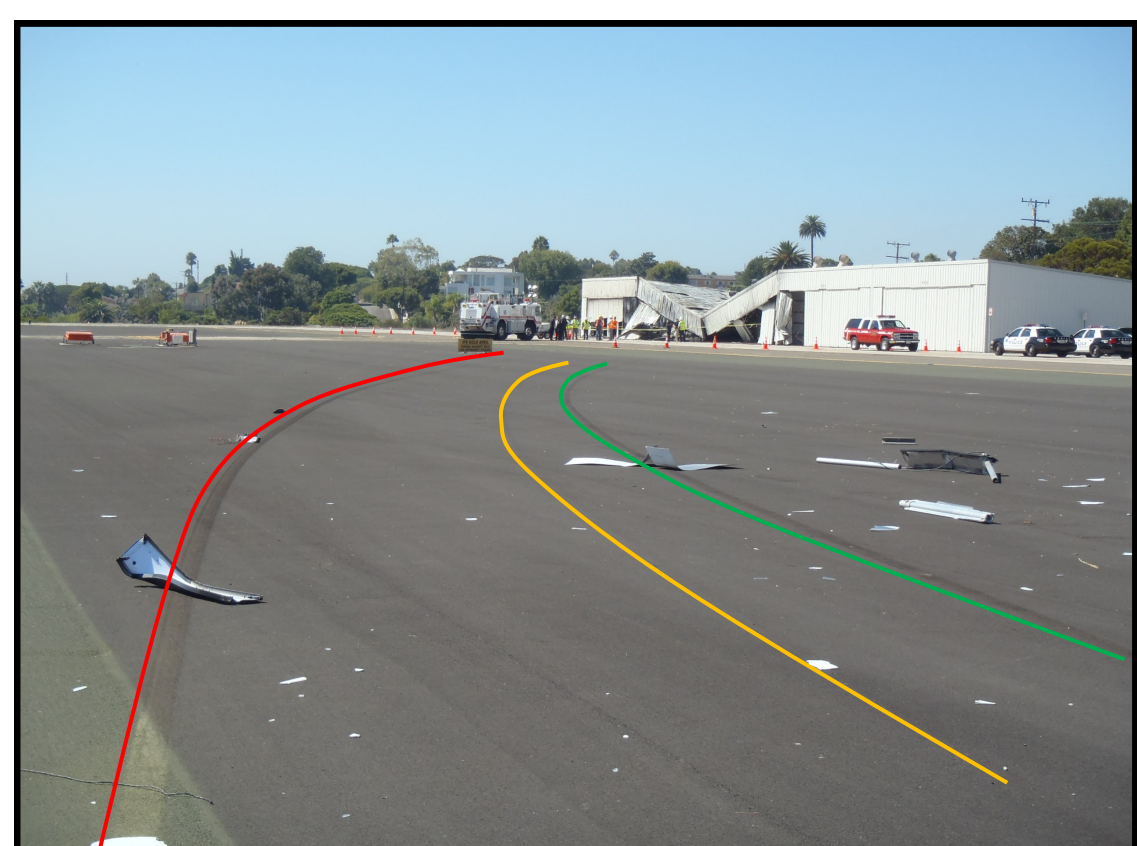
(F2) Black transfer marks for all tires leading to the main wreckage

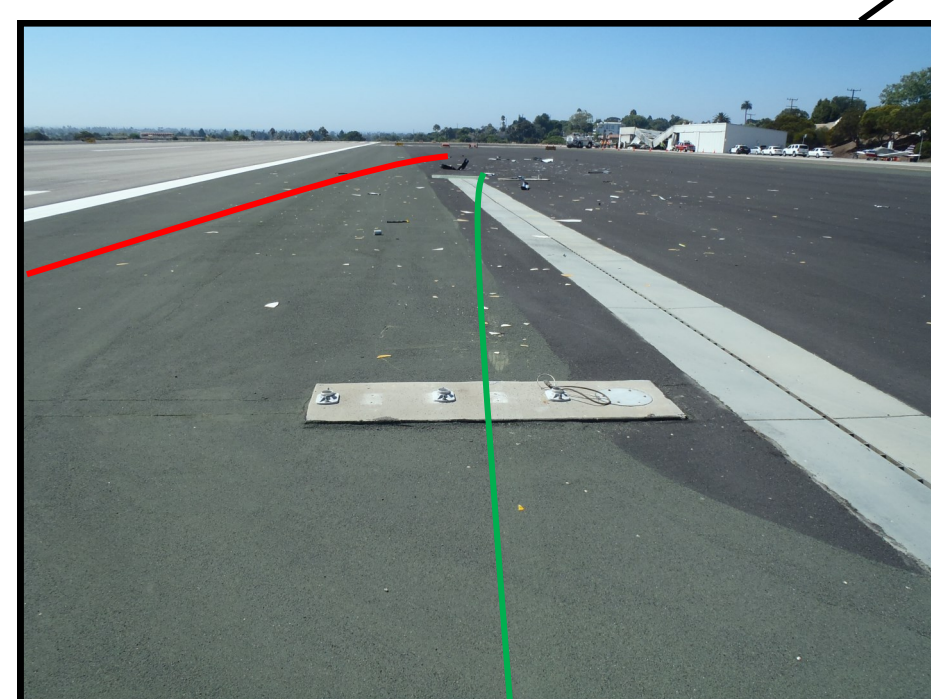
(D) Five tread marks from the right main landing gear tire beyond the remnants of a taxiway sign. Light scuffing of tarmac surface created by left main landing gear tire

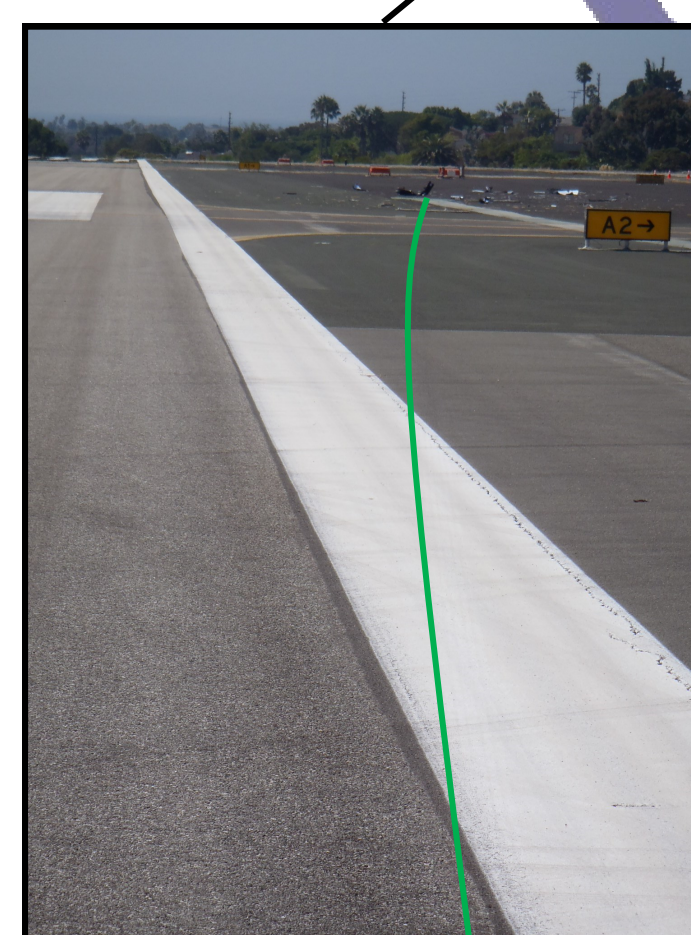
Light scuffing on the runway border displaying 5 treads of the right main landing gear tire.

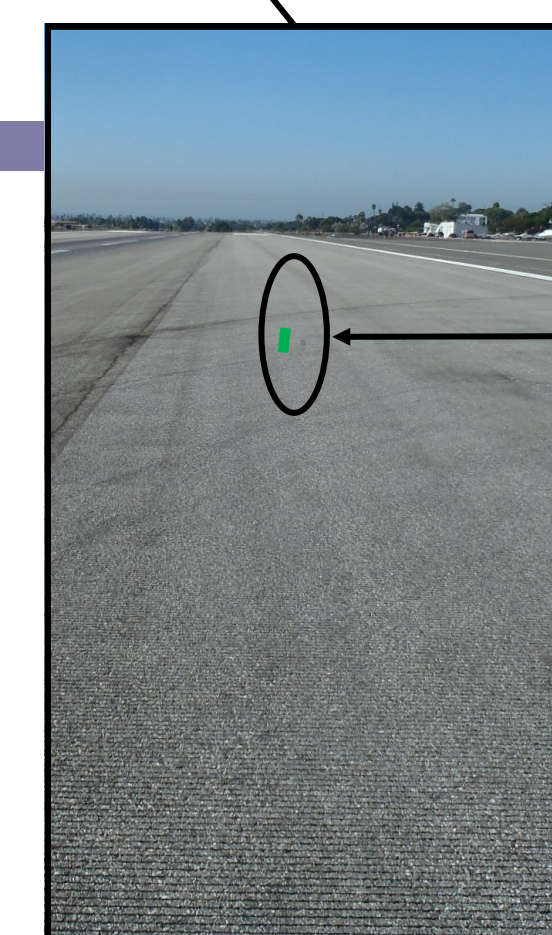
(A) First indication of landing gear ground contact. Light black transfer mark about 64-inches-long, consisting of 3 treads from the right main landing gear tire.
