NATIONAL TRANSPORTATION SAFETY BOARD

SATLOC Onboard CPU

Specialist's Factual Report
By George Haralampopoulos

Location: Hancock, Wisconsin
Date: August 26, 2016
Aircraft: Weatherly 620B
Registration: N2005C
Operator: Agricaire Flying Service
NTSB Number: CEN15LA399

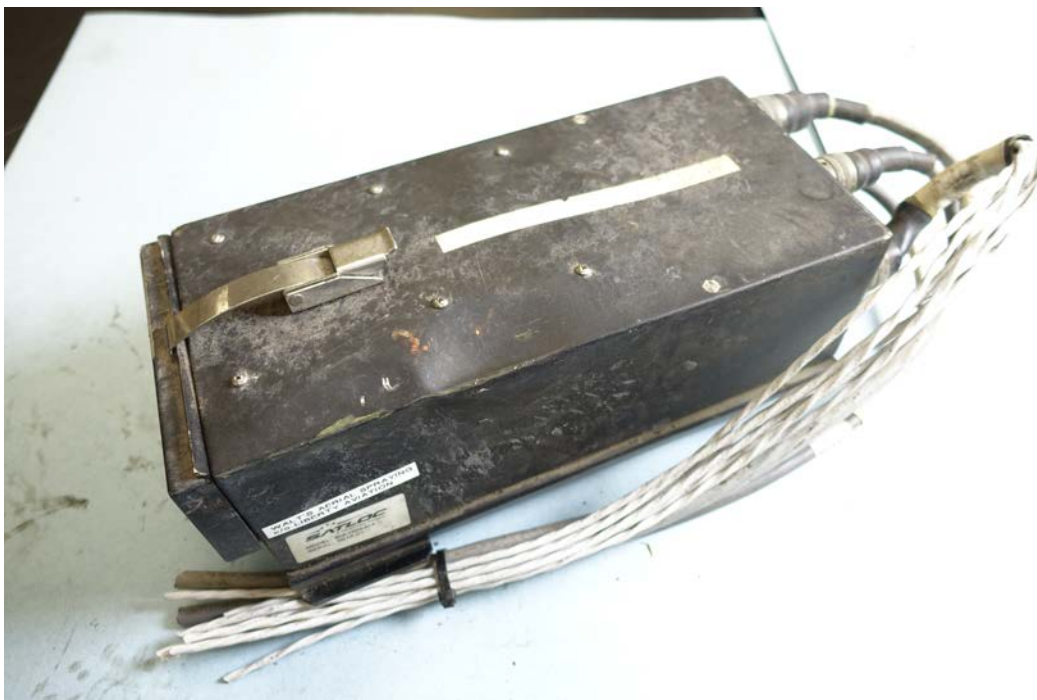
Upon arrival at the Vehicle Recorder Laboratory, an examination revealed the unit had sustained minor impact damage. The extent of the damage is shown in figure 1. An internal inspection revealed the unit's PCMCIA cards.

Figure 1. Photo of SATLOC CPU as received.
