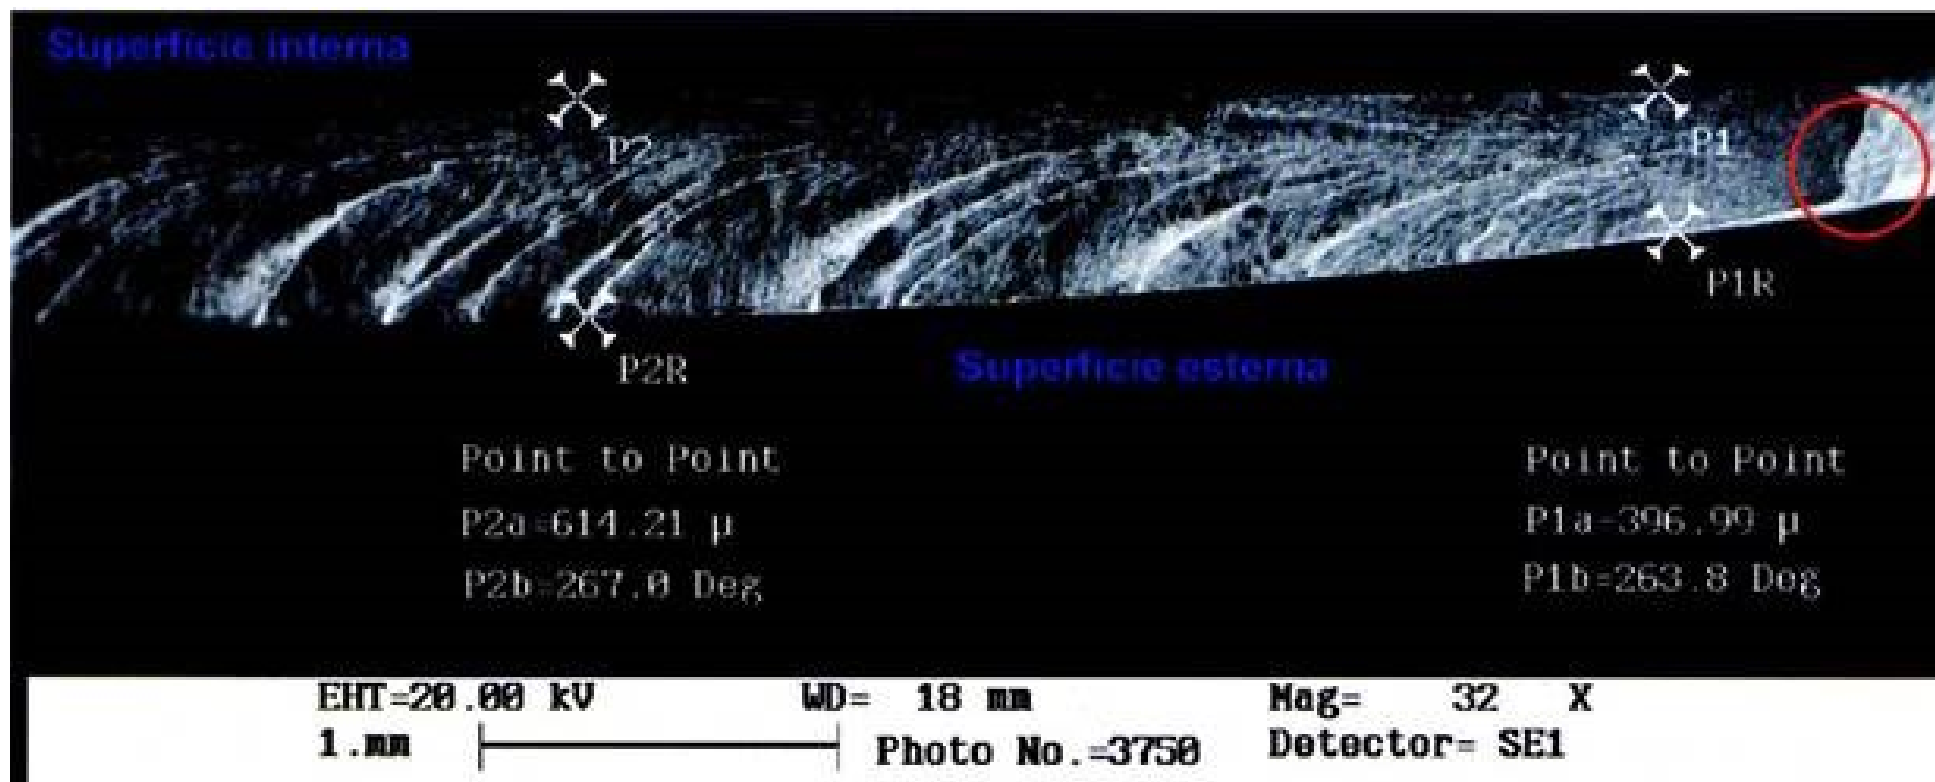
Photo 1 – Wide view, microscopic image of fracture surface (Courtesy of Leonardo)

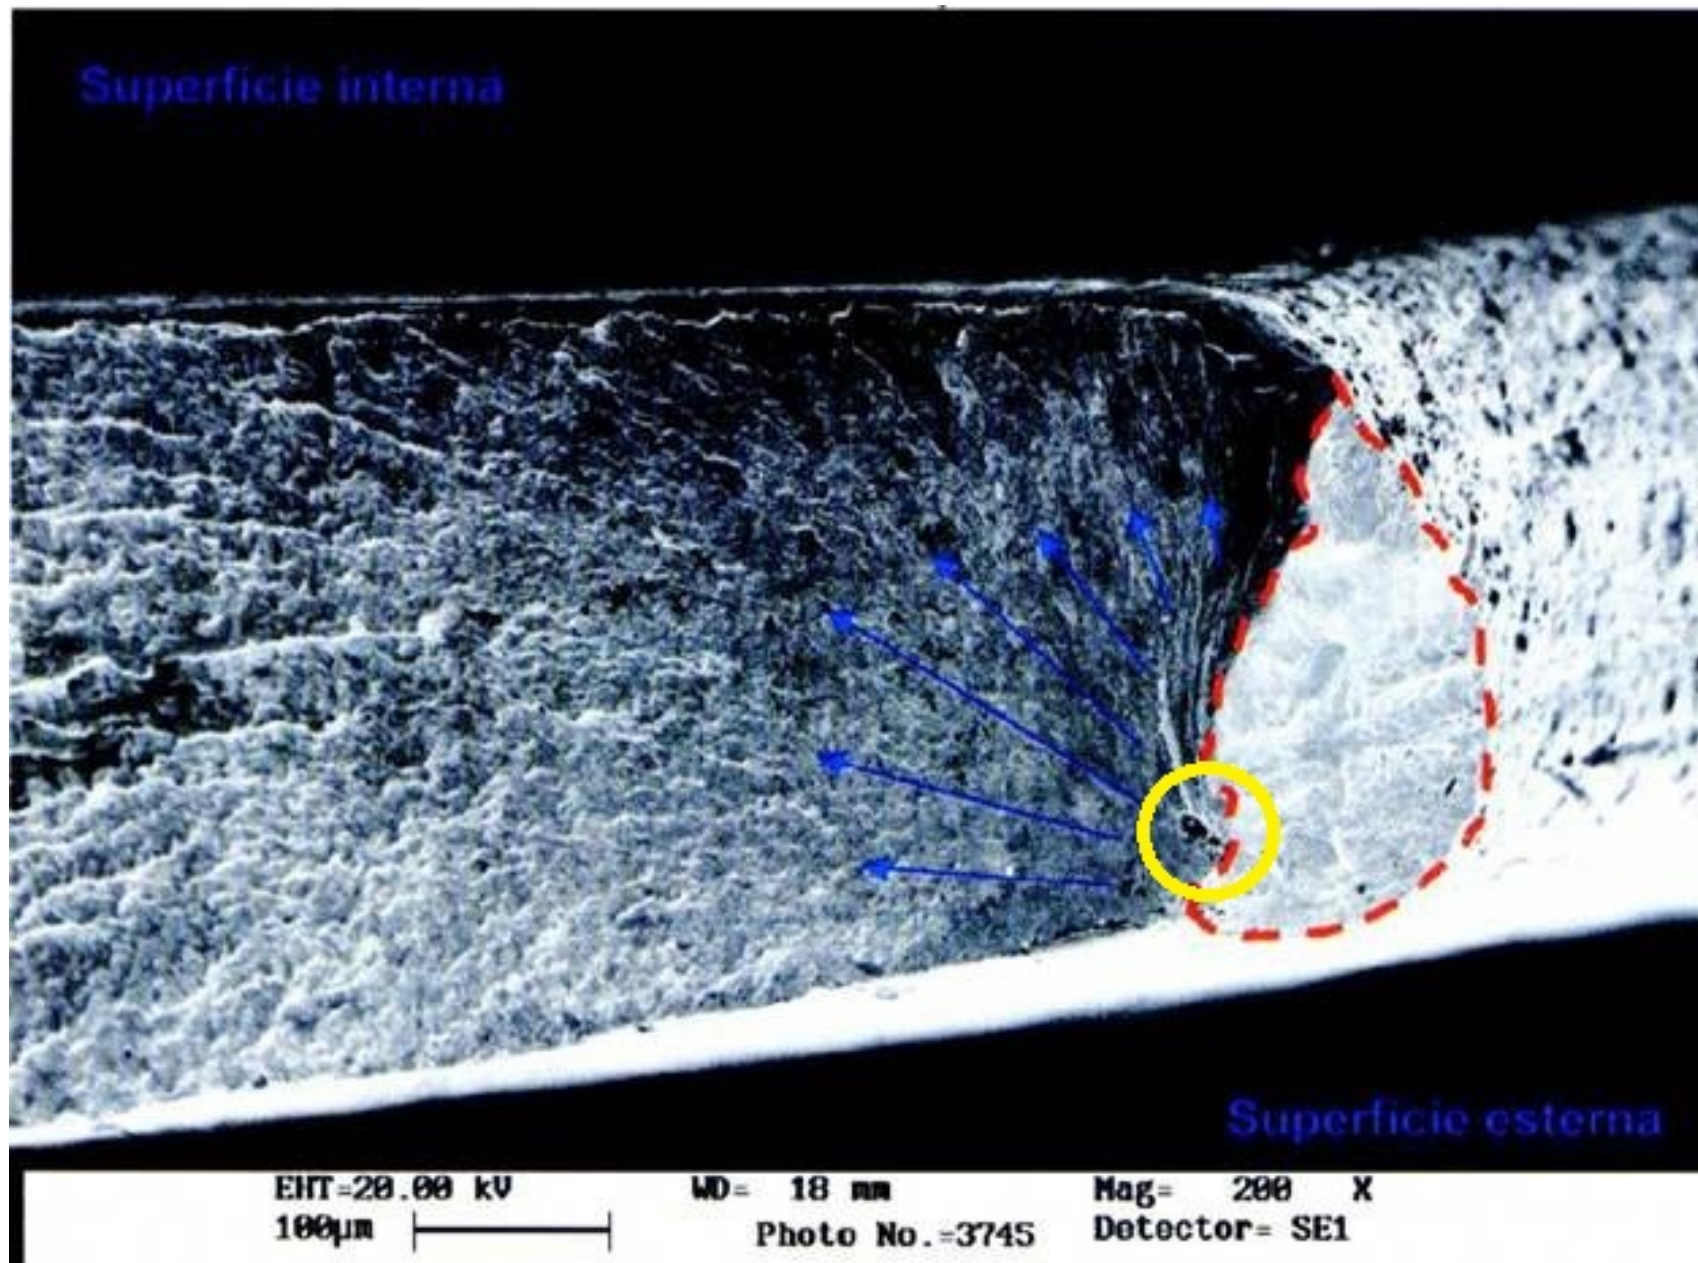
Photo 2 – Close view, microscopic image of crack propagation (Courtesy of Leonardo)
