NATIONAL TRANSPORTATION SAFETY BOARD

DCA-13-MR-002

DERAILMENT WITH HARZARDOUS MATERIALS RELEASE

SIGNAL GROUP FACTUAL REPORT

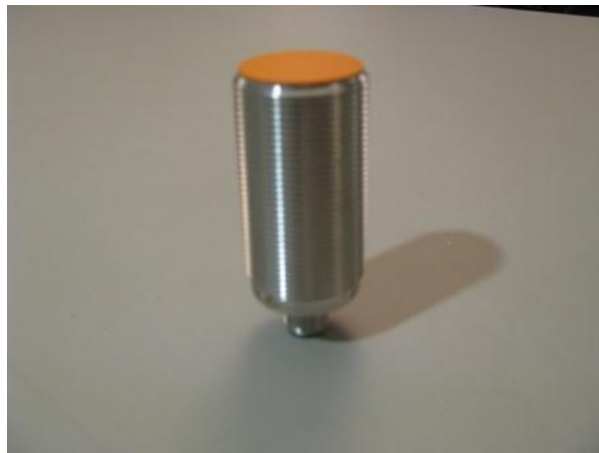
Four proximity detectors are used to detect when the moveable bridge is lined and locked for rail traffic. The slide rails are located outside each rail on each end of the movable span. Efector® 100 inductive sensors (See Figure 1) are used to detect when the slide rails are properly positioned for rail traffic. One sensor is located adjacent to each rail on the land/stationary side of the bridge.

Figure 1. Efector® 100 inductive sensor.

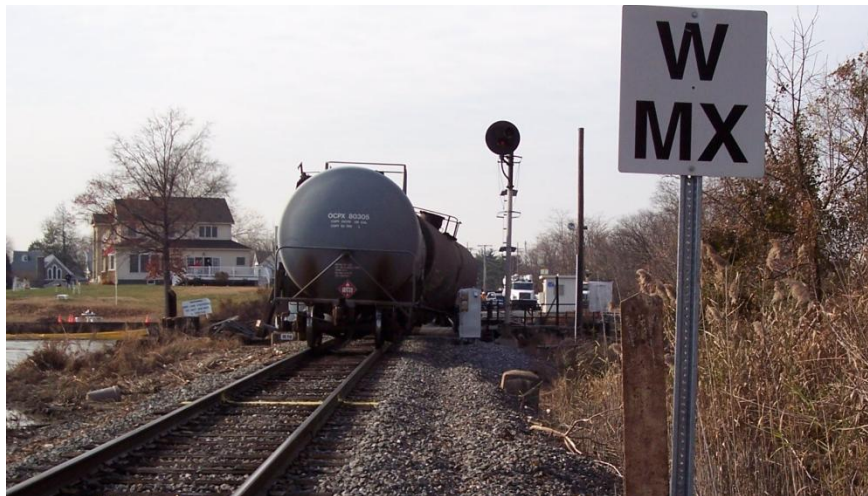
The 1S signal is pictured below. (See Figure 3.)

Figure 3. View of 1S Signal at Paulsboro Moveable Bridge

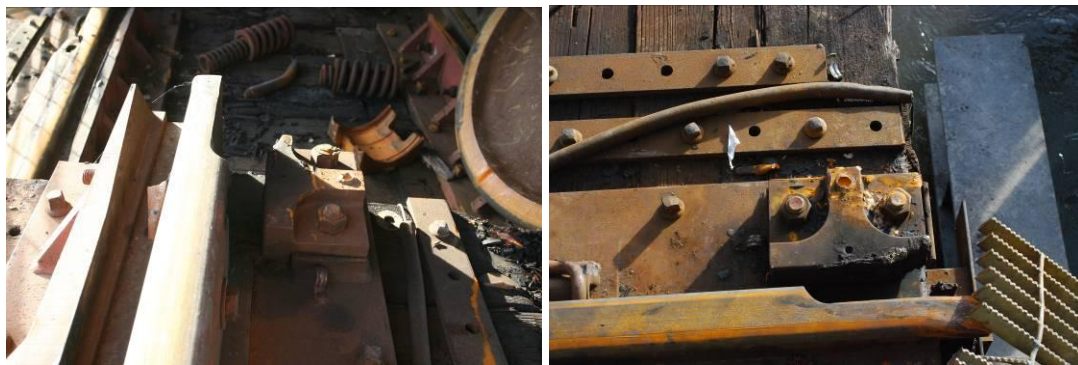
Figure 4. North End Proximity Switch Back View (L) and Overhead View (R).

- Photograph all signal cases both inside and outside. *Once the site was secured post-accident, photographs of all signal cases were taken.*
- If proximity detectors are recovered, photograph the location where they were found, and tag them as evidence and turn them over to the NTSB for laboratory testing. *Once the site was secured post-accident, all proximity detector photographs were taken.*

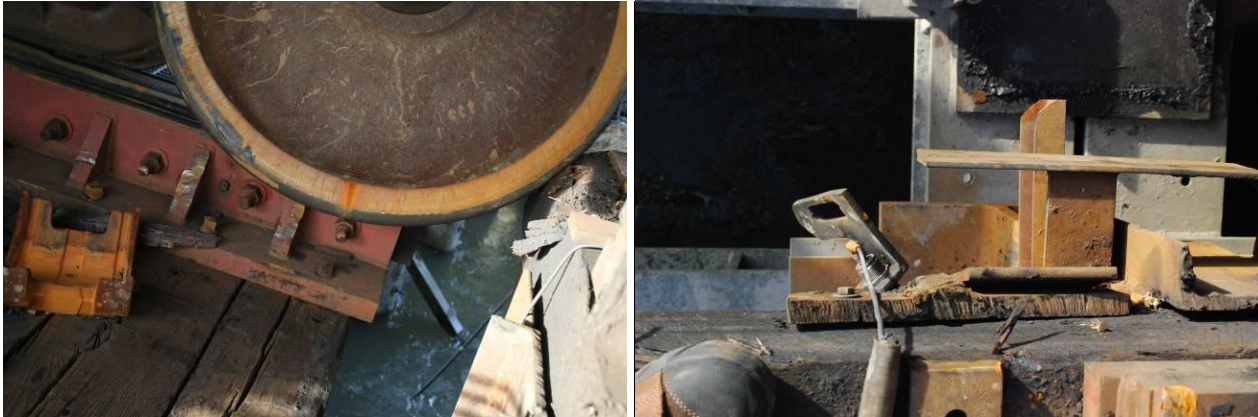
Figure 5. North End Proximity Switch Side View (L) and Overhead View (R).
