# National Transportation Safety Board

**New Jersey Transit**

**Collision with Bumping Post**

**Signal Group Factual Report**

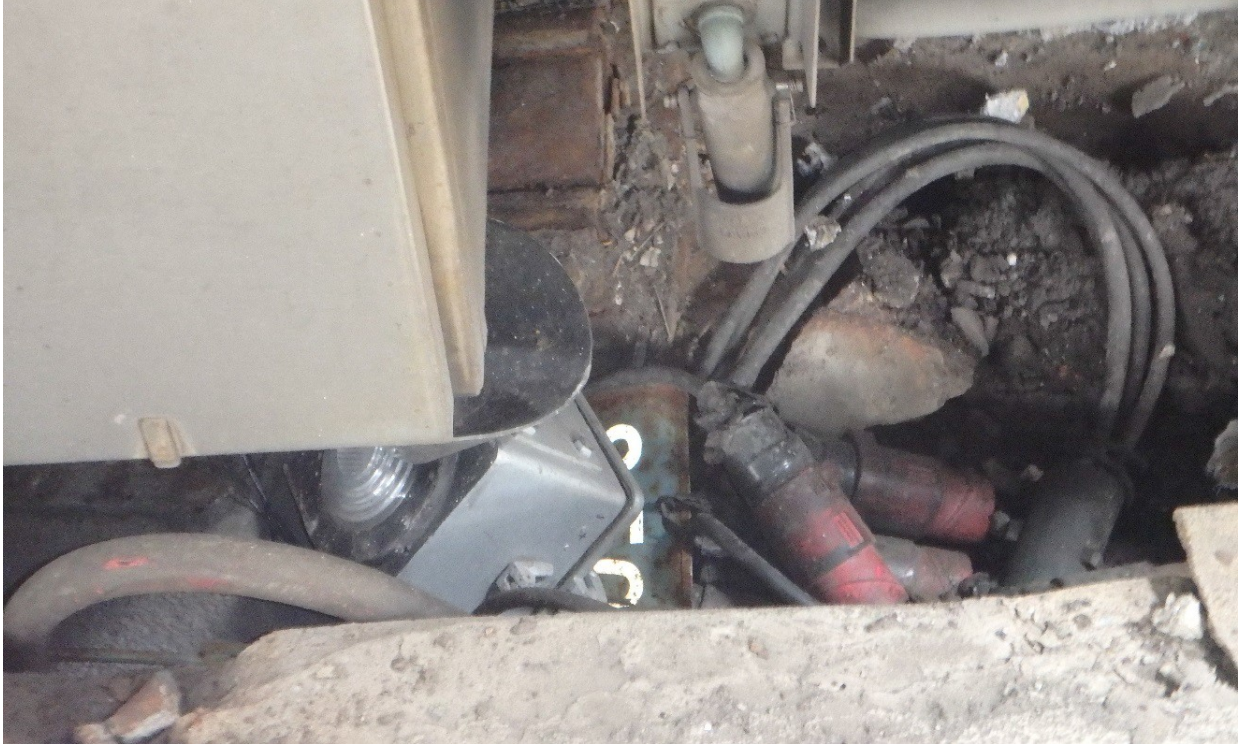
4 **Figure 5.** Damaged Dwarf Signal Train Shed Track 5.

19 Transcontrol manufactured the dwarf signal in train shed Track 5. It was equipped with a  
20 single signal head with a red lens and a 10-volt, 18w, clear bulb. The collision of train 1614 with  
21 the platform damaged the dwarf signal and connecting underground cable and track connections.

- 1 Figure 5 depicts damage to the dwarf signal in train shed track 5. The damage estimate to the signal
- 2 system provided by NJT is \$1,954.00.
