NATIONAL TRANSPORTATION SAFETY BOARD

SIMULATION STUDY: BIOMECHANICS

VEHICLE 1: 1999 Prevost H3-45 56-Passenger Motorcoach

NTSB #: **HWY-11-MH-005**

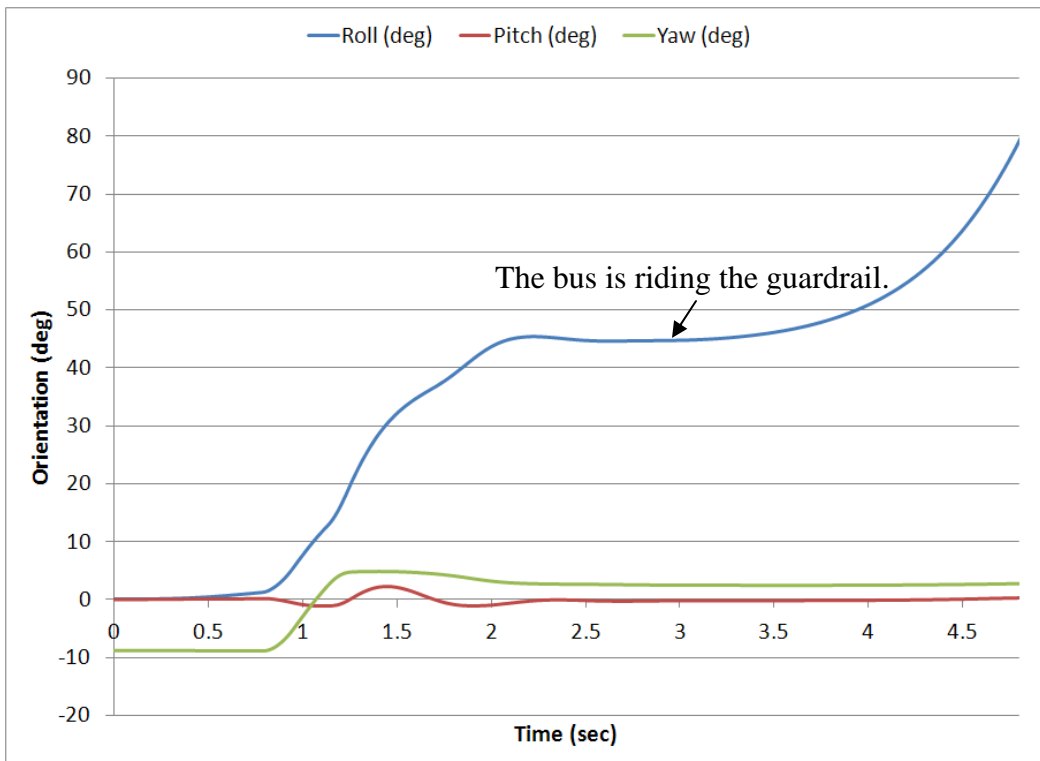
Figure 7: The orientation time history of the motorcoach based on the vehicle dynamics simulation.

The position, orientation and acceleration time history of the bus based on the vehicle dynamics simulation are shown in Figure 6 through Figure 8. Note that the vehicle dynamics simulation uses a coordinate system relative to the roadway. The positive X axis is the forward motion of the bus, positive Y is laterally to the left, and positive Z is vertically upwards. The position and orientation time histories were used as the vehicle motion in MADYMO. The vehicle simulations did not, however, include the final impact with the ground. The TruckSim program capabilities are limited to vehicle dynamics and not external impact to the body of the vehicle.

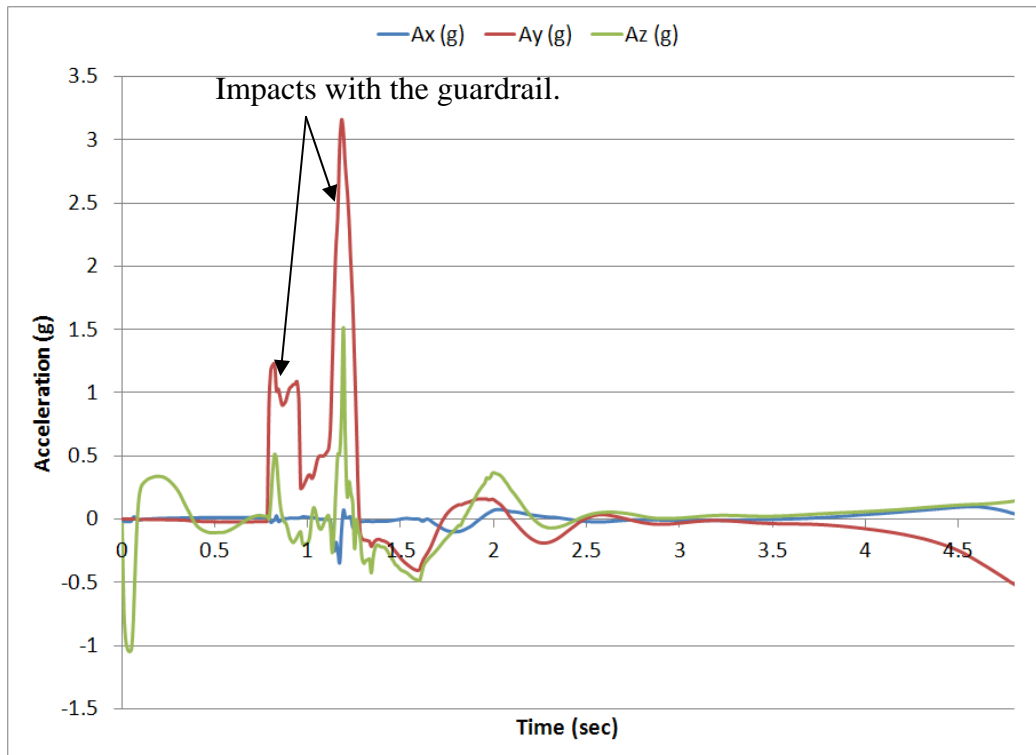
Figure 8: The linear acceleration time history of the motorcoach cg based on the vehicle dynamics simulation (note that the vehicle dynamics simulation did not include the bus sidewall to ground impact).

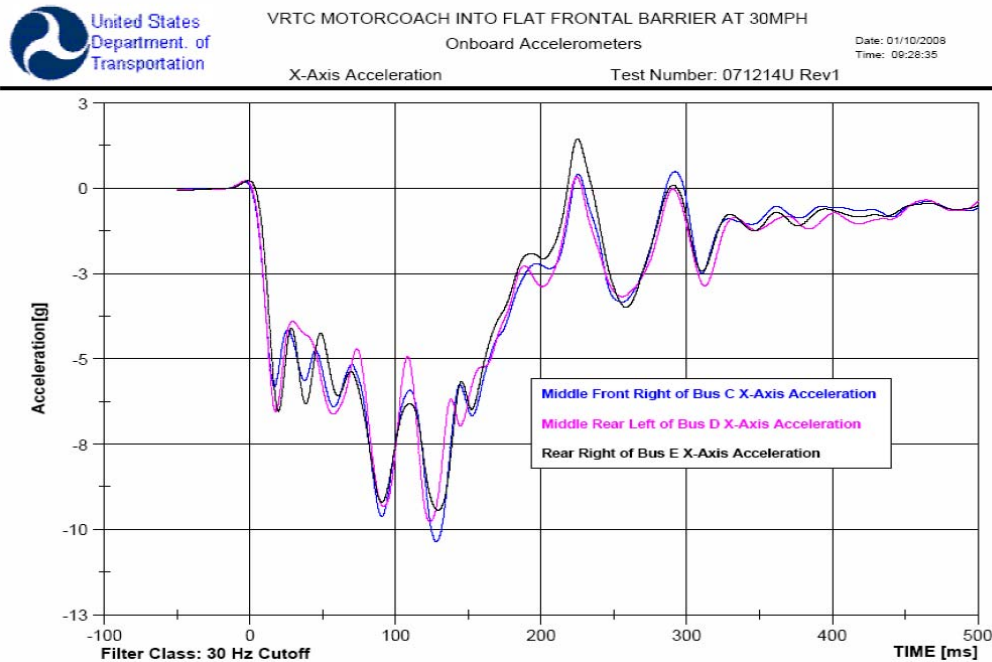
Figure 9: The recorded and filtered crash pulse in the x-direction from the 2007 full scale frontal barrier test.¹⁵

The impact speed was set at 30 mph into a rigid barrier with a full overlap. Twenty two dummies were on the test vehicle including 17 hybrid III 50th percentile males, 3 hybrid II 5th percentile females and 3 hybrid III 95th percentile males. The actual impact speed was recorded at 30.36 mph with a dynamic crush of 6.5 feet and a peak deceleration of 10g at 125 msec into the crash (Figure 9). This pulse was viewed as a potential worst case scenario for the deceleration of the bus when impacting the non-breakaway light pole. Ultimately, this pulse was not used in the simulation, as will be explained in a later section addressing occupant kinematics and positioning that created vulnerability to secondary impacts.

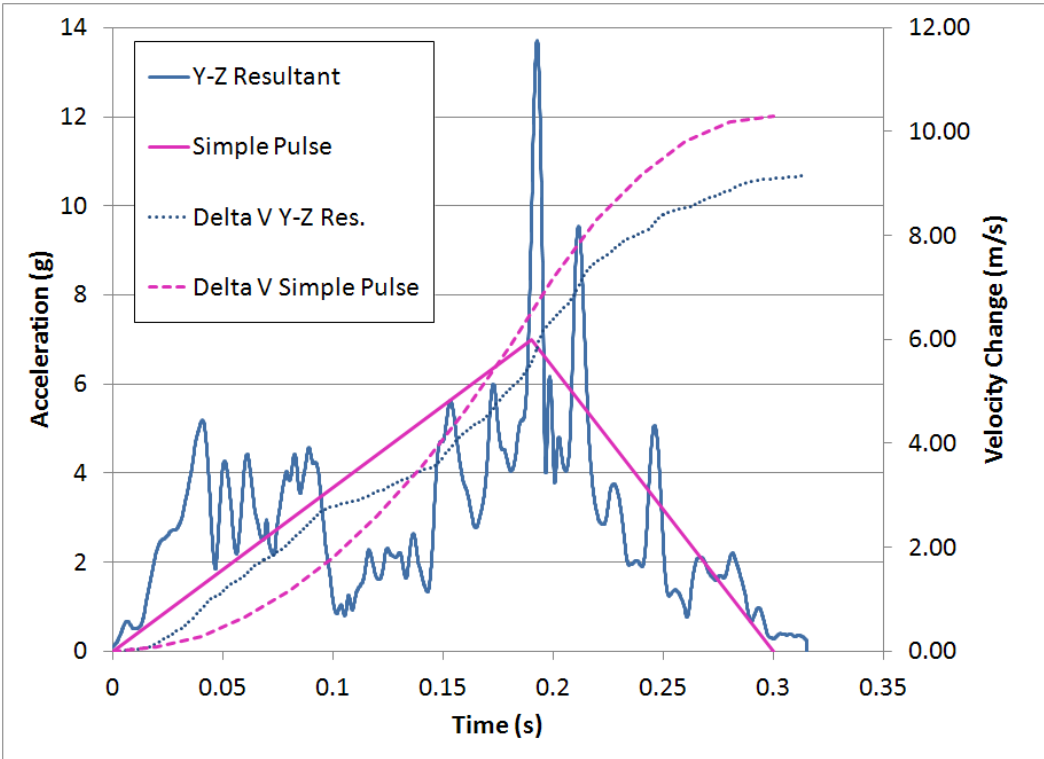
Figure 12: The simple triangular pulse representing the resultant acceleration and the velocity change at the front of the 1991 Prevost.

Simplified triangular pulse shapes were created to best represent the resultant accelerations and the change in velocity at the front and mid position of the bus. The resultant accelerations along with the simplified pulse and the calculated change in velocity for the

resultant acceleration and the simplified acceleration are shown in Figure 12 and Figure 13. For consistency, the duration of the pulse and the time to peak was held constant for both pulses.

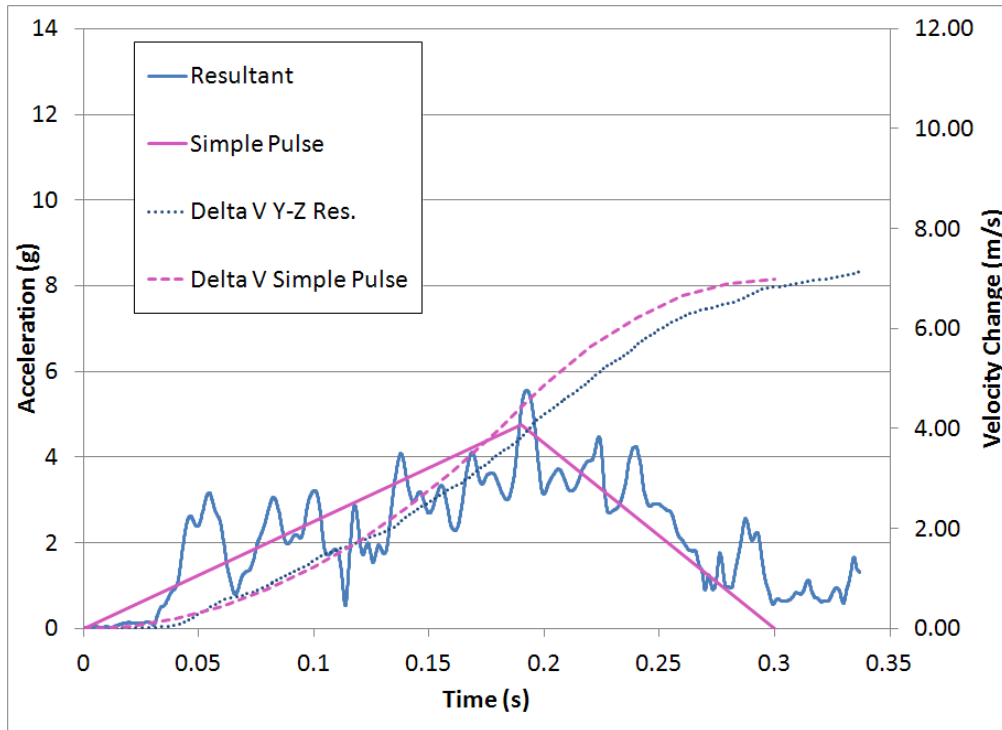
Figure 13: The simple triangular pulse representing the resultant acceleration and the velocity change at the middle of the 1991 Prevost.

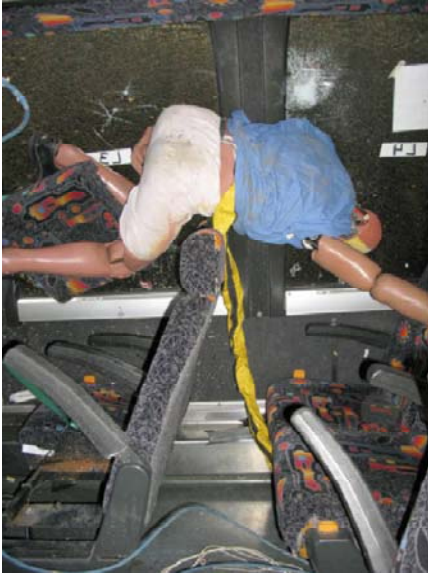
Figure 15: Post-Test View of Front Unrestrained Test Dummy (1991 PrevoSt LeMirage). The image has been rotated and flipped such that the occupant motion appears to be in the same direction as the accident vehicle's roll.

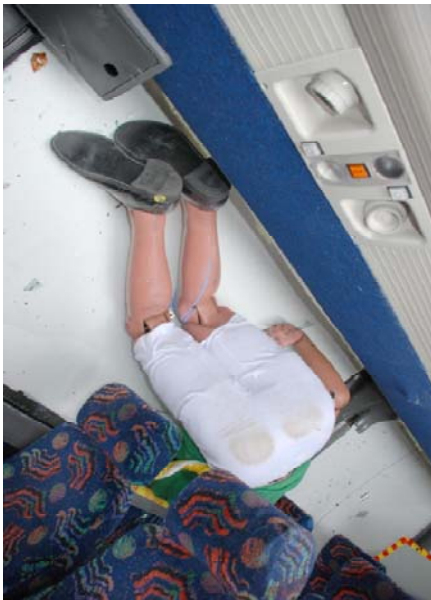
Figure 16: Post-Test View of Front Unrestrained Test Dummy (2000 MCI 102-EL3). The image has been rotated and flipped such that the occupant motion appears to be in the same direction as the accident vehicle's roll.

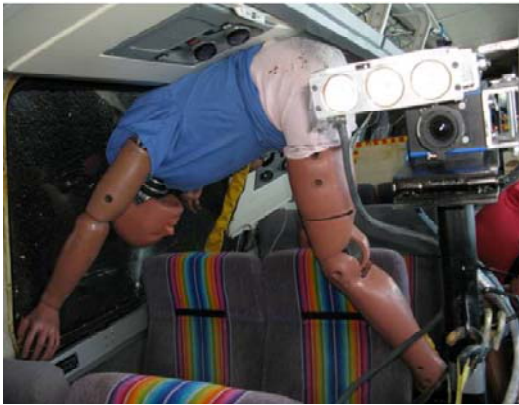
Figure 17: Post-Test View of Front Unrestrained Test Dummy (1992 MCI MC-12). The image has been rotated and flipped such that the occupant motion appears to be in the same direction as the accident vehicle's roll.

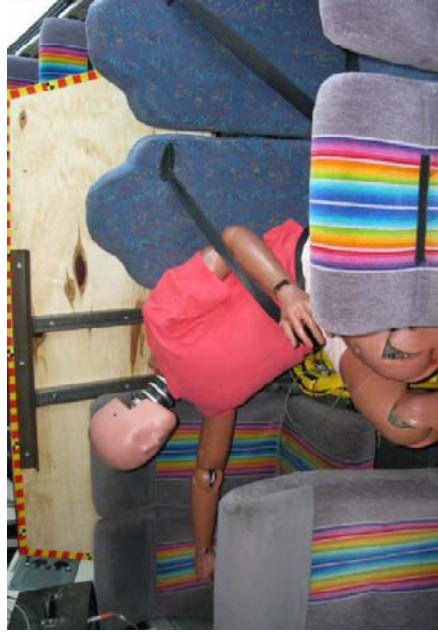
Figure 21: Post-Test View of Rear Restrained Test Dummy (1992 MCI MC-12). The image has been rotated and flipped such that the occupant motion appears to be in the same direction as the accident vehicle's roll.

The rear seat passenger's upper body also slid from the shoulder harness during the NHTSA R66 tests with both MCI buses. The final rest positions for these two passengers can be seen in Figure 21 and Figure 22. (The seats failed in the 1991 Prevost test. Therefore motion of the occupant out of the harness was not examined.) Note that the simulation view shown in Figure 23 was rotated and flipped to facilitate comparison to the NHTSA R66 tests.

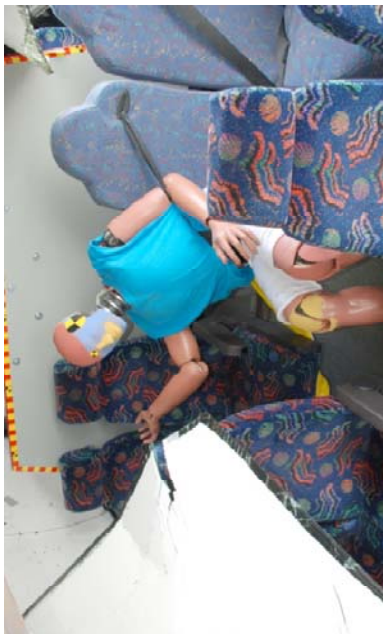
Figure 22: Post-Test View of Rear Restrained Test Dummy (2000 MCI 102-EL3). The image has been rotated and flipped such that the occupant motion appears to be in the same direction as the accident vehicle's roll.
