NATIONAL TRANSPORTATION SAFETY BOARD
Vehicle Recorder Division
Washington, D.C. 20594

Flight Display Factual Report

1. EVENT

Location: Tappahannock, Virginia
Date: August 19, 2019
Aircraft: Cirrus SR22
Registration: N621JE
Operator: Private
NTSB Number: ERA19FA251

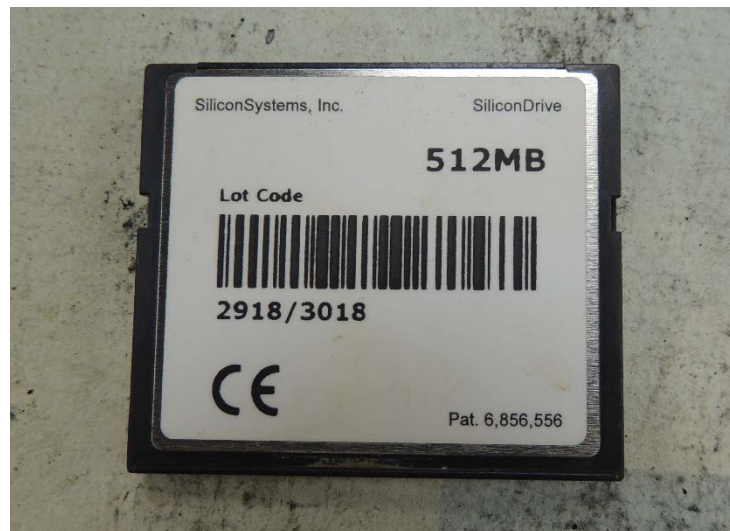
The data from the MFD arrived at the Vehicle Recorder Laboratory in the form of the CF card located within the full unit. The MFD card was read and converted to engineering units using laboratory equipment. A visual inspection showed the card appeared to be in good working order and undamaged. The state of the CF card as it arrived is shown below in Figure 1.

Figure 1. Undamaged CF Card from MFD

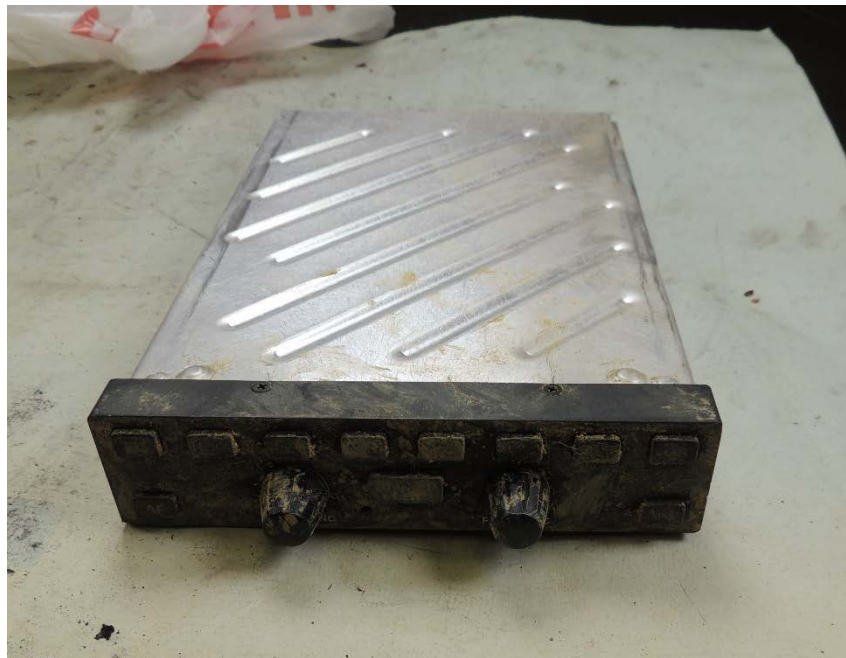
Upon arrival at the Vehicle Recorder Laboratory, the device showed signs of minor impact damage. The damage to the unit is shown below in Figure 2.

Figure 2. External damage to DFC-90 Autopilot Unit

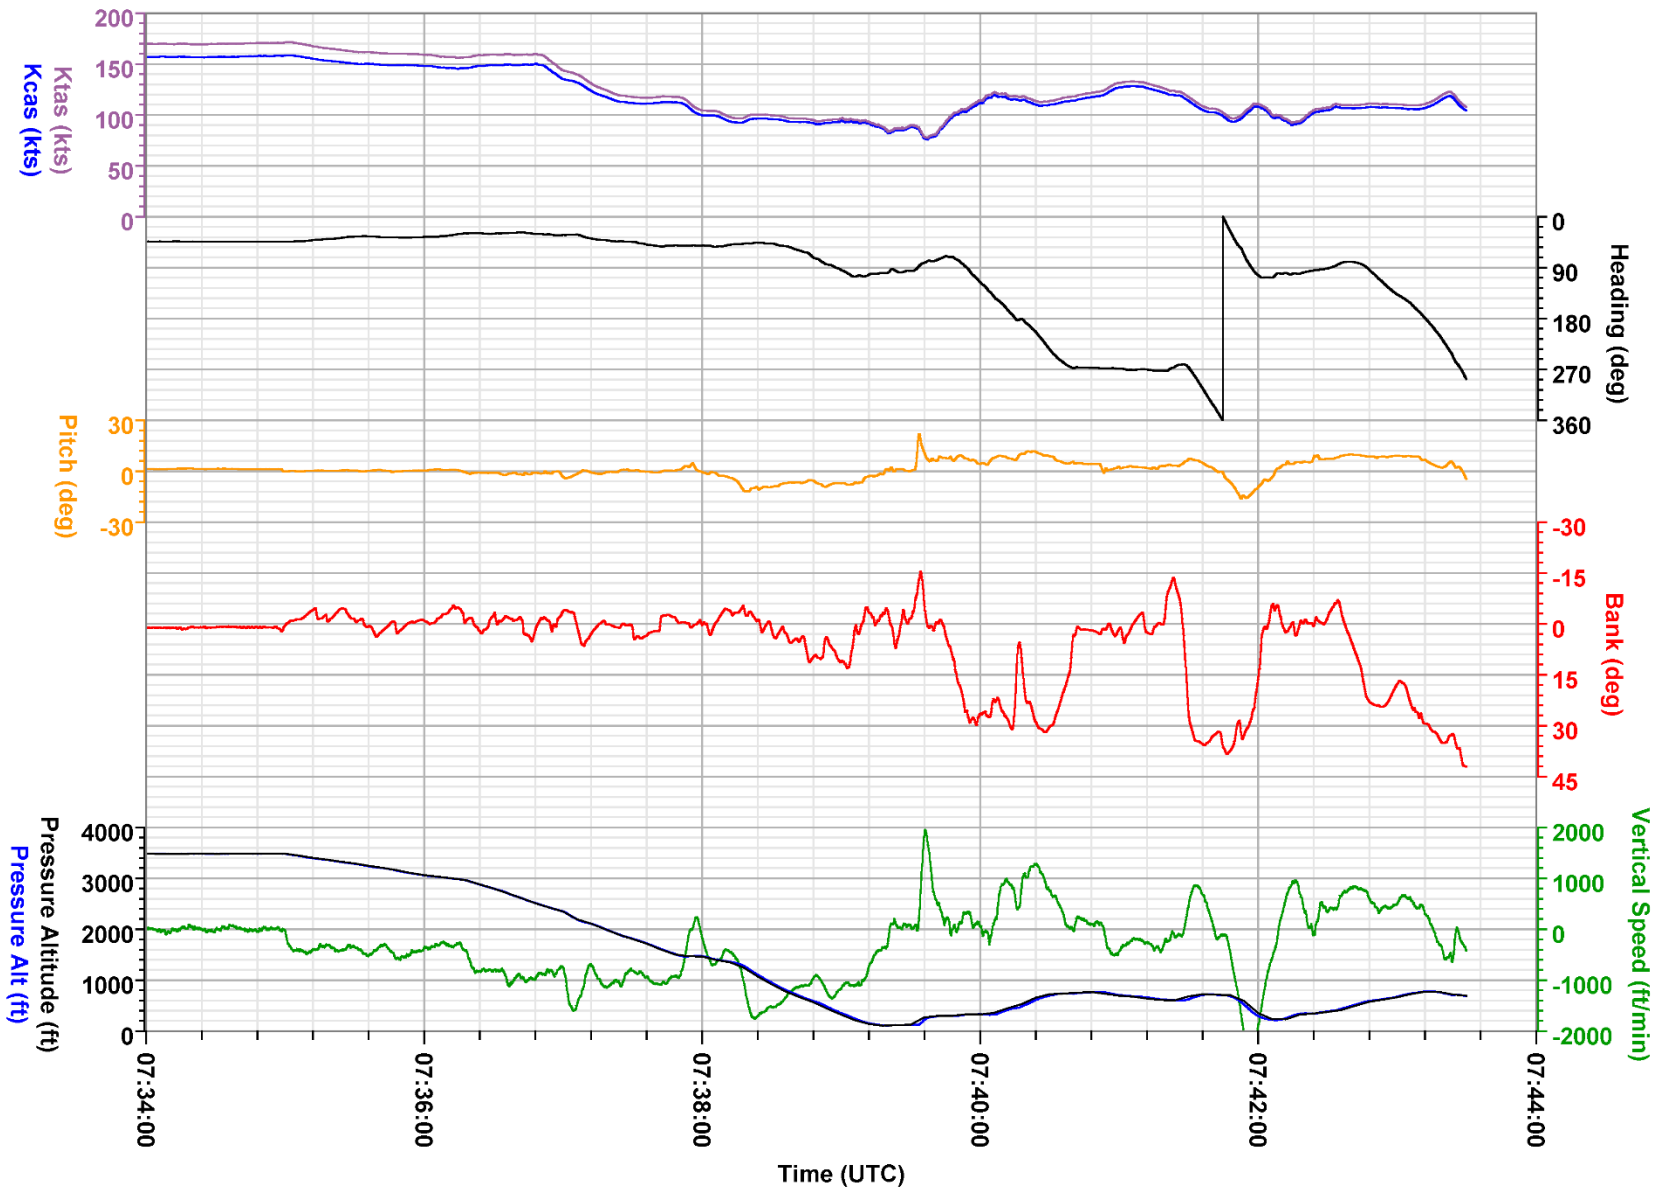
Figure 6 shows the air data, attitude, and heading parameters for the last 10 minutes of the accident flight from the DFC-90 as well as the pressure altitude recorded by both devices for timing alignment.

Figure 6. Air data, attitude, and heading for the last 10 minutes of the accident flight
