NATIONAL TRANSPORTATION SAFETY BOARD

Global Positioning System Device

Specialist's Factual Report
By Bill Tuccio, Ph.D.

Location: Osage Beach, Missouri
Date: March 11, 2015
Aircraft: Beechcraft B19
Registration: N774TA
Operator: Private
NTSB Number: CEN15LA172

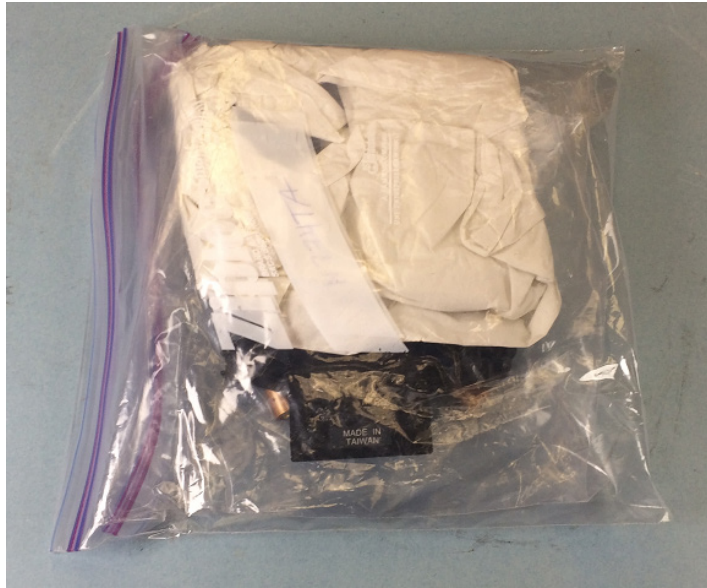
Figure 1. Photo of device, as received.

According to investigators, the device was retrieved from an unknown depth of fresh water in Lake Ozark, Missouri. The device was delivered to the NTSB Vehicle Recorder division in a sealed plastic bag, as shown in figure 1.

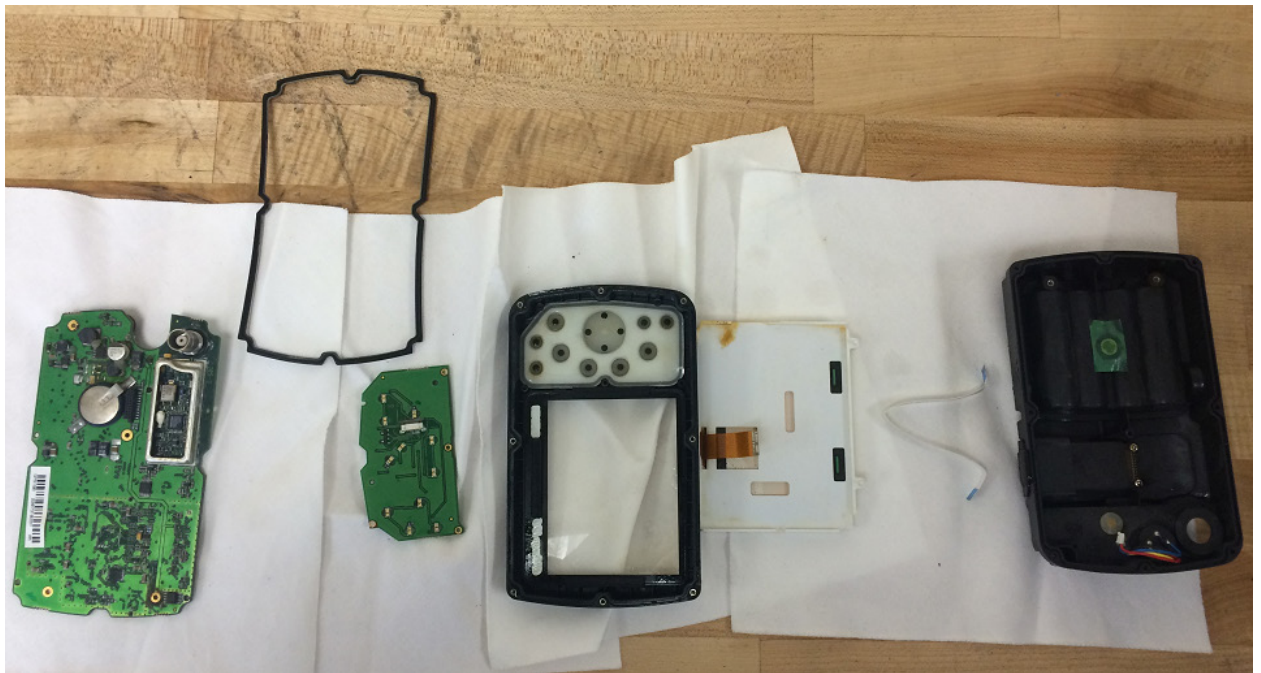
Figure 2. Components after disassembly and cleaning.

The unit was disassembled and each component was rinsed in deionized water, cleaned with Methanol, scrubbed with an acid brush, and then re-rinsed in deionized water. The components are shown in figure 2. After this treatment, all components were dried and vacuum-baked for 2 hours at 40° Celsius and 15 inches of Mercury to remove any remaining moisture and salts.

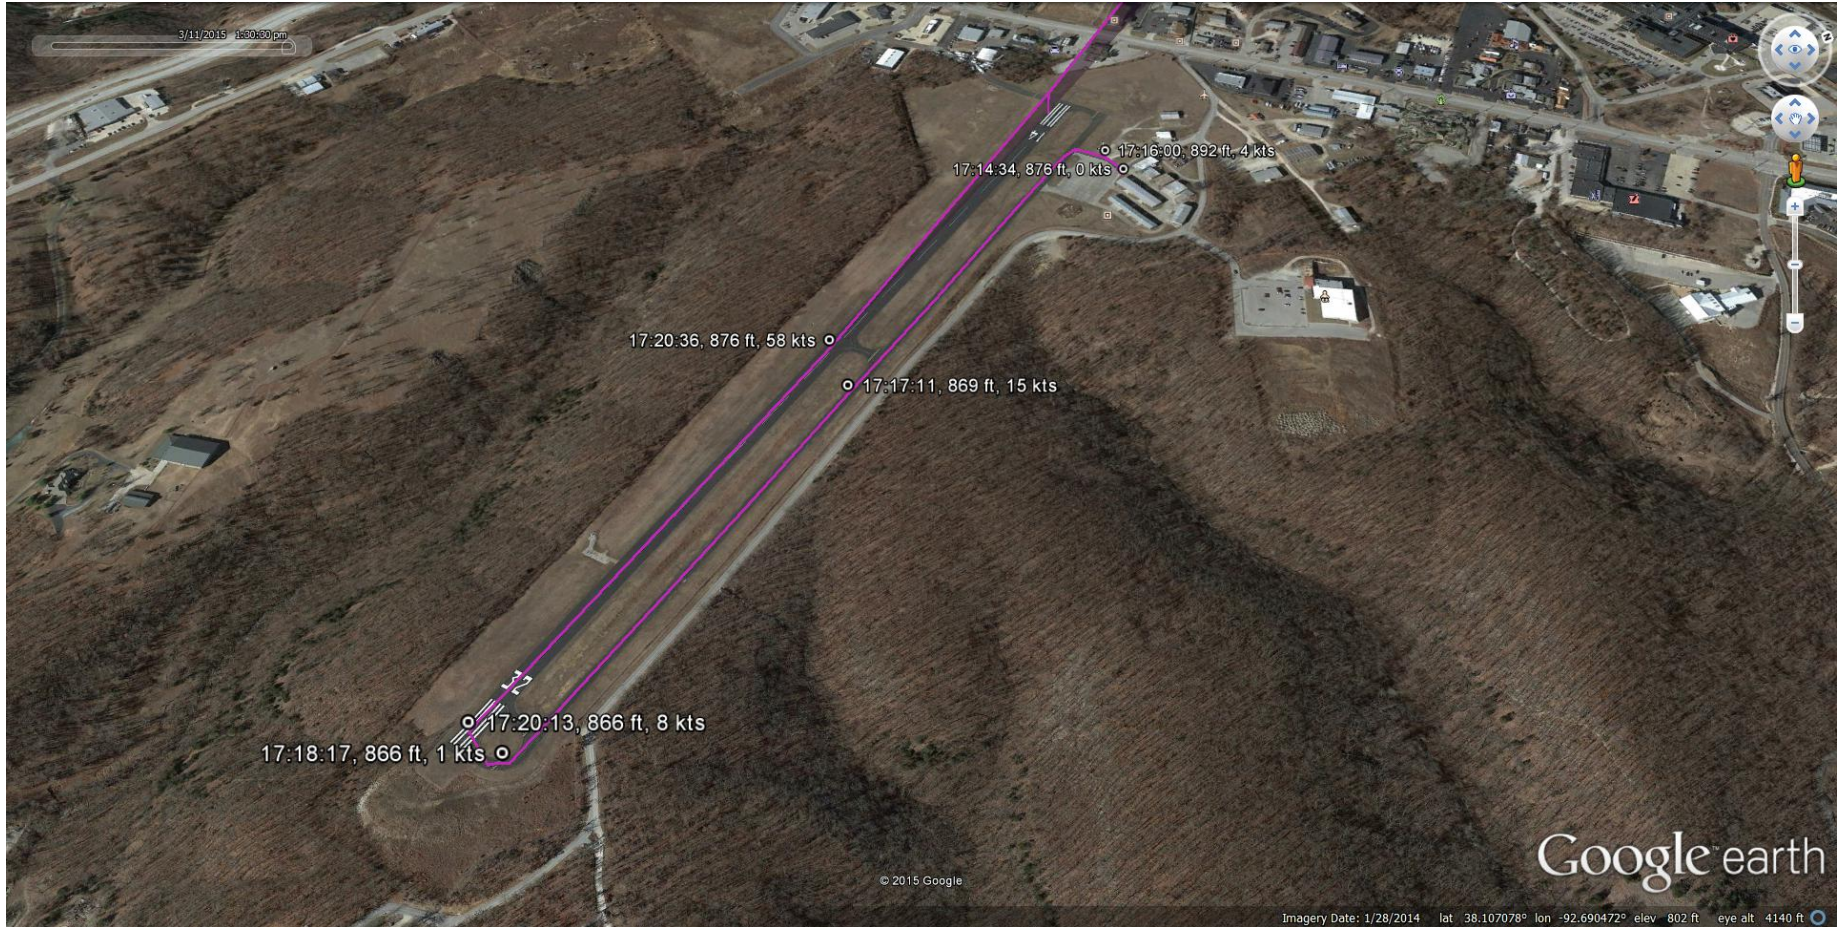
Figure 5. Google Earth overlay of accident ground operations.

Figure 5 shows ground operations at K15. By 17:16:00 UTC, the aircraft began to taxi towards runway 32. By 17:18:17 UTC, the aircraft reached runway 32 and by 17:20:13 UTC the aircraft began its takeoff roll.

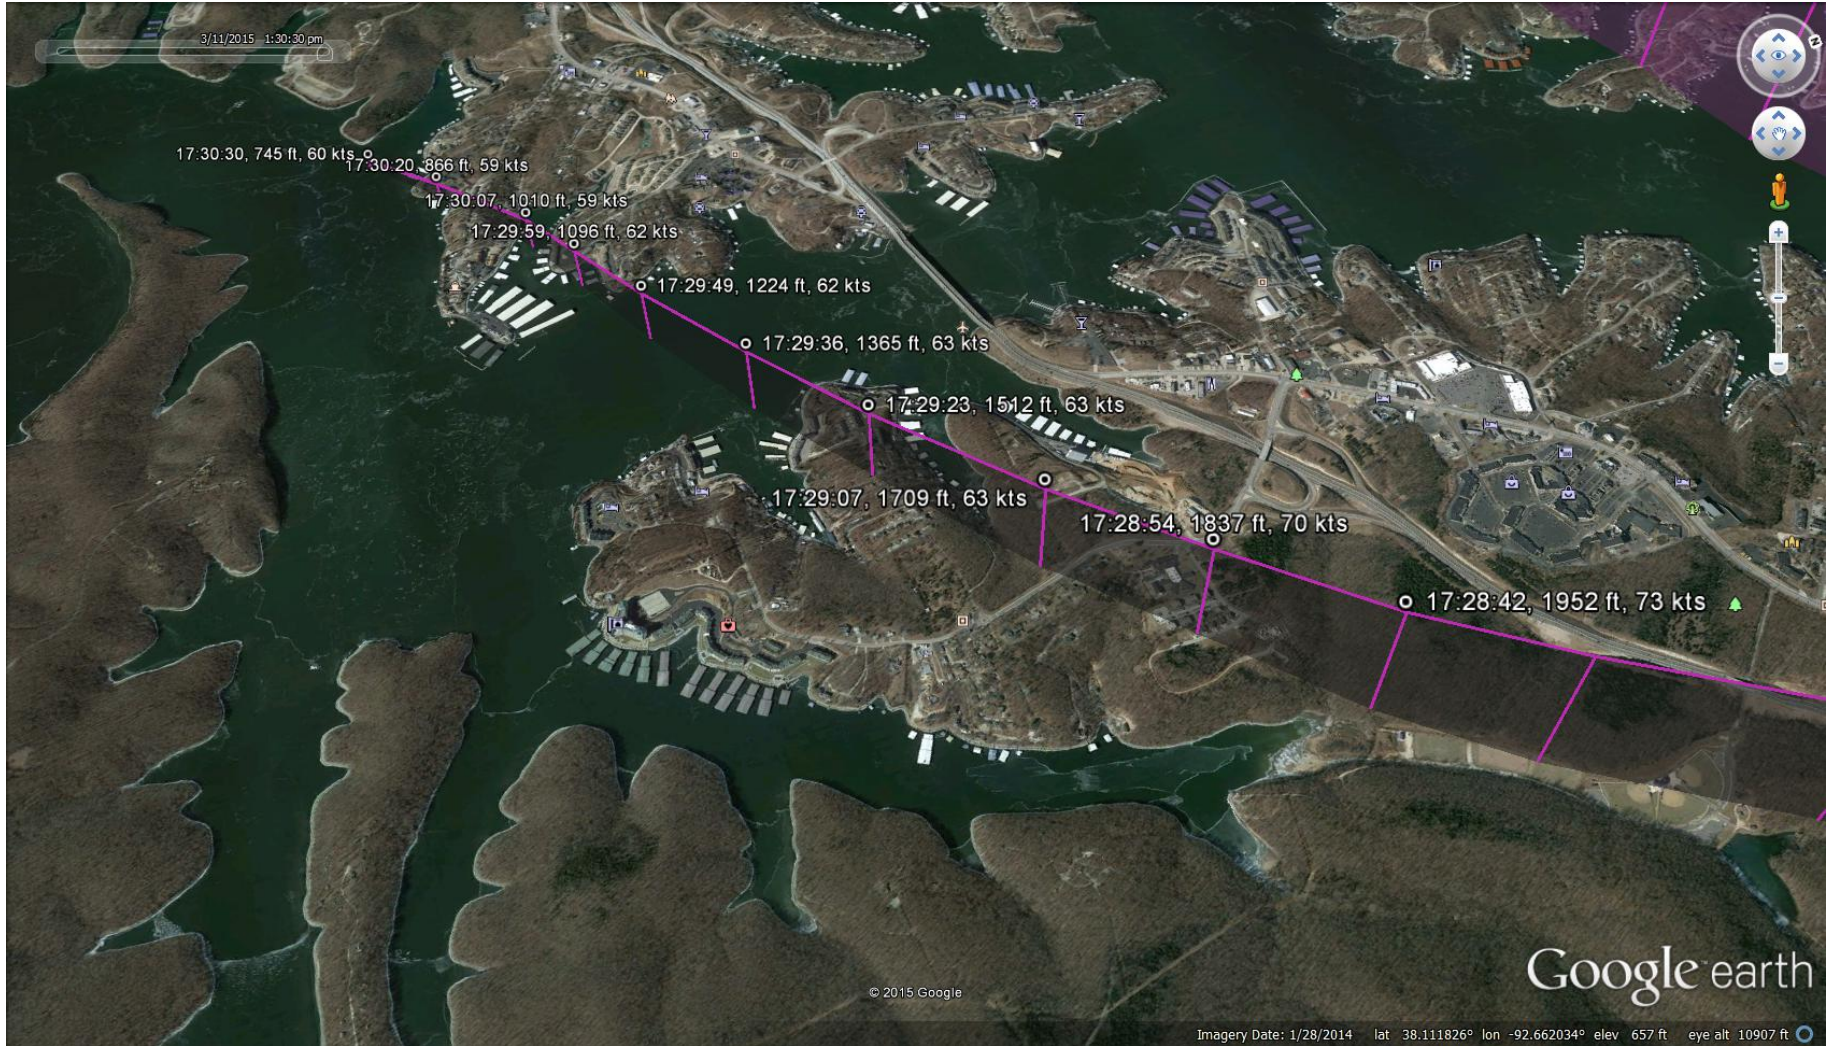
Figure 6. Google Earth overlay of end of accident recording.

Figure 6 shows the end of the recording. The aircraft descended southwest at about 63 knots groundspeed. The last recorded point was in Lake Ozark at 17:30:30 UTC.
