**NATIONAL TRANSPORTATION SAFETY BOARD**  
Vehicle Recorder Division  
Washington, D.C. 20594

## **Spoiler Control Unit Factual Report**

Location: Thomson, GA  
Date: February 20, 2013  
Aircraft: Beechcraft 390 Premier 1A  
Registration: N777VG  
NTSB Number: ERA13MA139

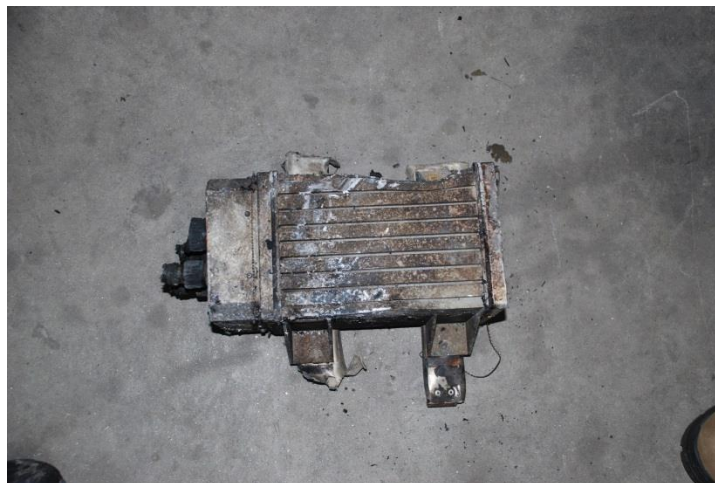
Upon arrival at the Vehicle Recorder Laboratory, an exterior examination of the device revealed major fire and impact damage to the unit's housing (figure 1). An interior inspection was performed and the SCU's bit and diagnostic card was located and removed (figure 2). The internal inspection of the card revealed fire damage consisting of bubbling to the cards conformal coating, displacement of memory chips, and a noticeable hot spot with burn damage to the card.

**Figure 1. Spoiler Control Unit as received.**

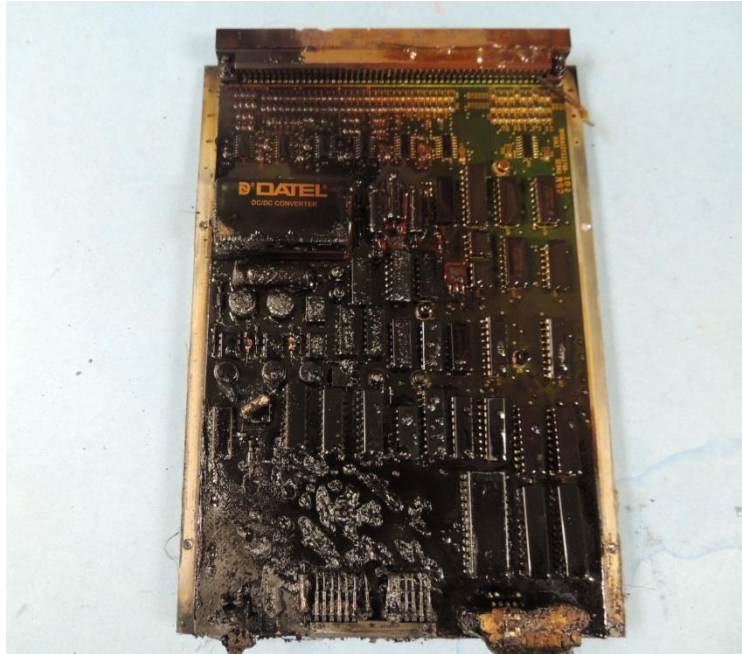
**Figure 2. Bit and diagnostic card as removed from SCU.**

The NVM chip was located, removed, and cleaned. Upon completing a preliminary binary reading of the chip, the chip was sent to Moog for download and readout.
